VFH

Repair Manual

Ref 310012 Rev. A
06-16

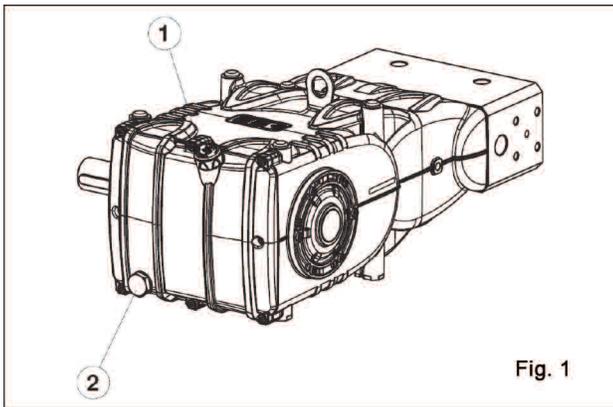
Fig. 1

Mechanical parts repair must be performed after removal of oil from the casing. To drain the oil, remove the oil dipstick, (1, fig. 1) and then the draining plug (2, fig. 1).

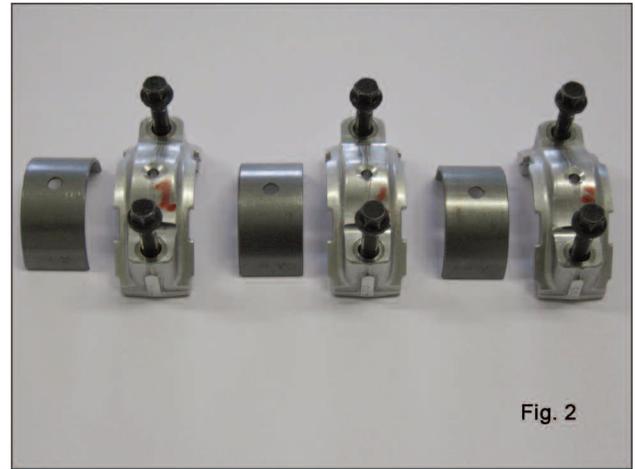
Fig. 2

- the pump shaft tab
- the rear cover
- the con-rod cap as follows: unscrew the cap fixing screws, remove the con-rod caps with their lower half-bearings (fig. 2) paying attention to the numbered sequence during disassembly.

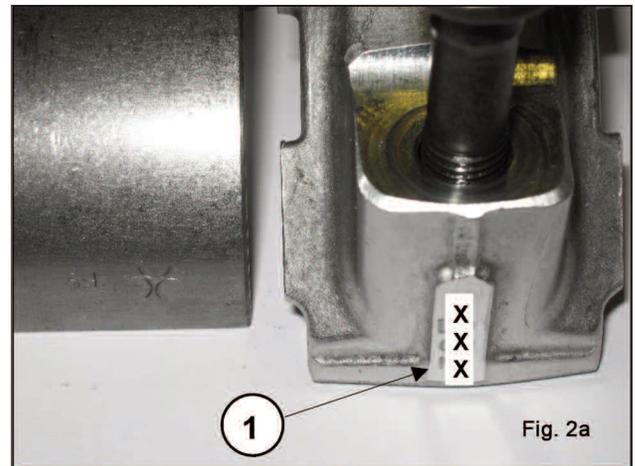
Fig. 2a

To avoid possible errors, caps and con-rod shanks have been numbered on one side (1, fig. 2a).

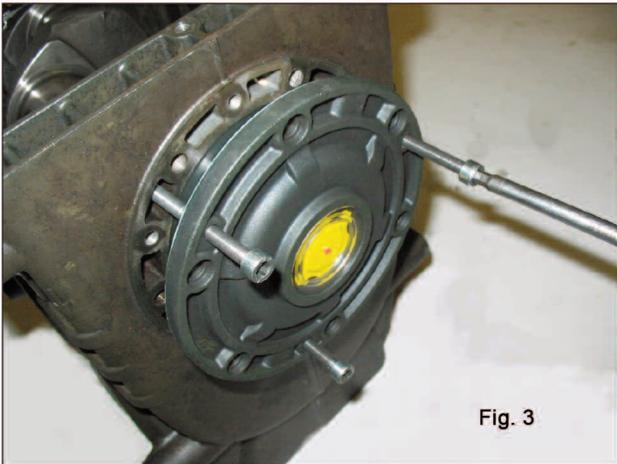
Fig. 3

- the side covers using - for extraction 3 fully threaded M6 x 50 screws, inserting them in the threaded holes as indicated in fig. 3.

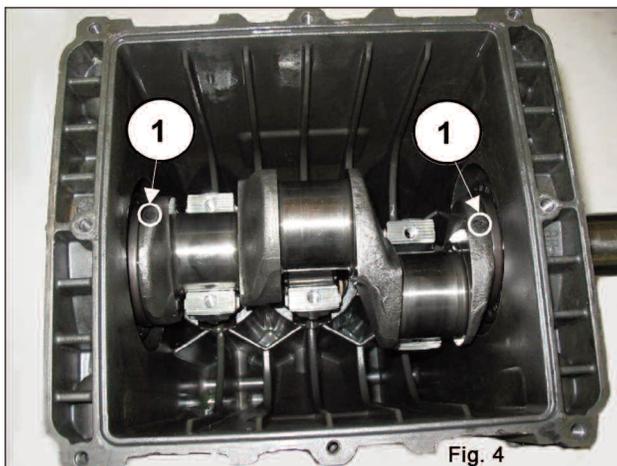
Fig. 4

- push the plunger guides forward with their con-rods to facilitate side extraction of the pump shaft. There are two reference points visible on the shaft (indicated with 1 in fig. 4 and in fig. 4a). These must be turned toward the operator to facilitate extraction.

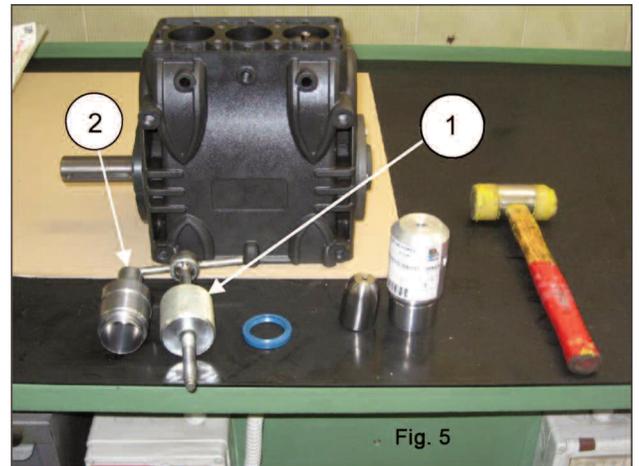
Fig. 5

Use the extractor p/n F26019400 (1, fig. 5) and the gripper p/n F27503900 (2, fig. 5). Insert the gripper as far as possible onto the seal ring with the aid of a hammer (fig. 5a), subsequently screwing the extractor to the gripper, and use extractor hammer (fig. 5b) until the ring to be replaced is removed (fig. 5c).

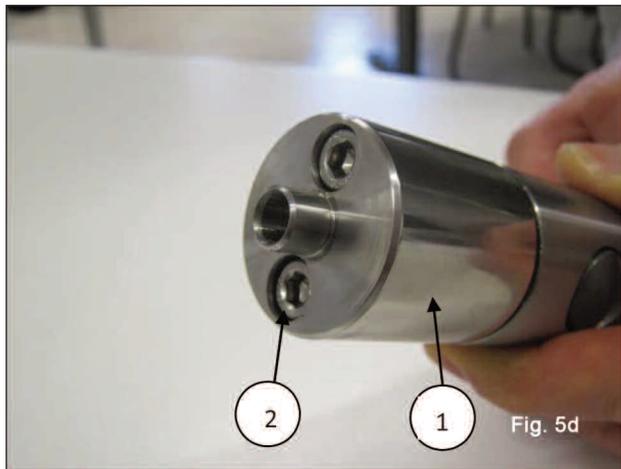
Fig. 5d

When disassembling the con-rod groups check the wear status of the plunger guide rods (1, fig. 5d), if necessary replace them removing the 2 fixing M6 screws (2, fig. 5d).

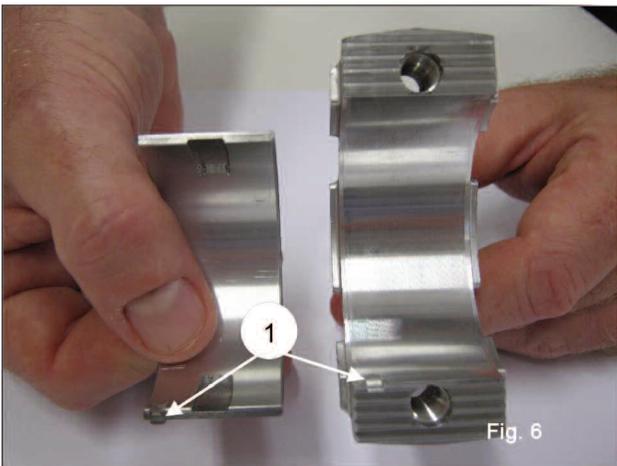
Fig. 6

Make sure that the reference marks on the upper half-bearings (1, fig. 6) and lower half-bearings (2, fig. 6a) are positioned in their respective seats in the con-rod and cap.

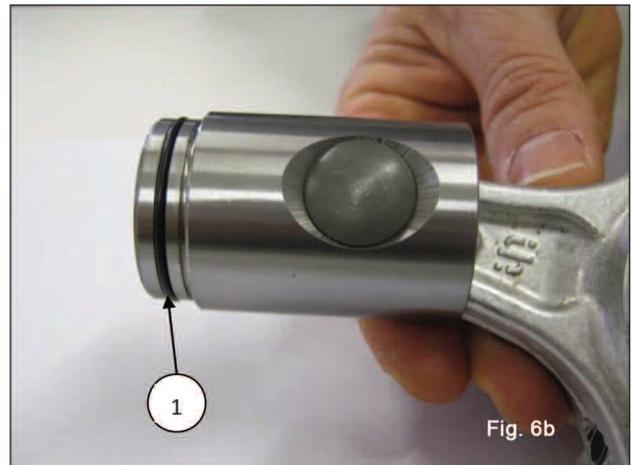
Fig. 6b

If the plunger guide rods have been disassembled, before reassembling them check the correct positioning of the sealing O-rings (1, fig. 6b) replace them if necessary. Tighten the plunger guide rods through the respective two M6 screws to the tightening torque indicated in Chapter 3.

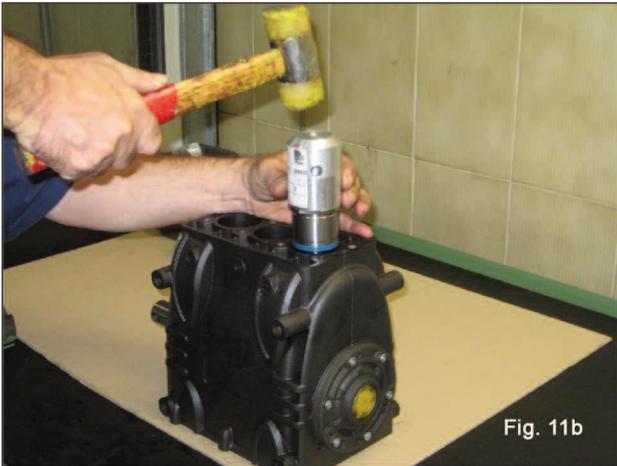
Fig. 11b

- After having completed tightening operations, check that the con-rod head has a side clearance in both directions.
- Insert the new plunger guide seal rings as far as possible into the relative seat on the pump casing (fig. 11), following the procedure described:
use the p/n F27904900 composed of a tapered bushing and a buffer. Screw the tapered bushing into the hole in the plunger guide (fig. 11a), insert the new seal ring on the buffer as far as it will go (determined by the height of the buffer) into its seat on the pump casing (fig. 11b), remove the tapered bushing (fig. 11c).

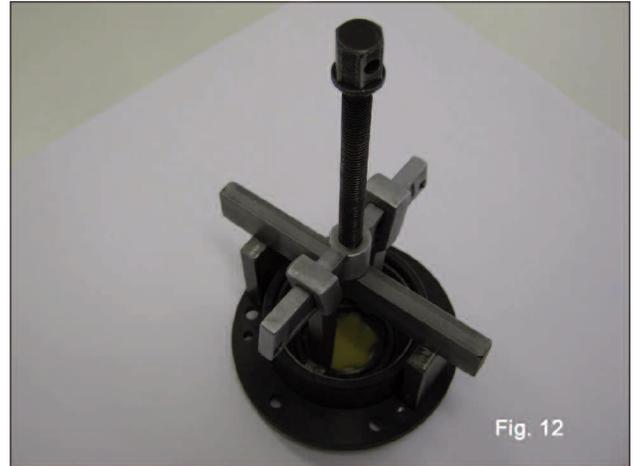
Fig. 12

After removing the side covers, as described above, remove the outer ring nut on the bearings from its seat on the covers, using a appropriate extractor as shown in fig. 12 and fig. 12a. Remove the inner ring nut on the bearings from the two ends of the shaft, again using a appropriate extractor or, alternatively a simple "pin punch" as shown in fig. 13.

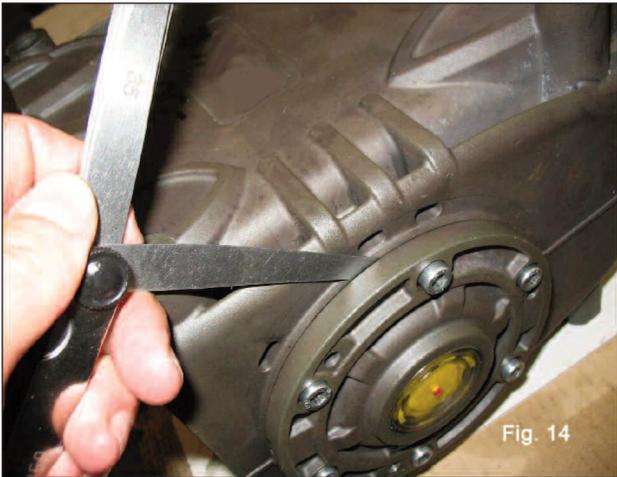
Fig. 14

Secure the PTO side flange to the casing, taking care with the lip seal as described previously and tighten the fixing screws to the recommended torque. Then feed the flange on the indicator side without shims in the case and start to move it closer, manually screwing the M6 x 40 service screws in equally, with small rotations such as to move the cover in slowly and correctly. Continuing the procedure in this way, a sudden increase in hardness during shaft rotation will soon be experienced. At this point, halt the forward movement of the cover and loosen the fixing screws completely. With the aid of a feeler gauge, measure the clearance between the sid cover and pump casing (see fig. 14).

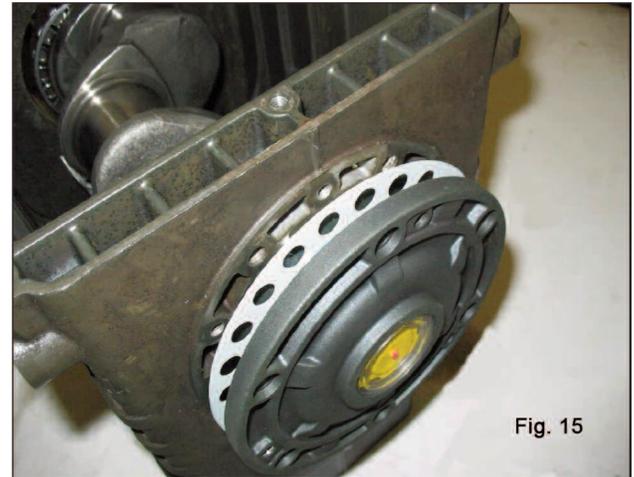
Fig. 15

Once the type and number of shims have been determined using the table, check the following: assemble the shim pack on the indicator side cover centering (fig. 15), secure the cover to the casing, following the procedure in 2.1.2 and tighten the screws to their recommended torque.

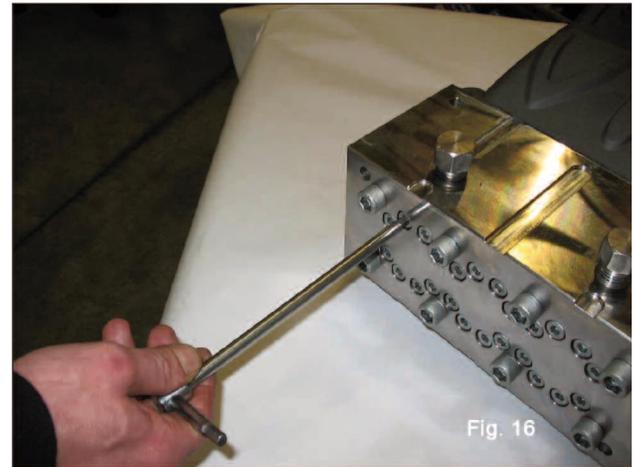
Fig. 16

- Loosen but do not remove the M8 x 100 screws fastening the liners to the head, as shown in fig. 16, so as to free them.

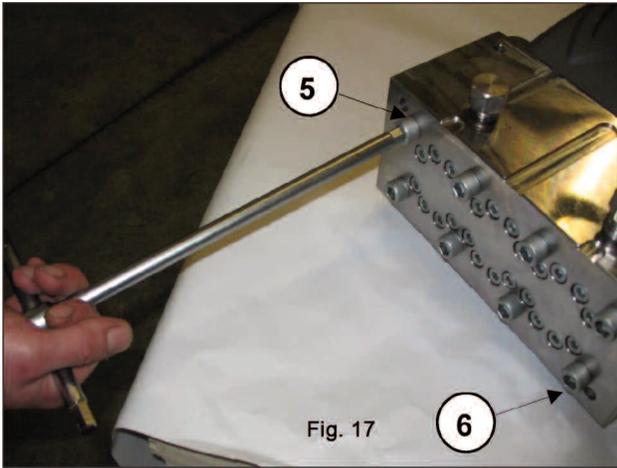
Fig. 17

- Unscrew the M12 x 260 head fixing screws No. 5 and No. 6 as shown in fig. 17 replacing them with two service pin-screws (p/n F27508200) as shown in fig. 18, then remove the remaining screws.

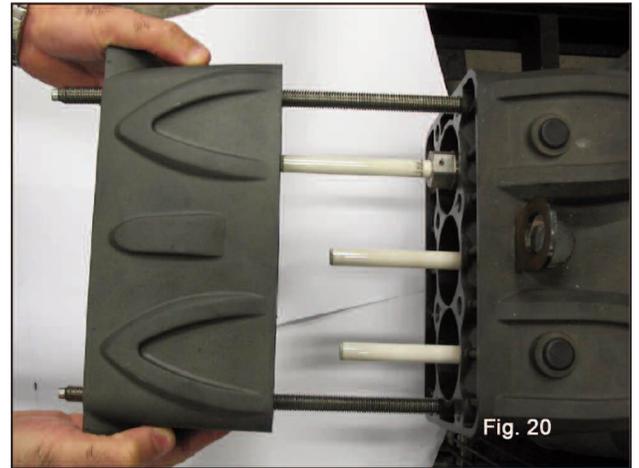
Fig. 20

- Separate the head and the spacer for the liners from the pump casing as shown in fig. 19 and fig. 20.

- Separate the head and the spacer for the liners from the pump casing as shown in 2.2.1 fig. 19 and fig. 20.

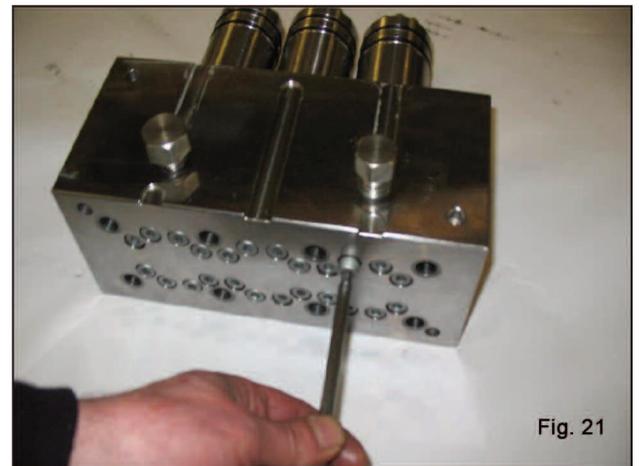
Fig. 21

- Take out the M8 x 100 screws fastening the liners to the head as shown in fig. 21 and proceed as shown in fig. 22.

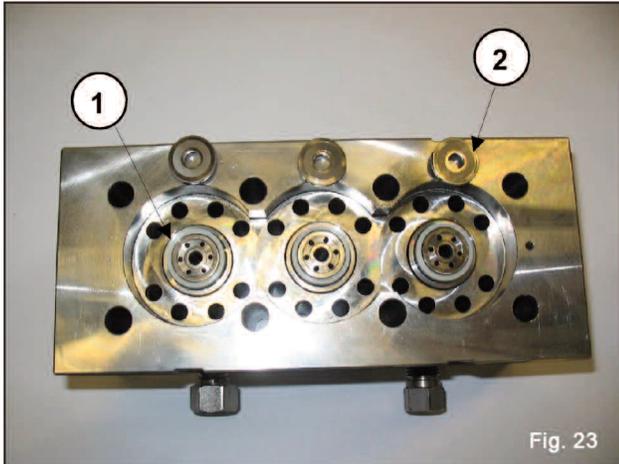
Fig. 23

When removing the liners, take care not to lose the valve seats, 1, and the flat valves, 2, as shown in fig. 23 which, being only laid down, could fall.

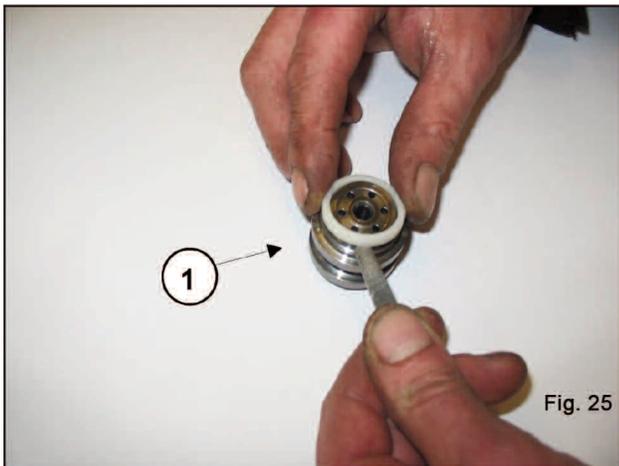
Fig. 25

- Extract the valve seats, 1, as shown in fig. 25, check the various components for wear and replace them if needed.

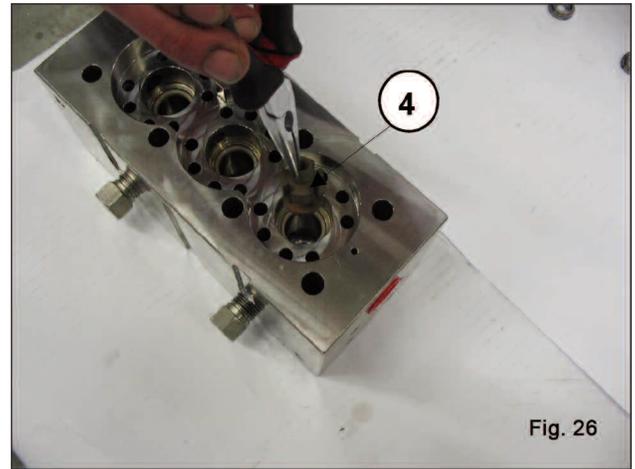
Fig. 26

- Extract the outlet plates, 3, and their guides, 4, with the springs, as shown in fig 26 and fig. 27, check for wear and replace if necessary, and in any case within the times indicated in the "Preventive Maintenance" table of Chapter 11 in the Owner's Manual.

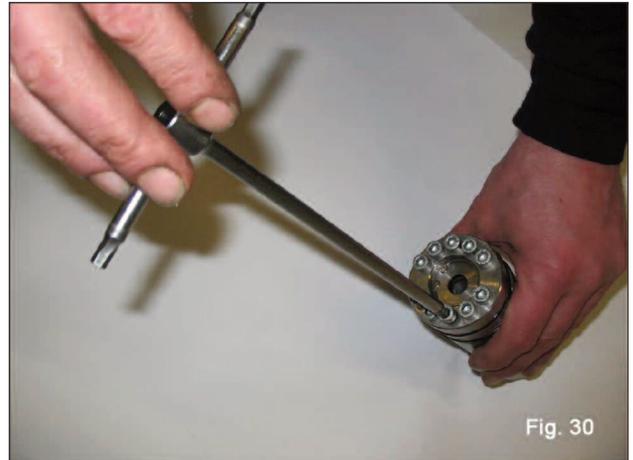
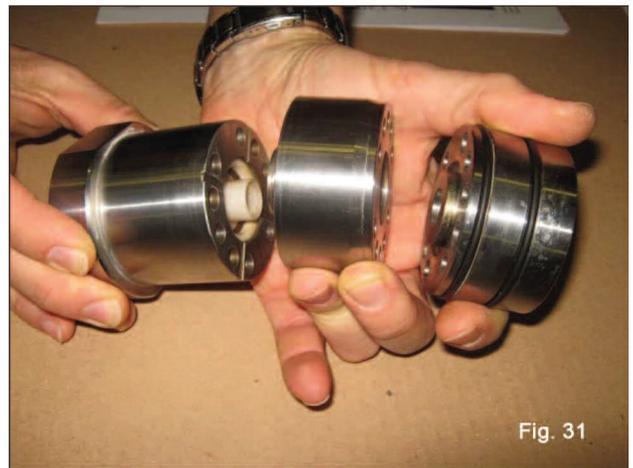
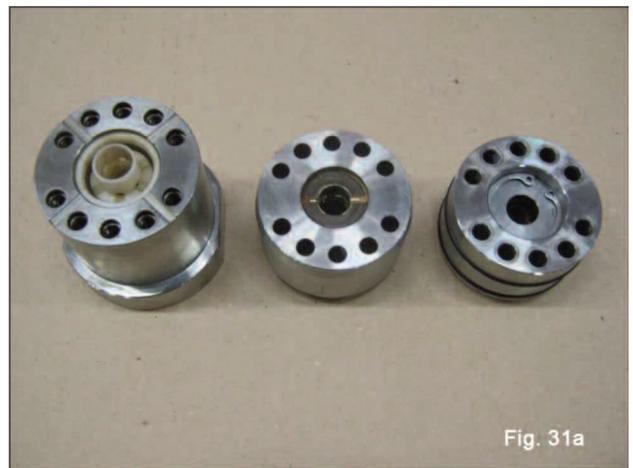
- Remove the pumping elements with a fork wrench and check for wear as indicated in fig. 28 and fig. 29, replace them if necessary.
- Remove the M6 x 80 screws that fix the LP seals supports, HP seals support and liner as shown in fig. 30 and proceed to the separation of all the components as indicated in fig. 31 and 31a.

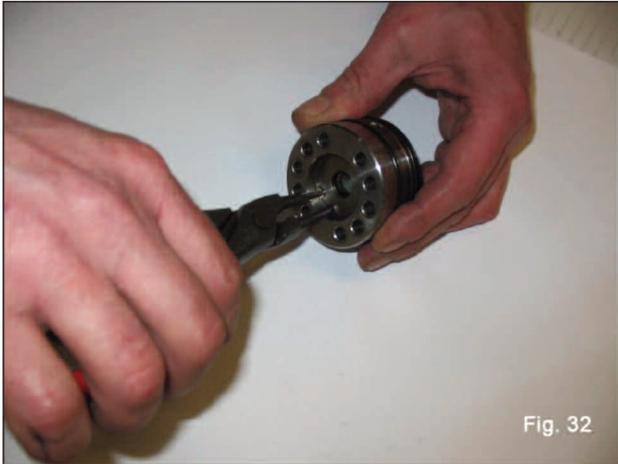
- Remove the seeger ring and the seal retainer ring as shown in fig. 32, and using a special plastic pin extract the LP (low pressure) seal, 1, as shown in fig. 33.

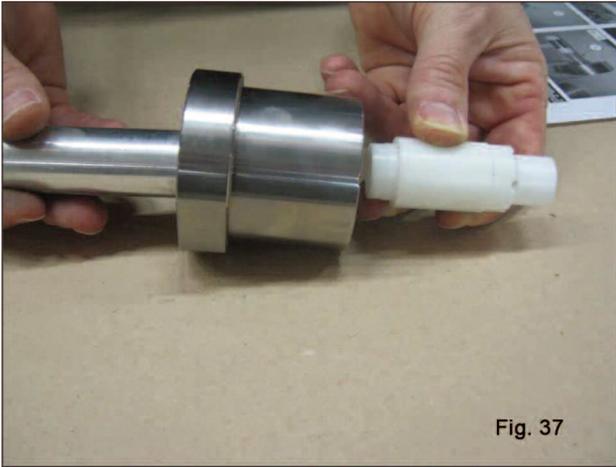
Fig. 37

- With separate HP seals support and a special pin (3, fig. 34) make the HP pack come out, pack (high pressure), 4, fig. 35, finally extract the head ring (fig. 36). The bushing for plunger, if replaced, is extracted from the liner with a special pin (fig. 37).

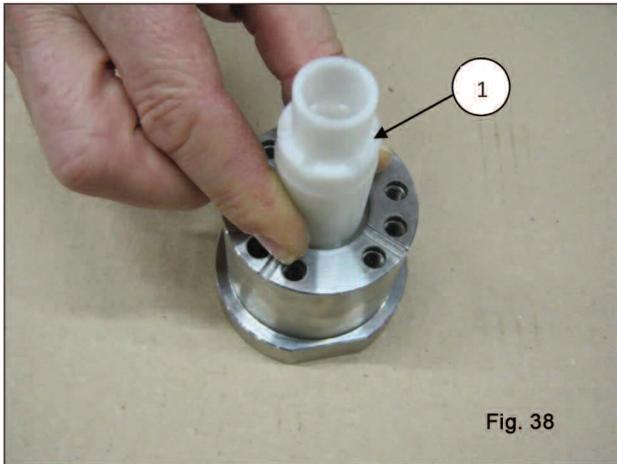
Fig. 38

- Insert the bushing for plunger and seal in the liner (1, fig. 38, fig. 39 and fig. 40).

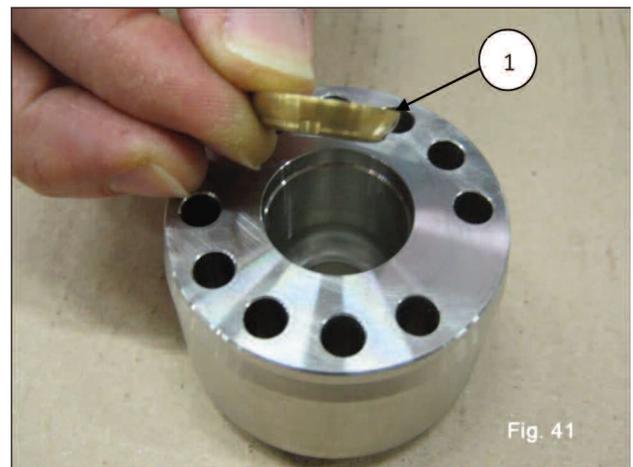
Fig. 41

- Introduce in the HP seals support, the head ring (1, fig 41) and then the HP packing; considering the slight interference between the seal and the HP seals support, to avoid damage we advise using a plastic pad (1, fig. 42 and 43).

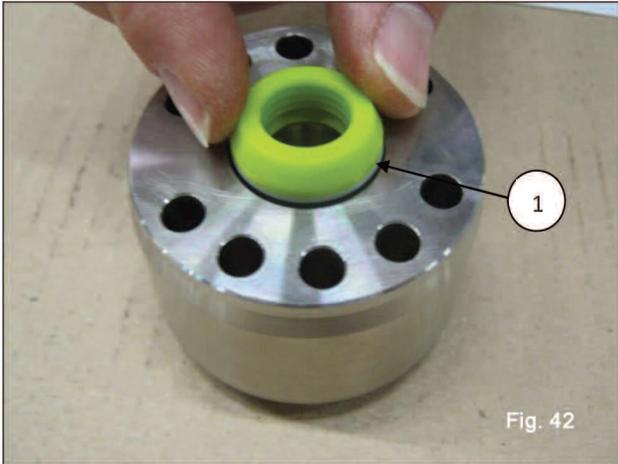
Fig. 42

The HP seal must be inserted into the liner with the energizing O-ring in the working direction of the plunger as shown in fig. 42 and fig. 44.

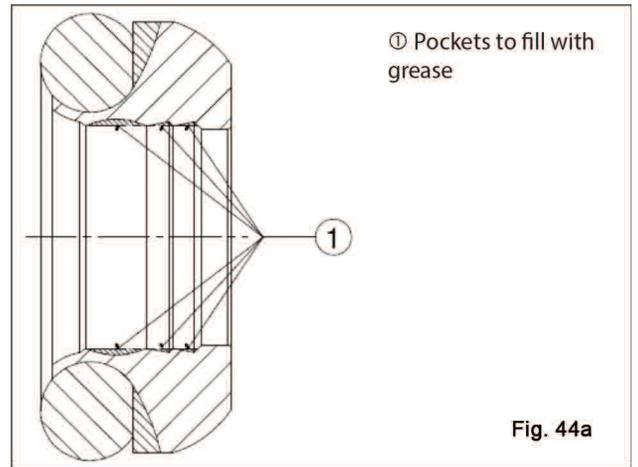
Fig. 44a

- A) The external diameter must only be slightly greased;
- B) On the internal diameter, grease must be applied paying great attention to filling all the pockets between the sealing lips as shown in fig. 44a.

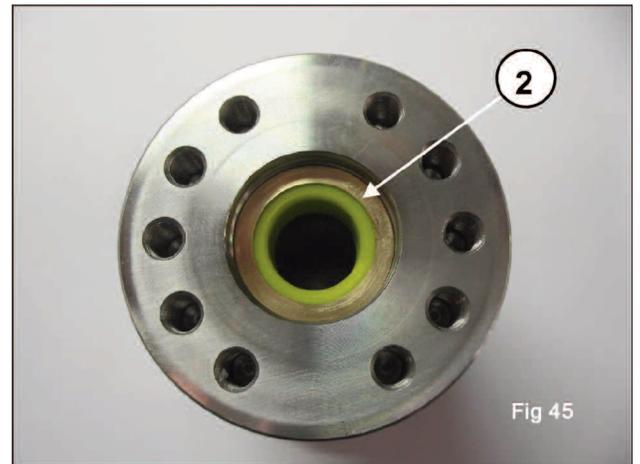
Fig 45

- Insert the anti-extrusion ring (2) and the gasket bushing (3) arranged as shown in fig. 45, 46 and 47.

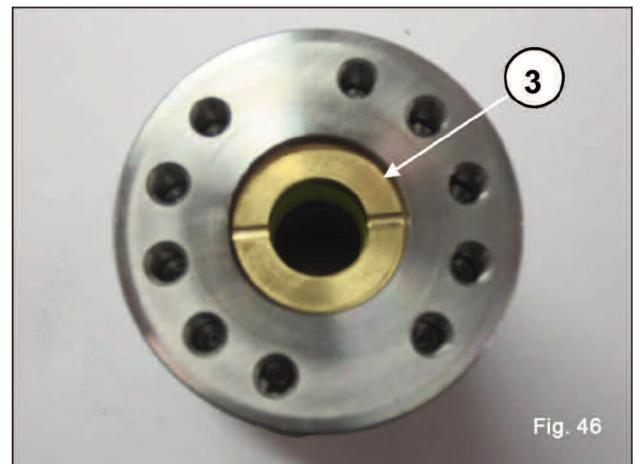
Fig. 46

! The gasket bushing (3) must be introduced into the liner with the outlets facing outwards (casing side) as shown in fig. 46 and in fig. 47.

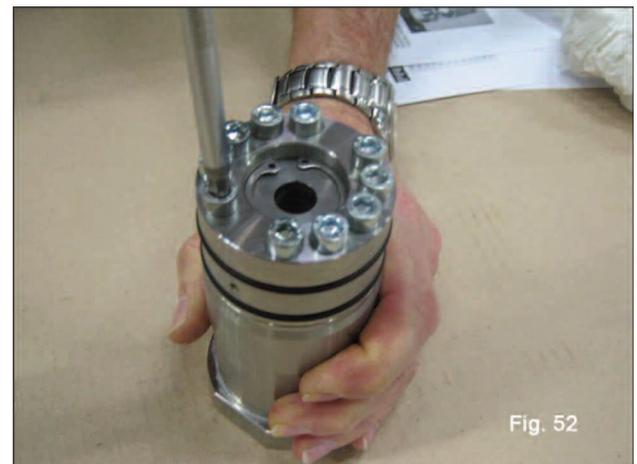
- Assemble the LP and HP seals support units - liner manually screwing the screws M6 x 80 as indicated in fig. 52. Then proceed with calibration using a torque wrench as indicated in Chapter 3.

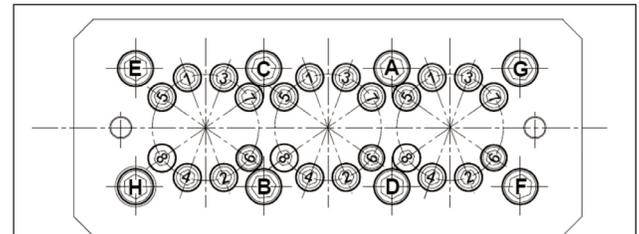
Fig. 54

OPERATION 1: Tightening M12x260 screws (pos. 48) in two phases observing the sequence indicated in figure: (A-B-C-D-E-F-G-H)

- Phase 1 = 40 Nm**
- Phase 2 = 80 Nm**

OPERATION 2: Tightening M8x100 screws (pos. 47) in four phases observing the sequence indicated in figure: (1-2-3-4-5-6-7-8)

- Phase 1 = 20 Nm**
- Phase 2 = 30 Nm**
- Phase 3 = 35 Nm**
- Phase 4 = 35 Nm**

- * The con-rod cap fixing screws must be tightened at the same time respecting the phases indicated on page 6.
- ** The head fixing screws (exploded position 57) must be tightened with a torque wrench respecting the sequence shown in the diagram in fig. 54.
- *** The liner fixing screws (exploded position 56) must be tightened in a single phase, respecting the sequence shown in the diagram in fig. 54.
- ****The support fixing screws must be tightened in two steps, respecting the sequence shown in fig. 53:
 1st Step: 12.5 ft.lbs. (17 Nm) according to the sequence indicated;
 2nd Step: 12.5 ft.lbs. (17 Nm) calibration check repeating the sequence indicated.
