KT24A/28A/30A/32A/36A/40A

Repair Manual

KT24A, KT28A, KT30A, KT32A, KT36A, KT40A

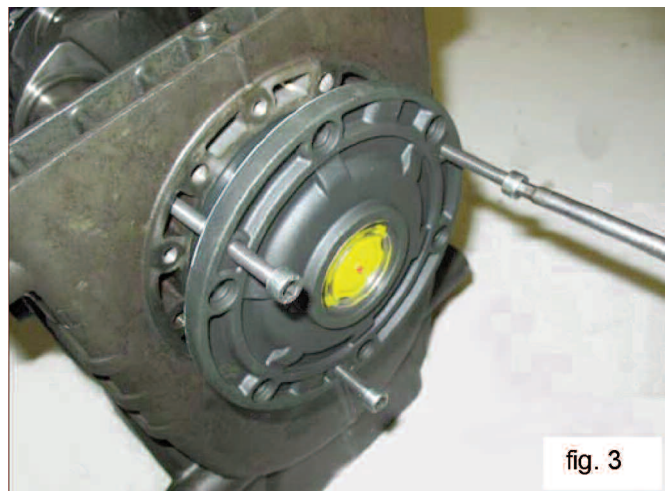
- The side covers using - for extraction 3 fully threaded M6 x 50 screws, inserting them in the threaded holes as indicated in fig. 3

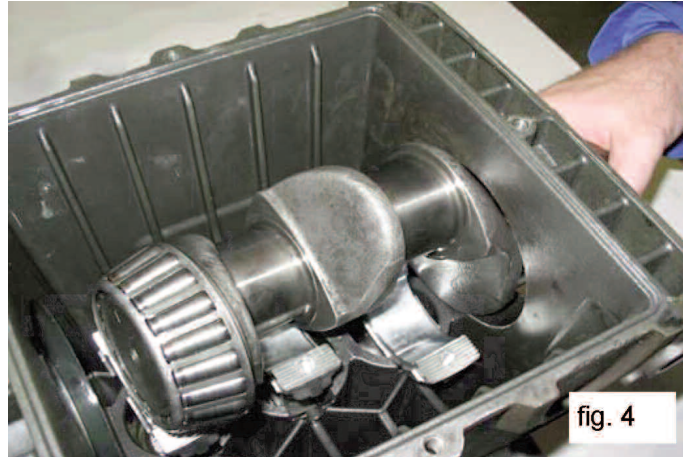
fig. 4

- Push the piston guides forward with their con-rods to facilitate side extraction of the pump as indicated in fig. 4.

To facilitate pump shaft insertion (without the tab), it is essential to repeat the operation performed during disassembly, pushing the piston/con-rod guide units as far down as possible (paragraph 2.1.1).

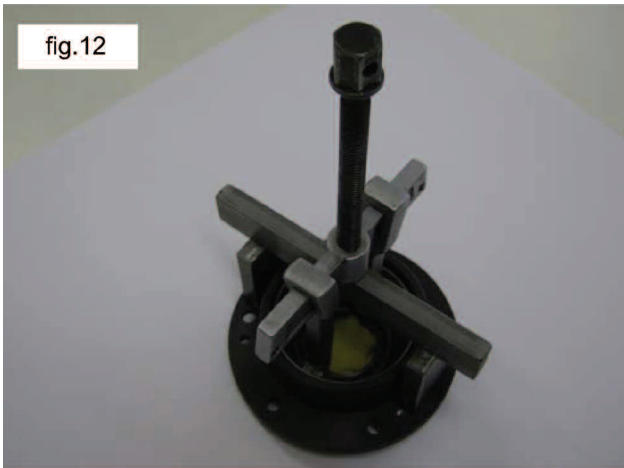
After removing the side covers, as described above, remove the outer ring nut on the bearings from its seat on the covers, using an appropriate extractor as shown in fig. 12 and 12a.

Remove the inner ring on the bearings from the two ends of the shaft, again using an appropriate extractor or, alternatively, a simple "pin punch" as shown in fig. 13.

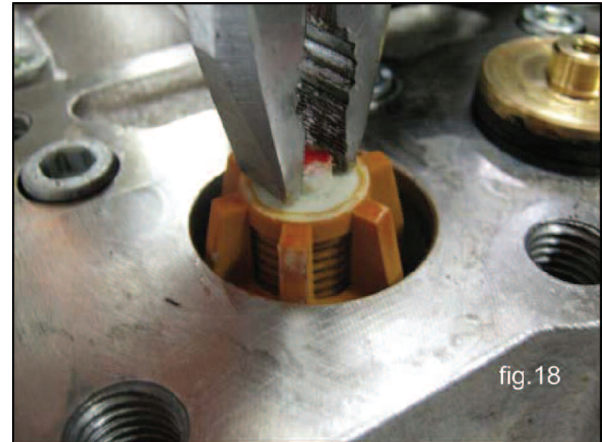
- Unscrew the 8 M14x40 suction valve cover fastening screws and the 8 m12x35 outlet valve cover fastening screws (fig. 16 and 16a) using the extractor hammer p/n F26019400 combined with tool F27726200 extract
- The KT24A, 28A, 30A, 32A suction and outlet valve units and KT36A or 40A inlet valve units using a simple tool as indicated in fig. 18
- Extract the KT36 or KT40 pump suction valve units using an extractor hammer part #F26019400 combined with tool #F27513600 (fig. 19).

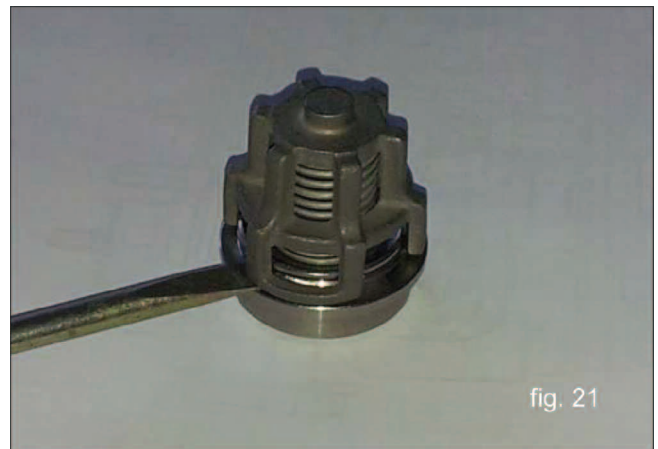
Dismantling of the suction and outlet valve units can be carried out screwing in a sufficiently long M10 screw which can move the valve plate and remove the valve guide from the seat (1, fig. 20). If the threaded holes should not be present on the valve guides, dismantling can be easily carried out by levering with simple tools (fig 21).

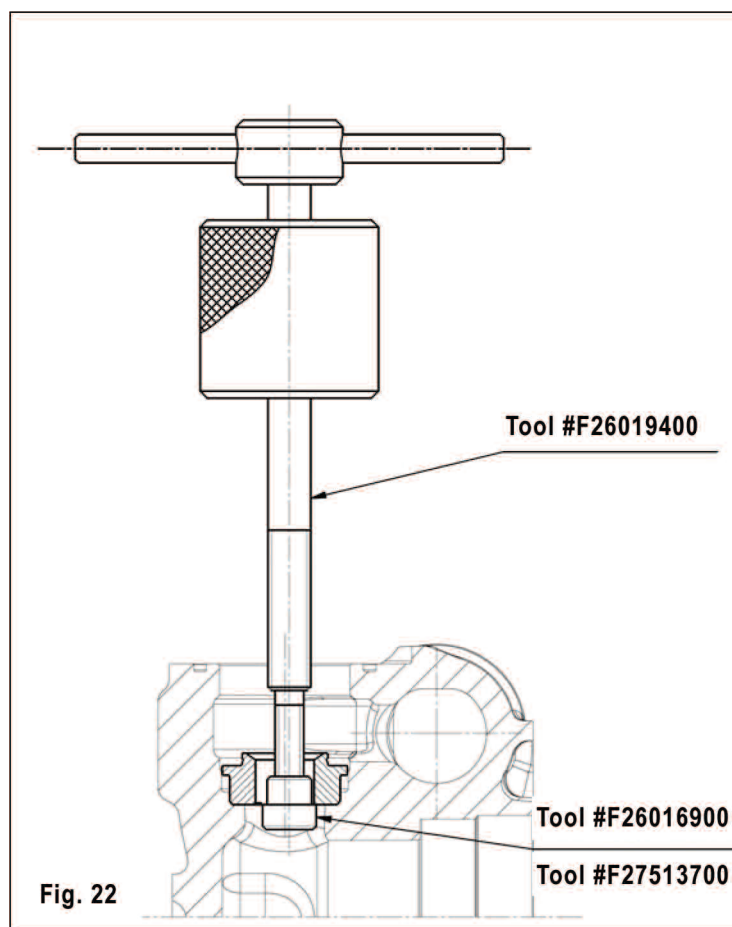
For KT24A, 28A, 30A, 32A use tools #F26019400, and F27513700 (fig. 22)

For KT36A and 40A use tools #F26019400, F27516900 (fig. 22)

For KT36A and 40A use tools #F26019400 and F27513700 (fig 22)

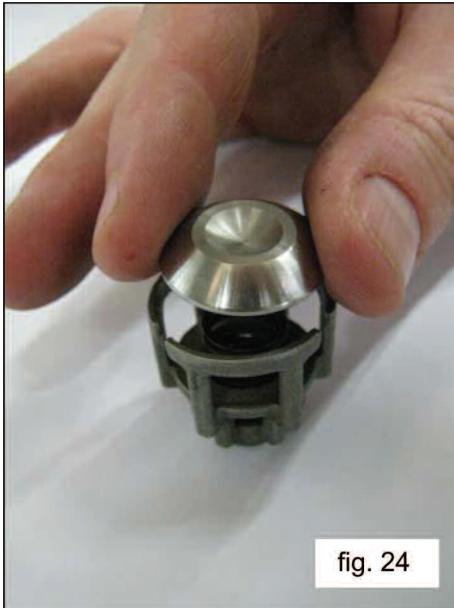
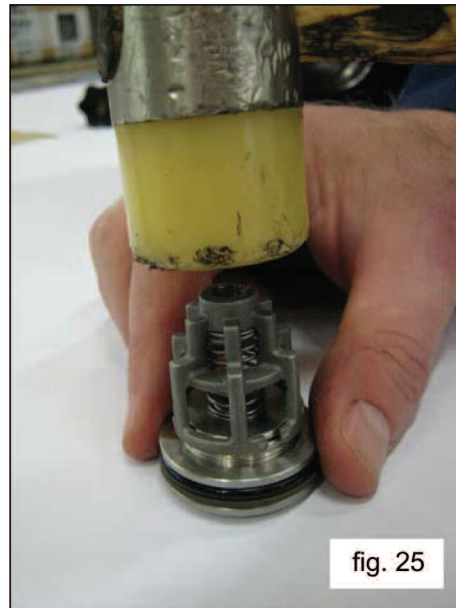
To reassemble the various components, follow the reverse operations listed above as described in point 2.2.1. Reassemble the valve unit (fig. 24) to facilitate insertion of the valve guide in the seat, use a hammer, acting on the whole circumference (fig. 25).

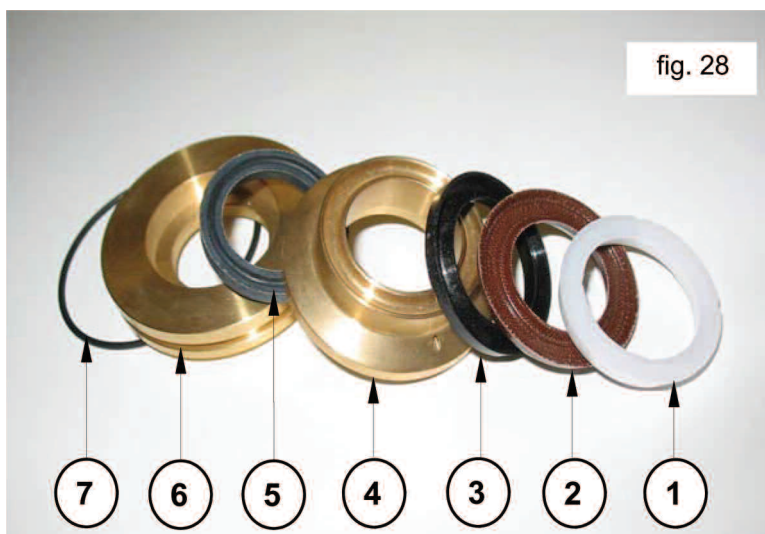
Pay attention to the order of seal pack disassembly as indicated in fig. 28 composed of:

1. Head ring
2. HP seal
3. Restop ring
4. Seals support
5. LP seal
6. Seal ring
7. O-ring

- A) Seals pack Respect the same order used during disassembly operations.
- B) Lubricate components 2,3 and 5 with OCILIS silicone grease p/n F12001600; this operation is also deemed necessary to facilitate adjustment of the lip seal on the piston.

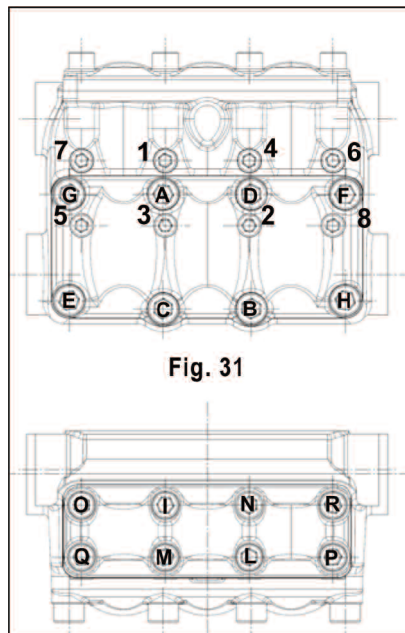
** The head fixing screws (exploded position 55) must be tightened with a torque wrench respecting the sequence shown in the diagram in fig. 31.

*** The valve cover fixing screws (exploded position 45) must be tightened with a torque wrench respecting the order shown in the diagram in fig. 31.
