KT16A/18A/20A/22A

Repair Manual

KT16A/18A/20A/22A SERIES

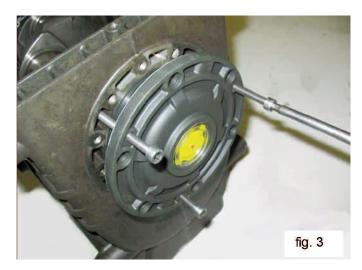
- The side covers using - for extraction 3 fully threaded M6 x 50 screws, inserting them in the threaded holes as indicated in fig. 3

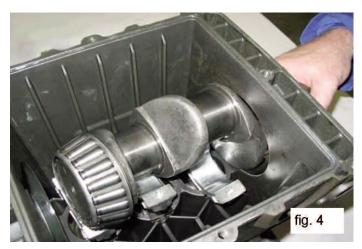
- Push the piston guides forward with their con-rods to facilitate side extraction of the pump as indicated in fig. 4.

To facilitate pump chaft insertion (without the tab), it is essential to repeat the operation performed during disassembly, pushing the piston/con-rod guide units as far down as possible (paragraph 2.1.1).

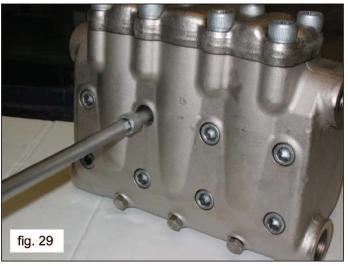
A) Unscrew the M10x140 head fixing screws as indicated in fig. 29.

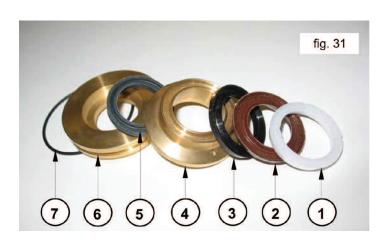
Pay attention to the order of seal pack disasembly as indicted in fig. 31 for KT20A and KT22A, and in fig. 31/a for KT16A and KT18A, composed of:

- 1. Head ring
- 2. HP seals
- 3. Restop ring
- 4. Seals support
- 5. LP seals
- 6. Seal ring
- 7. O-ring

- A) Seals pack Respect the same order used during disassembly operations.
- B) Lubricate components 2,3 and 5 with OCILIS silicone grease p/n F12001600; this operation is also deemed necessary to facilitate adjustment of the lip seal on the piston.

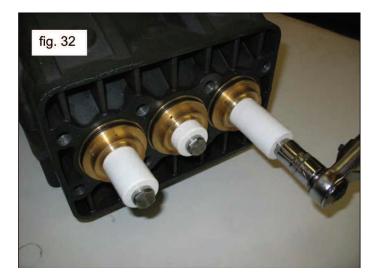
The piston unit does not require any routine maintenance. Maintenance is limited to visual checks only. To extract piston units: loosen the M7x1 piston fixing screws as indicated in fig. 32.
