Repair Manual

1.	INTRODUCTION	Page 3
2.	REPAIR INSTRUCTIONS	Page 3
	2.1 Repairing Mechanical Parts	Page 3
	2.1.1 Disassembly of Mechanical Parts	Page 4
	2.1.2 Assembly of Mechanical Parts	Page 15
	2.1.3 Increase and Reduction Classes	Page 27
	2.2 Repairing Hydraulic Parts	Page 27
	2.2.1 Dismantling the Head-Liners-Valves	Page 27
	2.2.2 Assembling the Head-Liners-Valves	Page 31
	2.2.3 Dismantling the Plunger Unit-Supports-Seals	Page 31
	2.2.4 Assembling the Plunger Unit-Supports-Seals	Page 33
3.	SCREW CALIBRATION	Page 37
4.	REPAIR TOOLS	Page 39
5.	REPLACING THE CONECTING ROD FOOT BUSHINGS	Page 40
6.	MAINTENANCE LOG	Page 41

This manual describes the instructions for Repairing SM Series pumps, and must be carefully read and understood before performing any repair intervention on the pump. Proper pump operation and longevity depend on the correct use and maintenance. General Pump declines any responsibility for damage caused by the misuse or the non-observance of the instructions described in this manual.

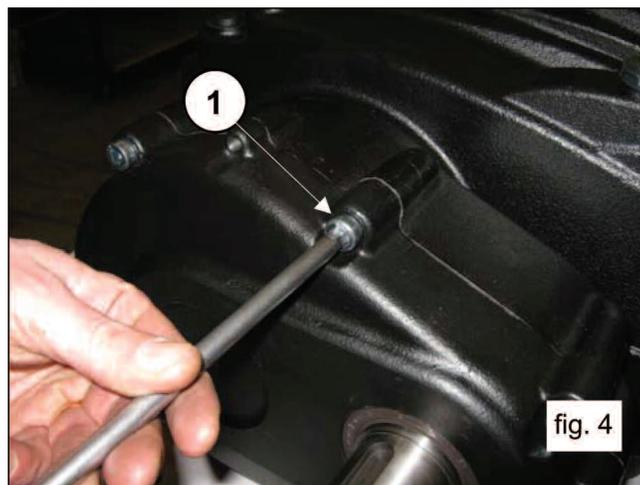
Unscrew the reduction gear cover fixing screws (1, fig. 4).

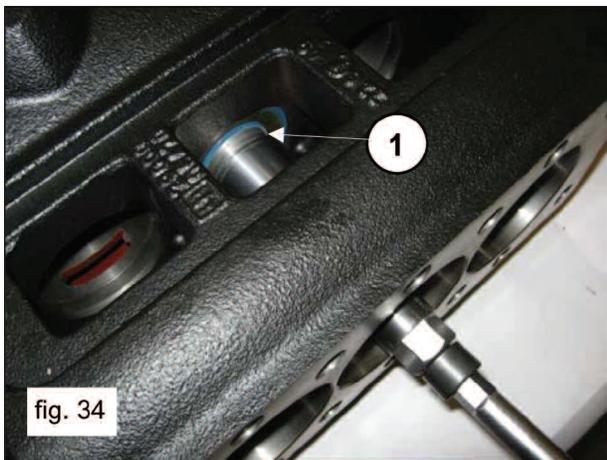
Insert the tool between the rod and the seal ring (1, fig. 34) and, with the extractor hammer, complete insertion of the tapered section inside the seal ring (1, fig. 35).

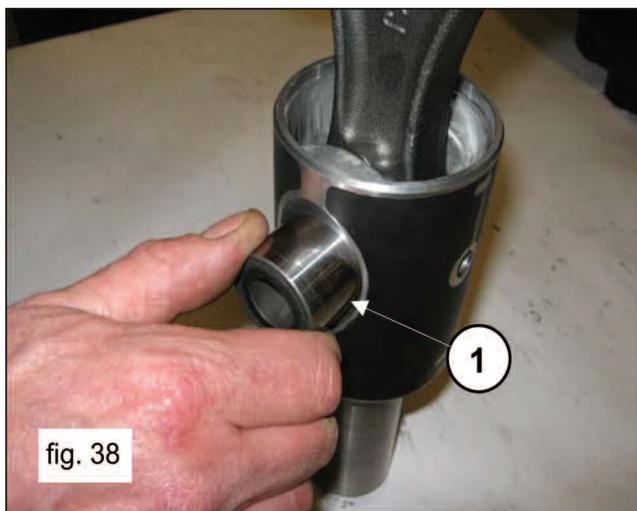
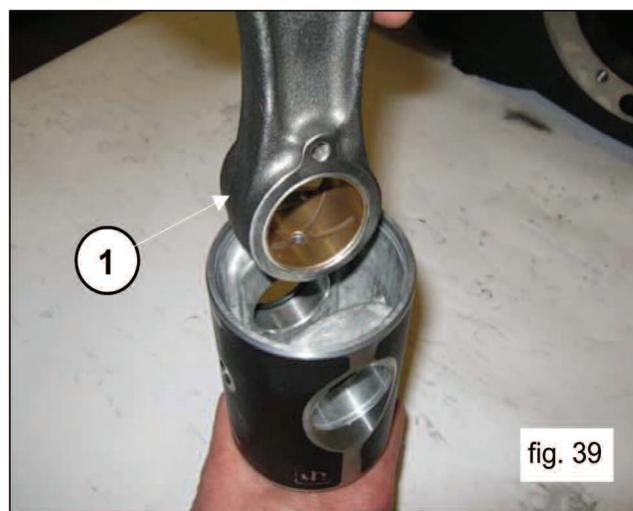
Remove the spindle (1, fig. 38) and extract the connecting rod (1, fig. 39).

Insert the connecting rod in the plunger guide (1, fig. 39) and then insert the spindle (1, fig. 38). Apply the two shoulder Seeger rings (1, fig. 37).

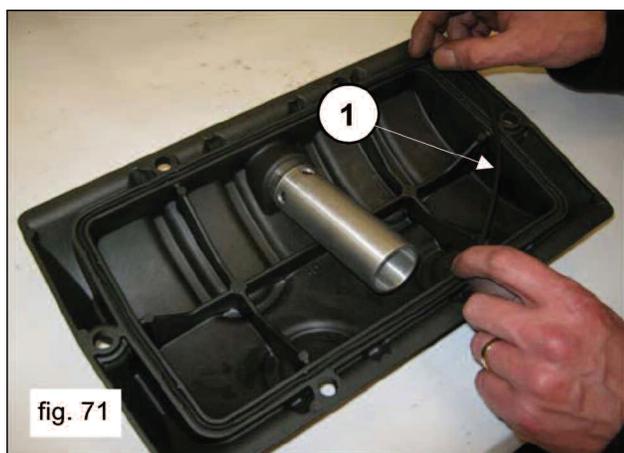
Insert the o-ring on the rear cover (1, fig. 71) and assemble the cover on the casing with the aid of (6) M10x30 screws (1, fig. 72).

Take care to fully and properly insert the o-ring in its housing on the cover to prevent them from being damaged during screw tightening.

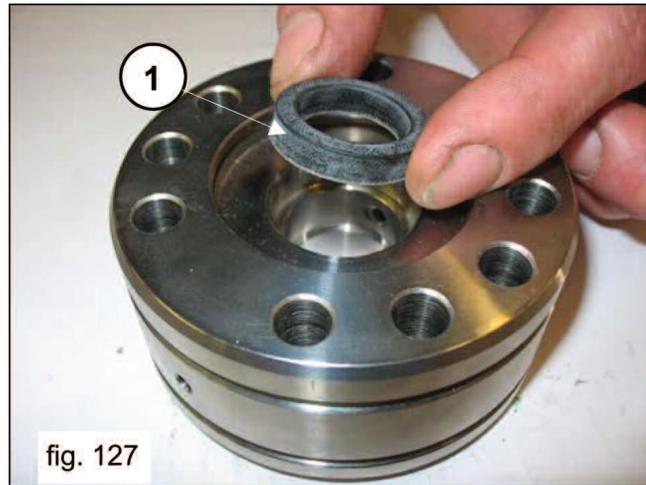
The LP seal must be inserted into the liner with the seal lip in the direction of plunger operation (1, fig. 126 and 127), lightly lubricating the outside diameter with silicone grease (OKS 1110 type). Replace the LP seal when it is worn.
