Repair Manual

GENERAL PUMP

KF5M SERIES

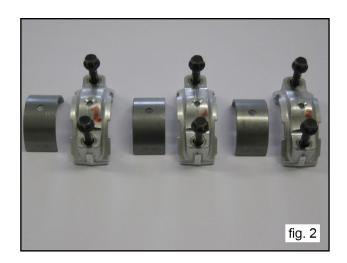
- Pump shaft key
- · Rear cover
- The con-rod as follows: unscrew the cap fixing screws, remove the con-rod caps with their lower half-bearings (fig. 2) paying attention to the numbered sequence during disassembly.

To avoid possible errors, caps and con-rod shanks have been numbered on one side (1, fig. 2/a)

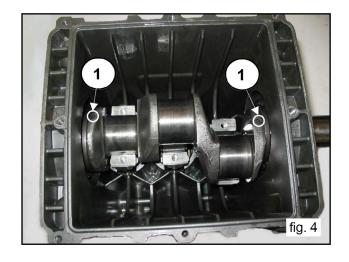
• Push the plunger guides forward with their con-rods to facilitate side extraction of the pump shaft. There are two reference points visible on the shaft (indicated with 1 in fig. 4 and in fig. 4/a). These must be turned towards the operator to facilitate extraction.

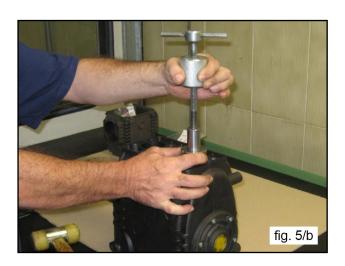
- Remove the pump shaft
- Complete disassembly of the con-rod units by removing them from the crankcase and removing the plunger guide pins.
- Remove the pump shaft seal rings using standard tools.
- Remove the plunger guide seal rings as described below: Use the extractor hammer (#F26019400) (1, fig.5) and the pliers (#27503900) (2, fig. 5). Insert the gripper as far as possible onto the seal ring with the aid of a hammer (fig. 5/a), subsequently screwing the extractor to the gipper, and use the extractor hammer (fig. 5/b) until the ring to be replaced is removed (fig. 5/c).

When disassembling the con-rod groups check the wear status of the plunger guide rods (1, fig. 5/d), if necessary replace them removing the 2 fixing M6 screws (2, fig. 5/d).

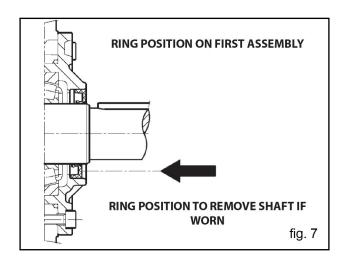
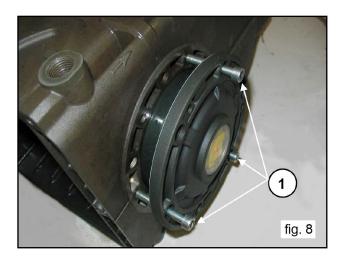
To facilitate filling of the first section and relative press fitting of the covers on the crankcase, we recommend using 3 partially-threaded M6 x 40 screws (1, fig. 8), then completing the operation with screws supplied $(M6 \times 16)$.

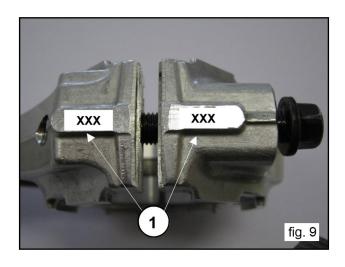
• Couple the con-rod caps to their shanks, referring to the numbering (1, fig. 9). **Not the correct assembly direction of the caps.**

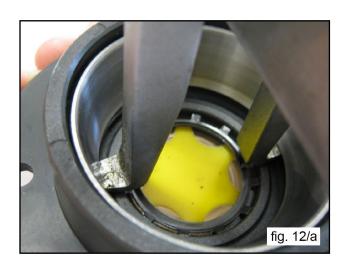
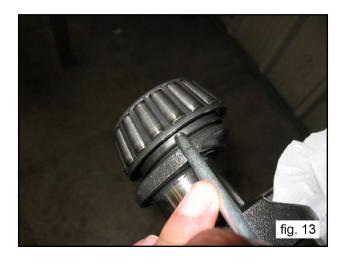
After disassembling the side covers as indicated in paragraph 2.1.1, remove the outer ring nut of the bearings from their covers and the inner ring nut, with the remaining part of the bearing, from the two shaft extremities using a standard pin extractor or similar tool as indicated in fig. 8 and fig. 9.

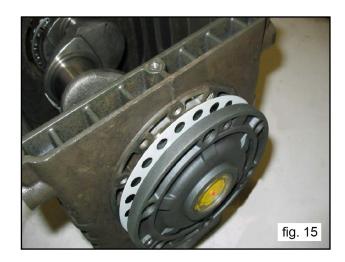
- Insert the shims under the cover on the sight glass side (see fig. 15), secure the cover to the crankcase, following the procedure in paragraph 2.1.2, and tighten the screws to the recommended torque. Verify that the shaft rotation stall torque is between 3-4.5 ft lbs (4-6 Nm).
- If the torque is correct, connect con-rods to the crankshaft, if torque is not correct reposition the shims again repeating the operations.

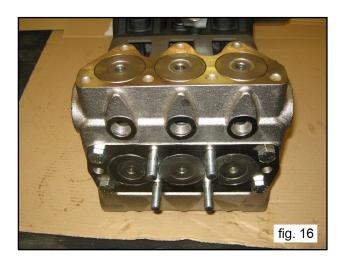
- A) Unscrew the 12 M12x35 screws and the 4 M12 nuts fastening the valve cover and the front cover, then remove the cover (fig. 16).
- B) Remove the valve plugs using a M12 extractor hammer (fig. 16/a).
- C) Extract the balls using a magnet or similar tool (fig. 16/b).
- D) Move the inlet and outlet valve housings using the tool (#F27922400) (see mechanical drawings in par. 4.1) as indicated in fig. 17, fig. 17/a, and 17/b.

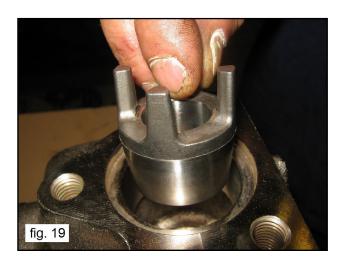
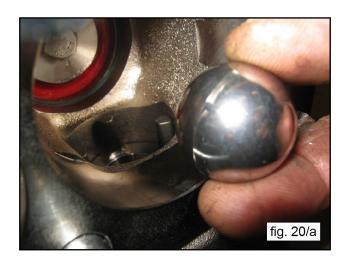
Assemble the inlet and outlet valve seats using the buffer (#F27702200) (see mechanical drawings in par. 4.1), ensuring that the tapered surfaces of the seats are locked in the tapered seats on the head (fig. 19 and fig. 20). Now position the ball in the seat (fig. 20/a), reassemble the valve caps and, at the front, reposition the valve covers. At the front, calibrate the respective M12x35 screws and M12 nuts with torque wrench as indicated in chapter 3 "SCREW CALIBRATION".

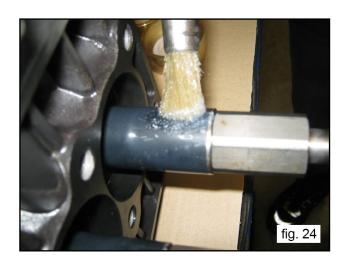
B) Reposition the wiper support with lubrication on the bush (fig. 24), in the crankcase seat (fig. 24/a). If removed, replace the plunger spacer unit with bush lubrication after assembling the wiper support (see par. 2.2.3.2). Make sure not to damage the seal lip.

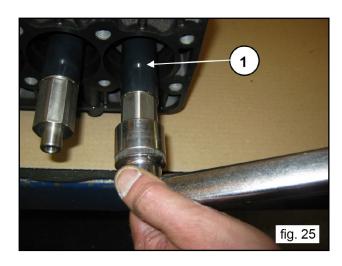
A) After having removed the head and the head spacer, free the units as indicated in fig. 25.

B) Check and verify their conditions, replace if necessary. Check and verify the conditions of the bushes assembled on the spacer (1, fig. 25); replace them if necessary.

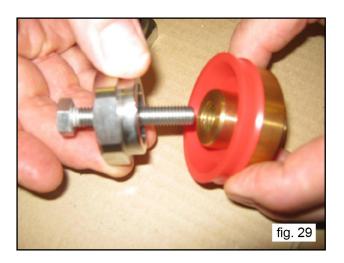
A) Assemble the plunger seal with the seal support (on which the O-ring will be replaced), the seal fastening bush and the M8 screw (fig. 29).

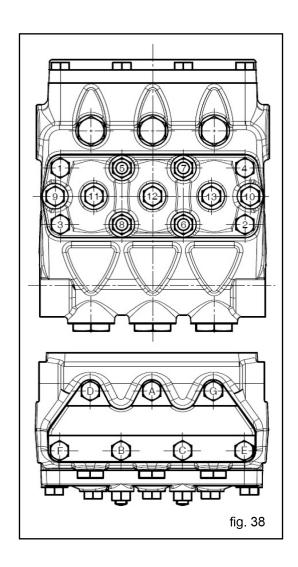
- * The con-rod cap fixing screws must be tightened respecting the phases indicated on page 9.
- ** The head fixing screws exploded view pos. 29 must be tightened with a torqure wrench, lubricating the threaded shank, following the order shown in the diagram in fig. 38.
- *** The cover fixing screws and nuts exploded view pos. 21 and 30 must be tightened with a torque wrench, lubricating the threaded shank, following the order shown in the diagram in fig. 38.
- The stud bolt M7 exploded view pos. 27, is to be mounted on the spacer exploded view pos. 22 with loctite 243 (#F12006400).

Description	Exploded view pos.	Material	Tightening torque ft lbs / (Nm)
Cover Fixing Screw	40	8.8	7.38 (10)
Plunger Guide Rod Fixing Screw	65	A2-70	7.38 (10)
Plunger Fixing	13	Stainless steel A2	14.75 (20)
Con-rod Cap Fixing Screw	47	12 R	22.13* (30)
Head Fixing Nut - Cover	30	8.8	59** (80)
Head Fixing Scew	29	8.8	59** (80)
Stud Bolt M12	31	8.8	59** (80)
Screw Fix. Cov. Valves - frt.	21	8.8	59*** (80)
Stud Bolt M7	27	C40	14.75**** (20)
Plunger Spacer	22	Stainless steel	14.75 (20)
Screw Fixing lifting Bracket	46	8.8	14.75 (40)
Plug G 1/2"	16	Nickel plated brass	14.75 (40)
Plug G 1"	9	Zinc plated steel	73.76 (100)

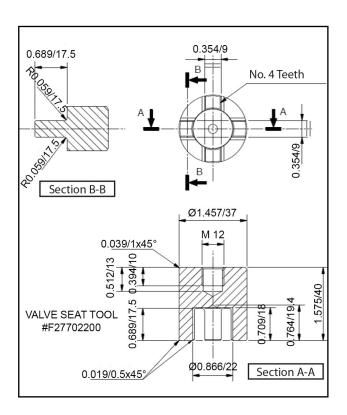
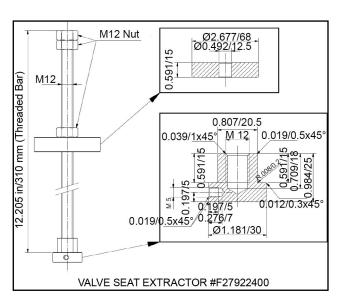
4.1 Valve Seat Assembly / Disassembly Tool Mechanical Drawings.

For proper assembly of the valve seats and relative disassembly, use tool (#F27702200) and (#F27922400).

Valve seat assembly tool (see par. 4.1)	#F27702200
Buffer for pump shaft oil seal	#F27904800
Buffer for plunger guide oil seal	#F27904900

Inlet / outlet valve seats (see par. 4.1)	#F27922400
Inlet and outlet valve plug	Extractor hammer
Plunger guide oil seal	#F27503900
