Repair Manual

MK40A-MK45A-MK50A

MK55A-MK60A-MK65A

This manual describes the instructions for Repairing MK Series pumps, and must be carefully read and understood before performing any repair intervention on the pump. Correct use and adequate maintenance is fundamental for the pump's regular operation and long wear. General Pump declines any responsibility for damage caused by the misuse or the non-observance of the instructions described in this manual.

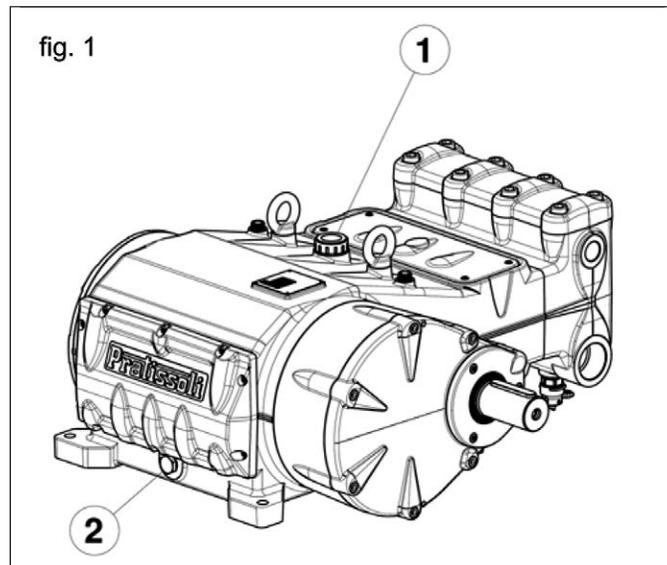
Crank mechanism repair operations must be carried out after draining the oil from the crankcase. To drain the oil, remove the oil refill cap 1, Fig. 1, and then the draining plug (2, fig. 1).

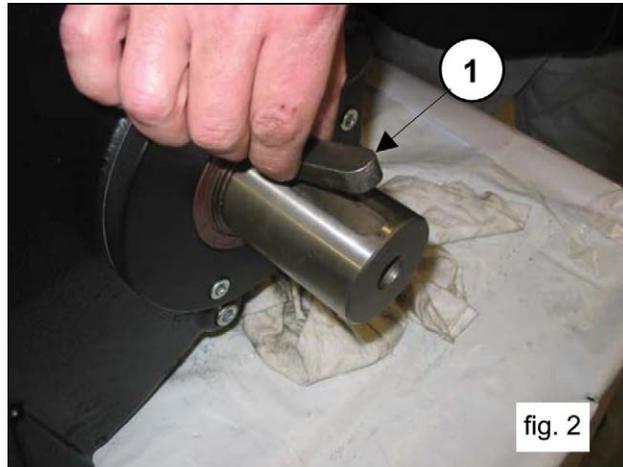
Completely drain the oil from the pump, then remove the key from the shaft (1, fig.2).

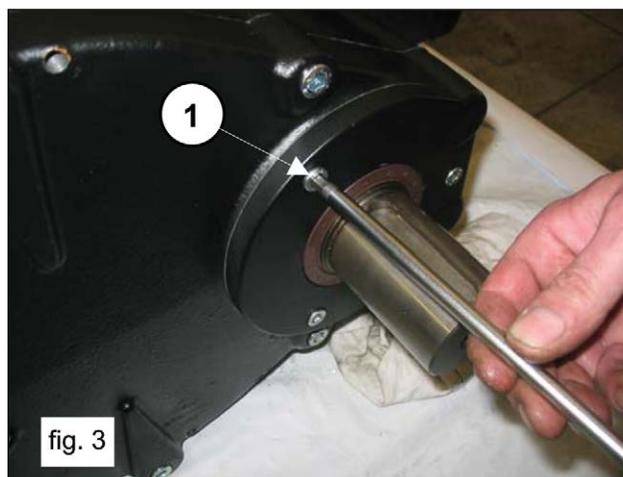
Unscrew the reducer flange fastening screws (1, fig. 3) and remove the flange from the shaft.

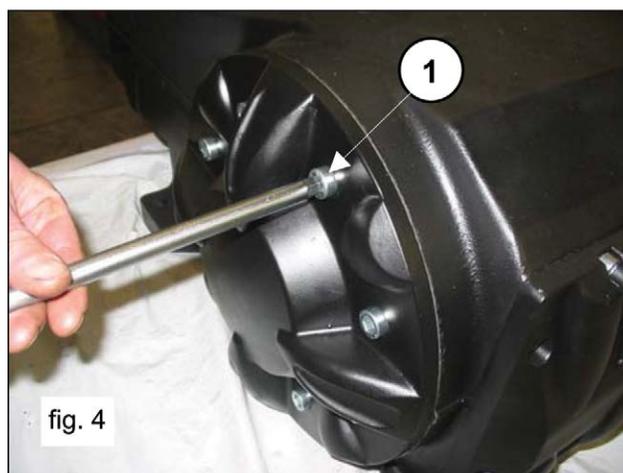
On the opposite side, unfasten the screws (1, fig. 4) and therefore remove the bearing cover.

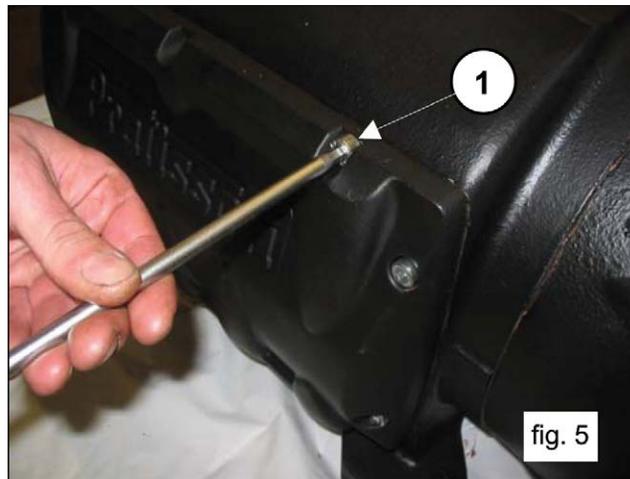
Disassemble the crankcase cover by unfastening the relevant screws (1, fig. 5).

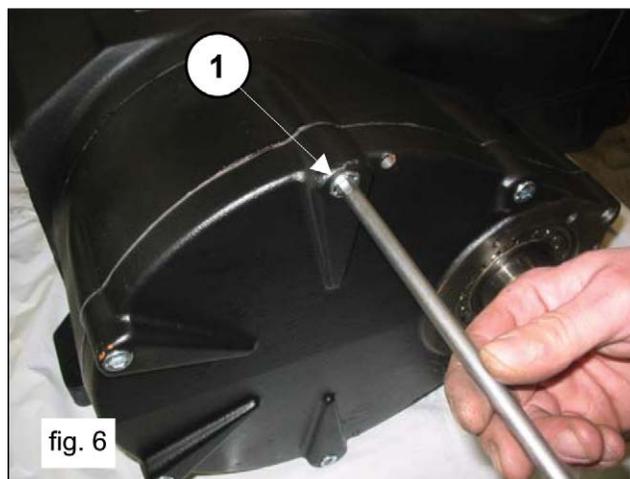
Unfasten the reducer cover screws (1, fig. 6).

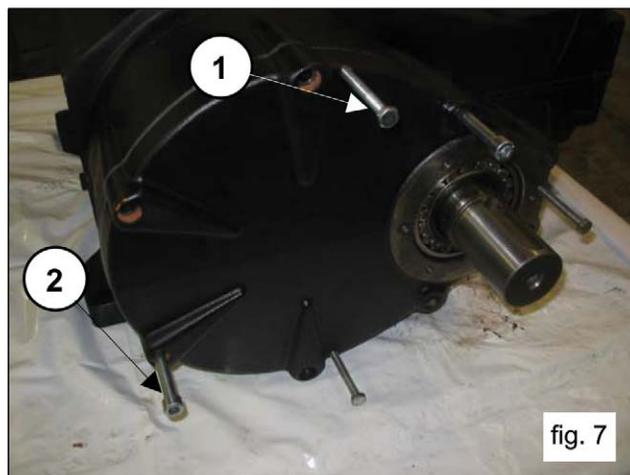
Insert 3 dowels, or 3 M8 threaded screws (1, fig. 7) in the appropriate holes to aid extraction, and two sufficiently long M10 screws in order to support the cover (2, fig. 7).

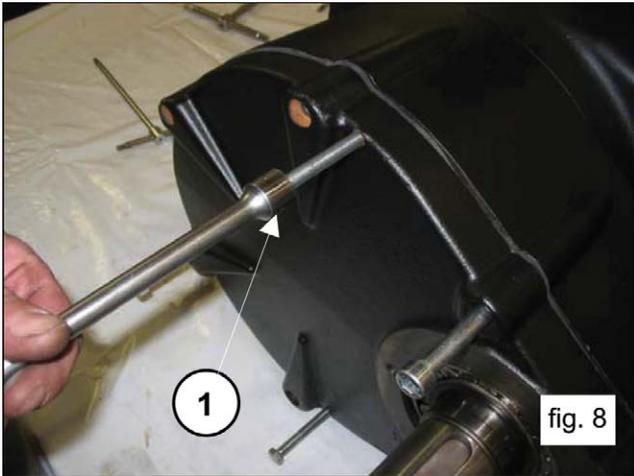
Screw on the 3 threaded screws (1, fig. 8) and simultaneously, using the appropriate tool (p/n 27516700), hammer on the tool itself so that the bearing remains on the pinion when extracting the cover (1, fig. 9).

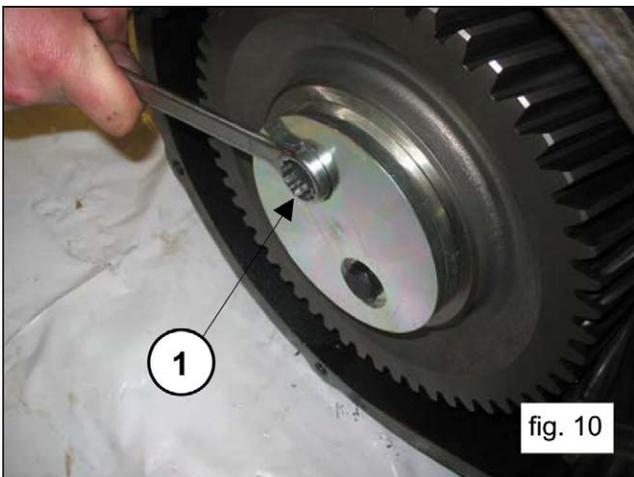
When this operation is complete, remove the reducer cover and then slip off the bearing from the pinion. Remove the screws that fasten the ring gear stopper (1, fig. 10), and remove the stopper itself (1, fig. 11).

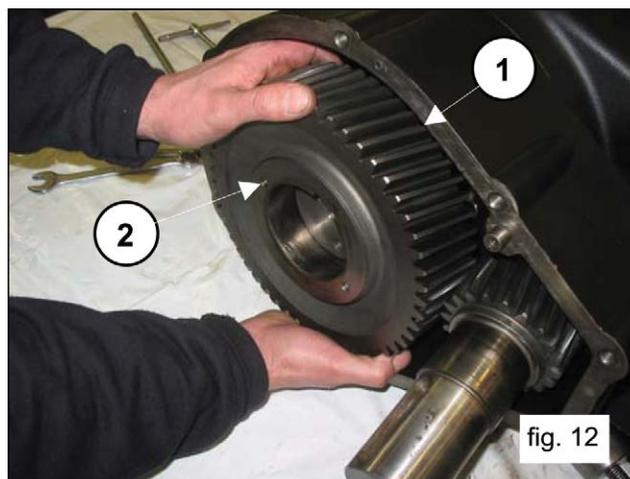
Remove the ring gear (1, fig. 12). If necessary, use a slide hammer applying it to the 2 M8 holes (2, fig. 12).

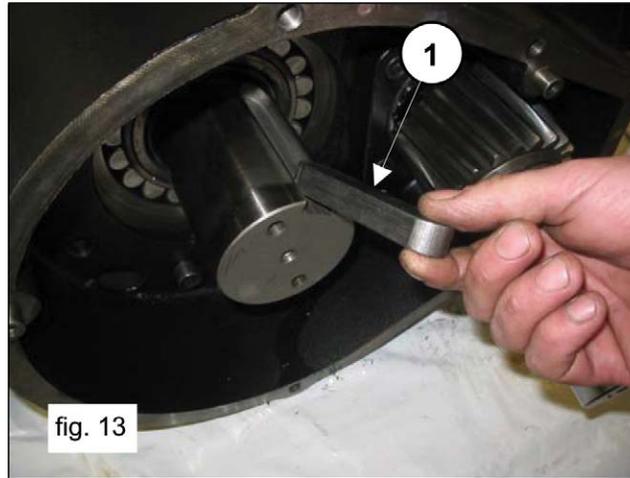
Remove the key from the shaft (1, fig. 13).

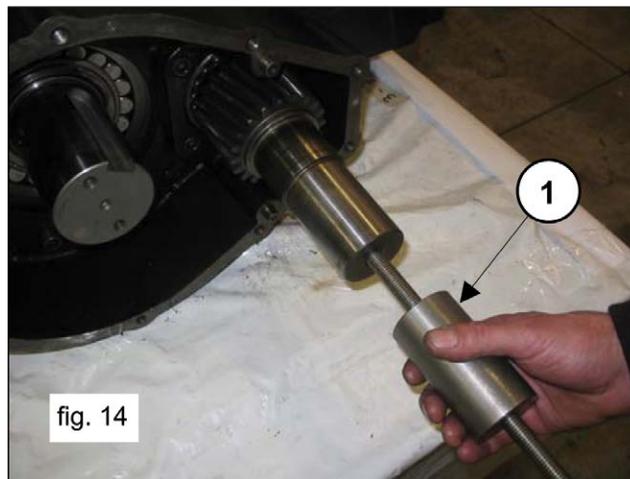
Remove the pinion by using a slide hammer applying it to the M14 hole (1, fig. 14).

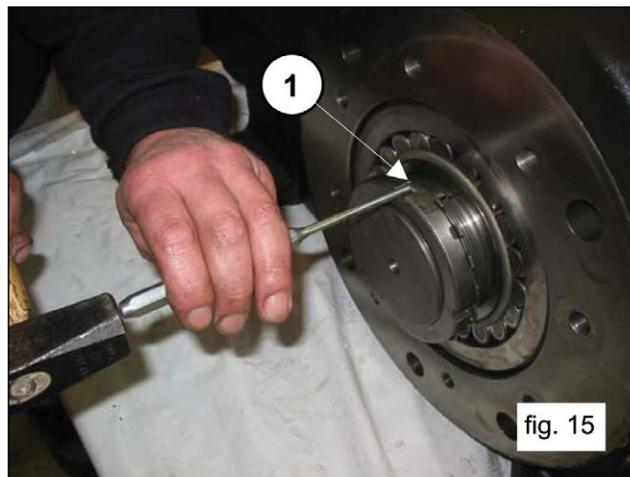
Lift the safety washer key (1, fig. 15)

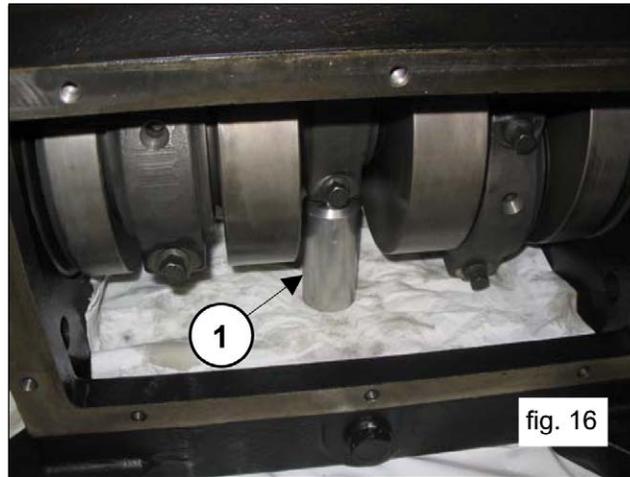
Insert a spacer under the connecting rod to block shaft rotation (1, fig. 16).

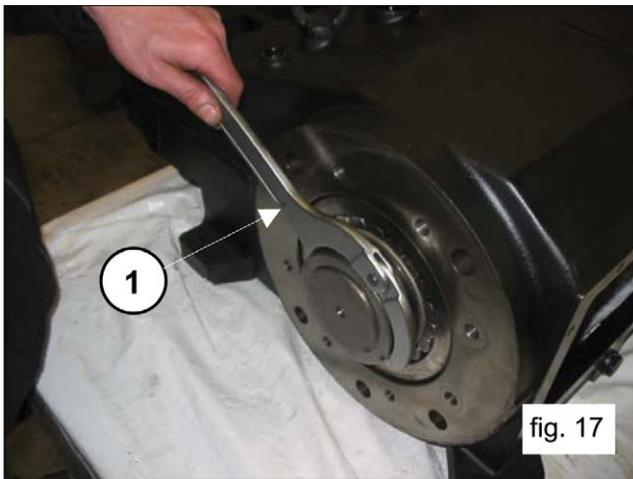
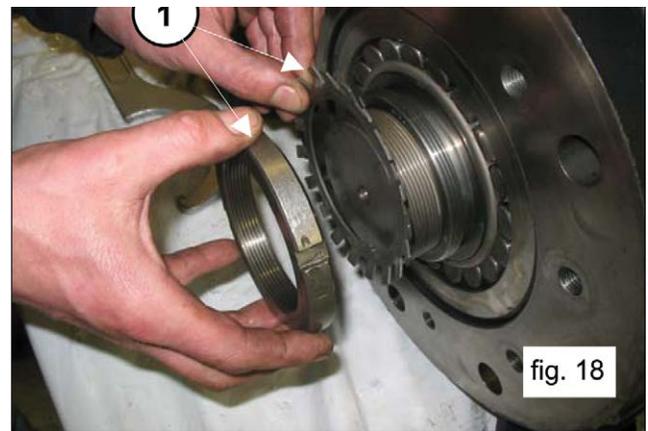
Using an appropriate wrench, unscrew and remove the ring nut (1, fig. 17) and then remove the safety washer (1, fig 18).

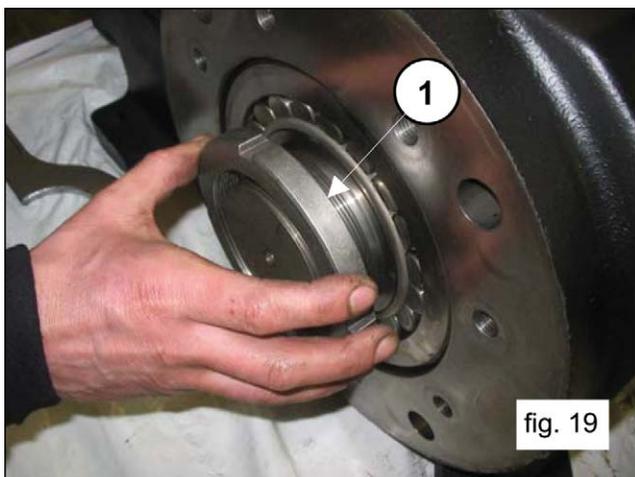
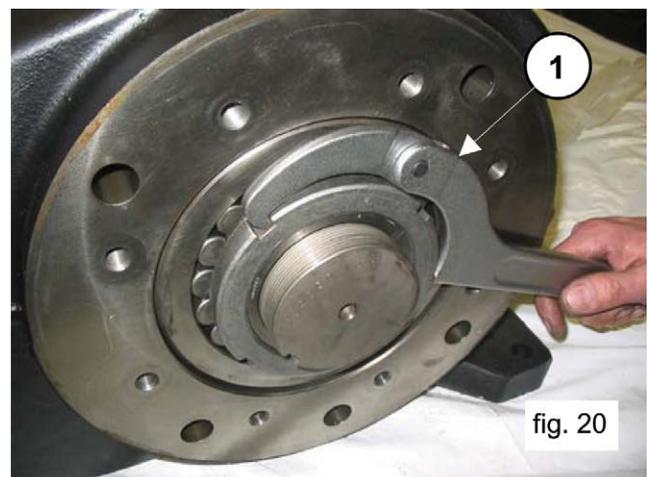
Screw a SKF KM19 type ring nut onto the pressure sleeve (1, fig. 19), then loosen the sleeve using an appropriate wrench (1, fig. 20).

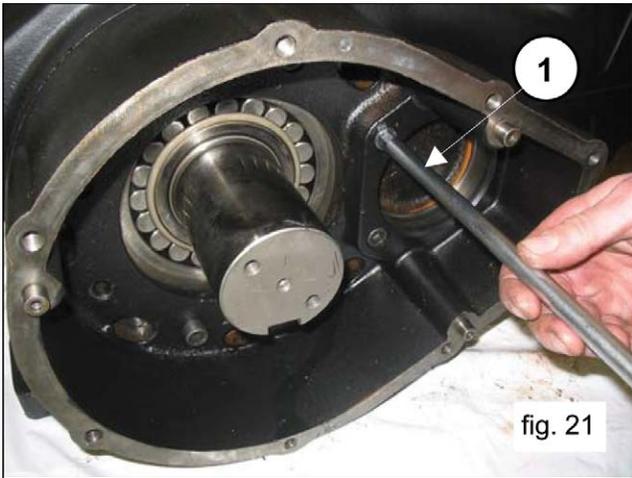
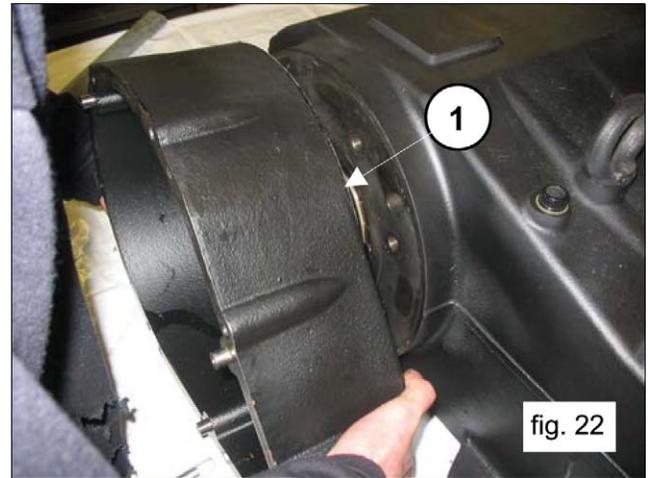
On the opposite side, unfasten the reducer case screws (1, fig. 21), and then remove the case (1, fig. 22).

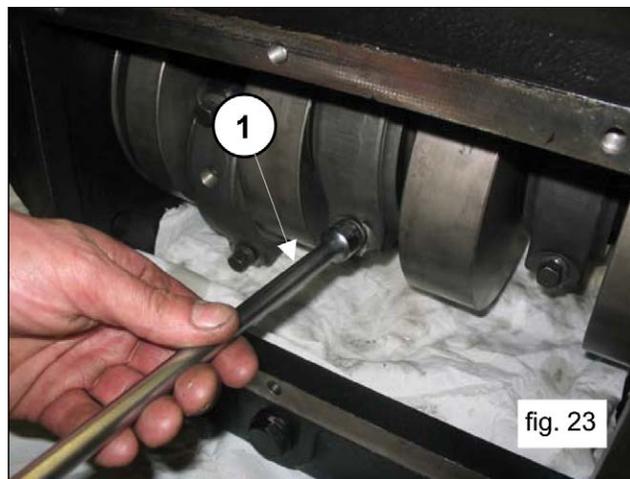
Unscrew the connecting rod screws (1, fig. 23).

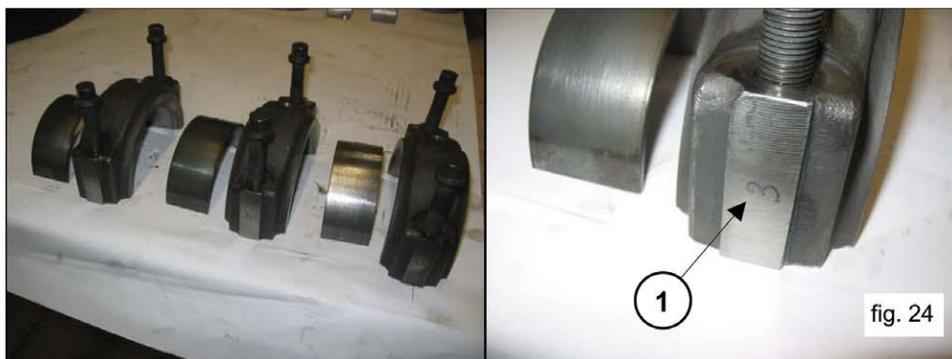
To avoid error, caps and connecting rods are numbered on one side (1, fig. 24).

Separate the caps from the connecting rod; correct coupling is guaranteed by the numbering on the side (1, fig. 33).

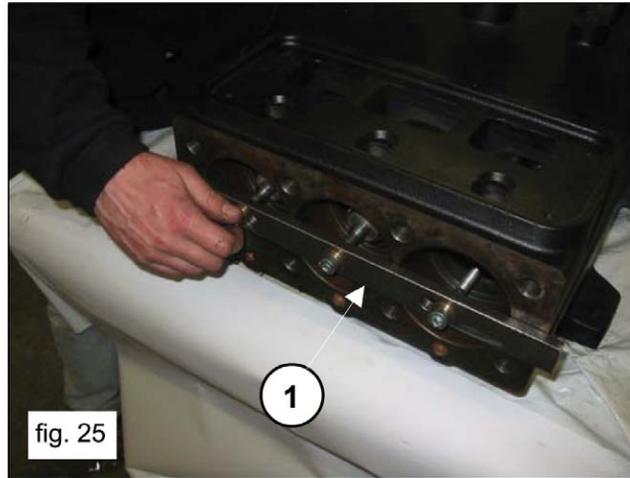
Push the connecting rods forward in the direction of the hydraulic side in order to push out the crankshaft. Use the appropriate tool (p/n 27566200) to facilitate this operation (1, fig. 25)

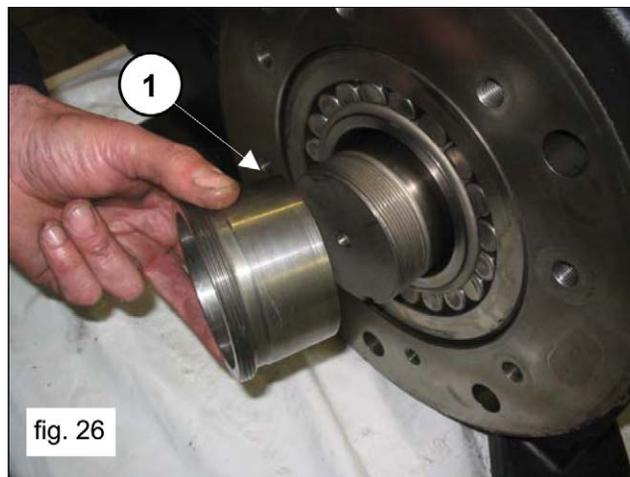
Remove the pressure sleeve (1, fig. 26).

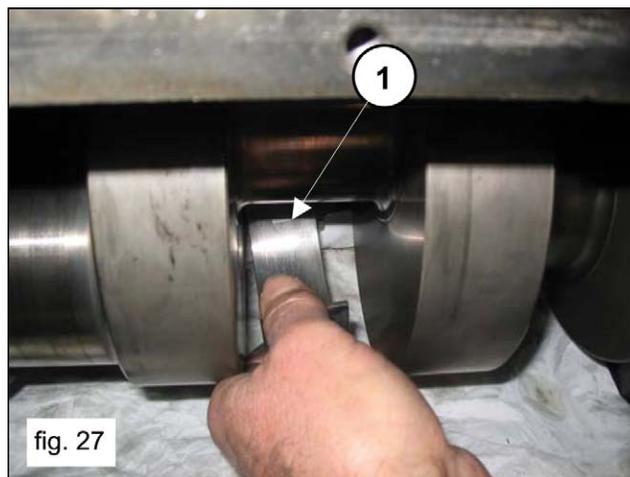
Remove the upper split bearing of the connecting rods (1, fig. 27).

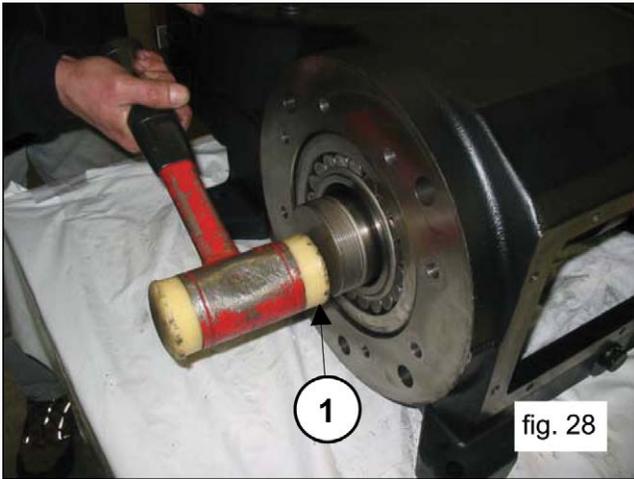
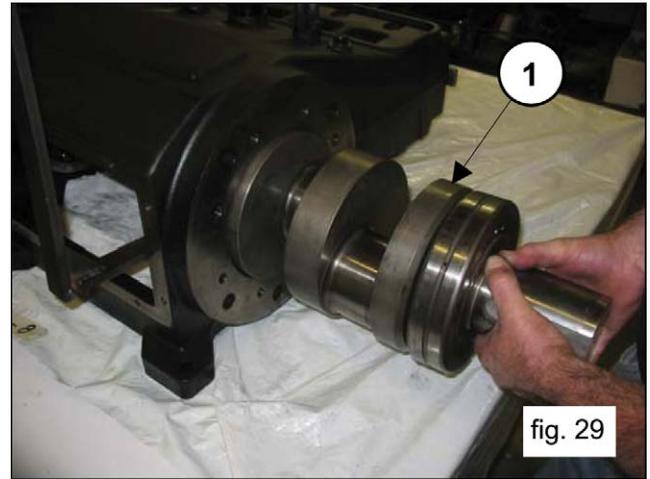
Remove the crankshaft with the help of a hammer on the PTO side (1, fig. 28). Remove the shaft and the bearing (1, fig. 29).

Insert the shaft (1, fig. 29) until the pre-assembled bearing is aligned with the edge of the crankcase (1, fig. 43).

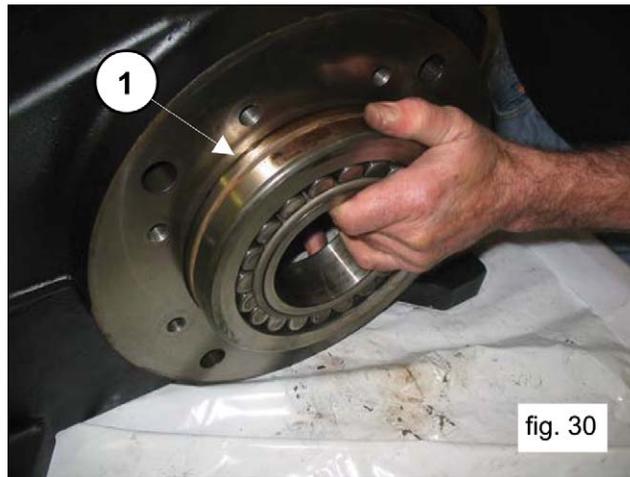
On the opposite side, extract the bearing (1, fig. 30)

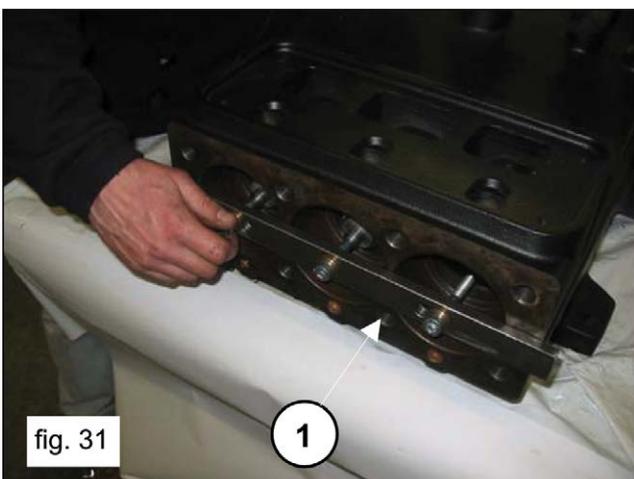
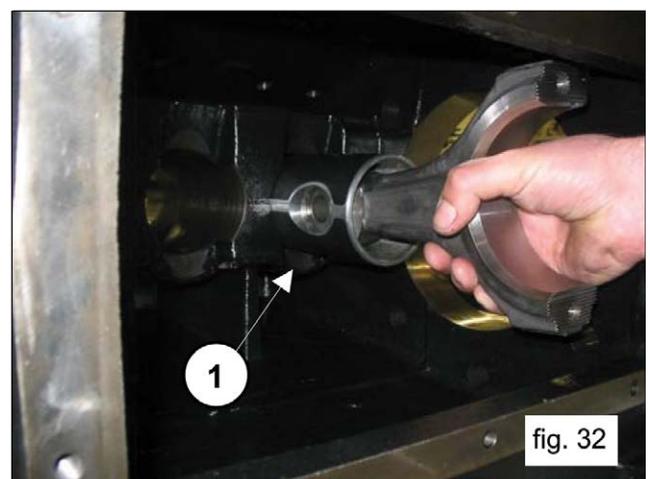
If the replacement of one or more connecting rods or plunger guides is necessary, please operate as follows: Unfasten the screws of the tool (p/n 27566200 to unlock the connecting rods (1, fig. 31) and therefore extract the connecting rod-plunger guide units from the opening behind the crankcase (1, fig. 32).

After verifying the perfect cleaning of the crankcase, insert the connecting rod-plunger guide unit inside the cylinders of the crankcase (1, fig. 32).

Block the three units using the correct tool, p/n 27566200(1, fig 31).

Remove the device that blocks the connecting rods using p/n 27566200 (1, fig. 31).

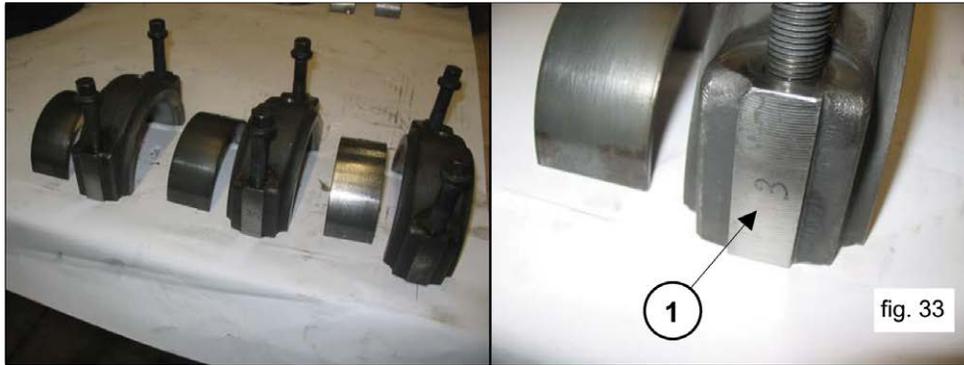
Couple the connecting rods with the previously disassembled caps; be sure to respect numbering (1, fig. 33).

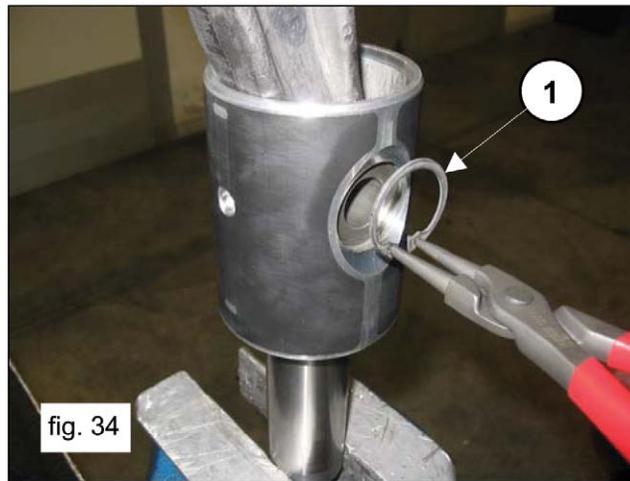
Remove the two seeger rings that block the plunger pin by using the appropriate tool (1, fig. 34).

Insert the connecting rod in the plunger guide (1, fig. 36) and then insert the pin (1, fig. 35). Apply the two seeger rings using the correct tool (1, fig. 34).

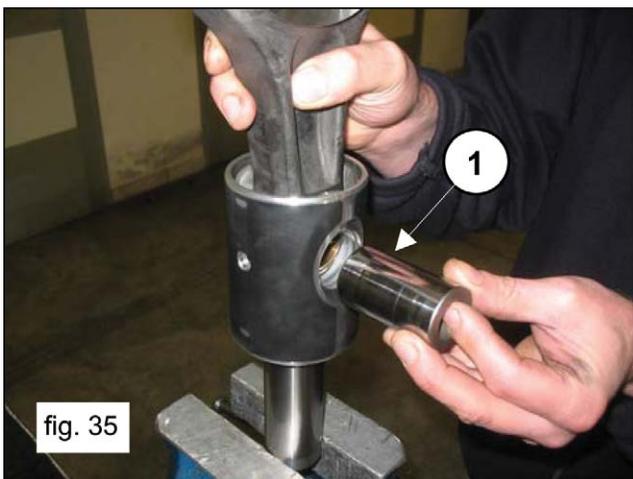
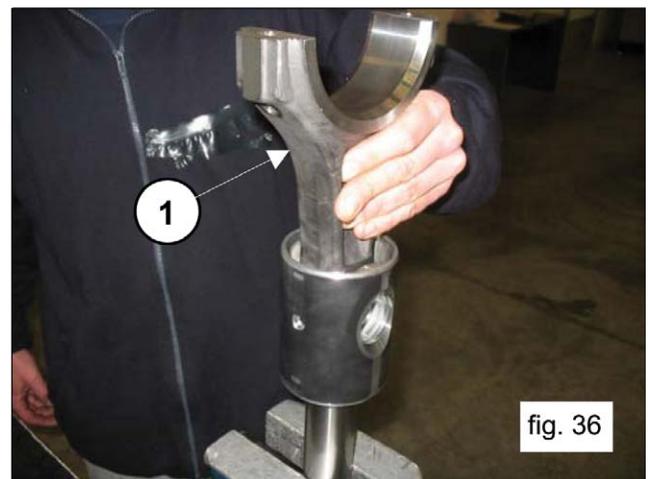
Remove the pin (1, fig. 35) and then remove the connecting rod (1, fig. 36).

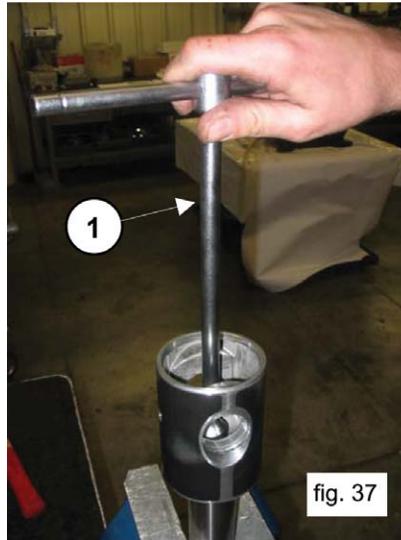
To separate the rod from the plunger guide, unfasten the M10 hexagonal-head screws using a size 17 socket wrench (1, fig. 37).

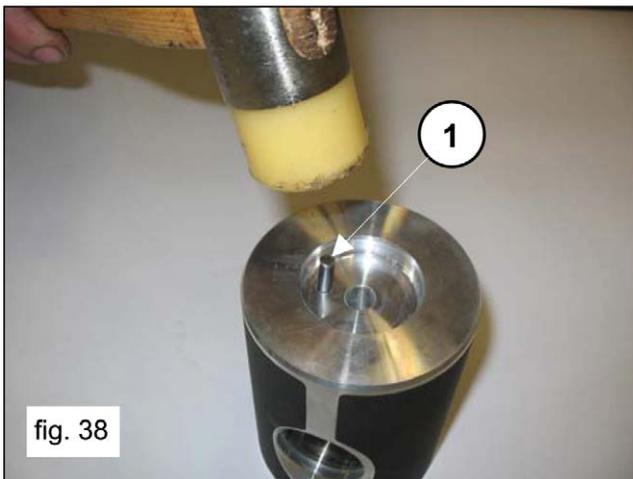
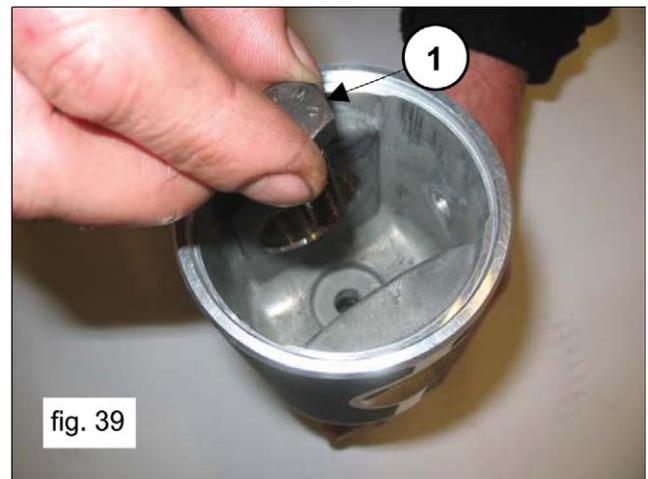
Insert the Ø5 pin in the appropriate hole on the plunger guide (1, fig. 38) and connect the rod to the plunger guide using M10 x 35 screws (1, fig. 39).

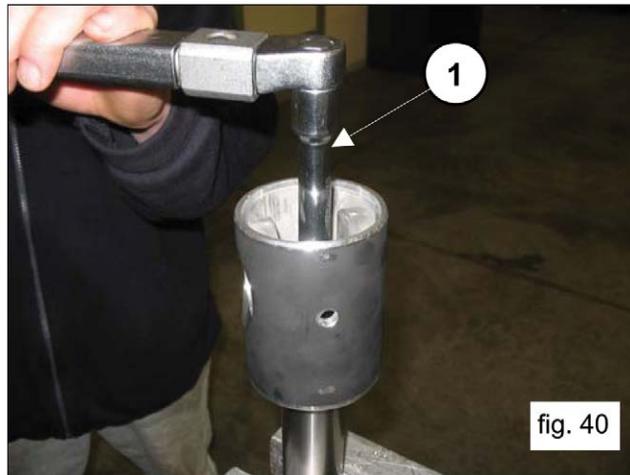
Block the rod using a clamp, and proceed with calibration using a torque wrench (1, fig. 40) as indicated in paragraph 3. "SCREW CALIBRATION"

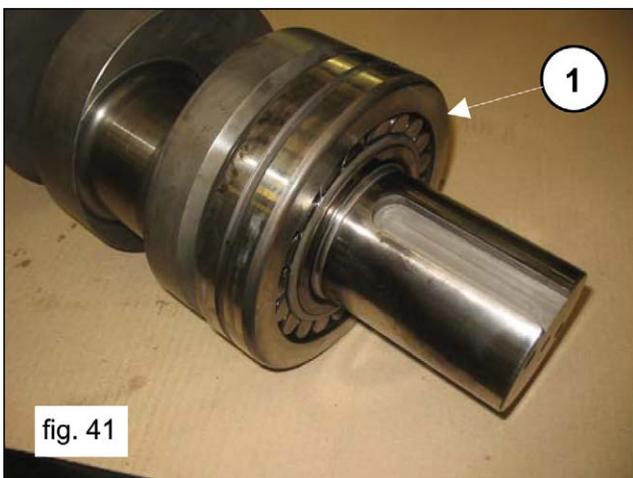
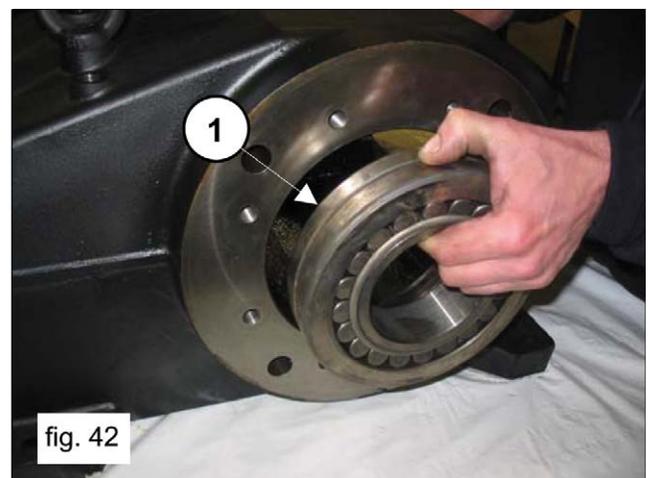
Pre-assemble the bearing, PTO side, on the shaft (1, fig. 41) and assemble the bearing on the opposite side on the crankcase (1, fig. 42).

The bearing in fig. 42 has a tapered internal ring. Verify that the taper goes from the outside towards the inside in order to allow the subsequent insertion of the sleeve.

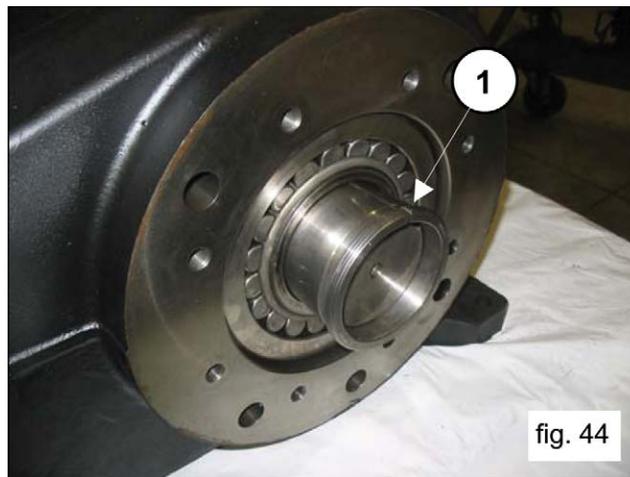
Manually insert the pressure sleeve to maintain the shaft alignment (1, fig. 44).

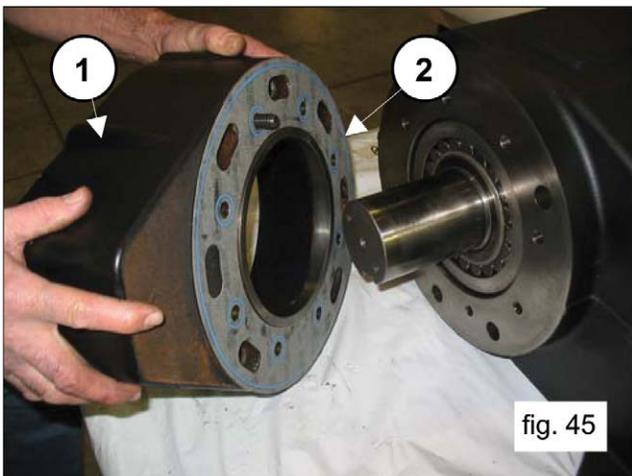
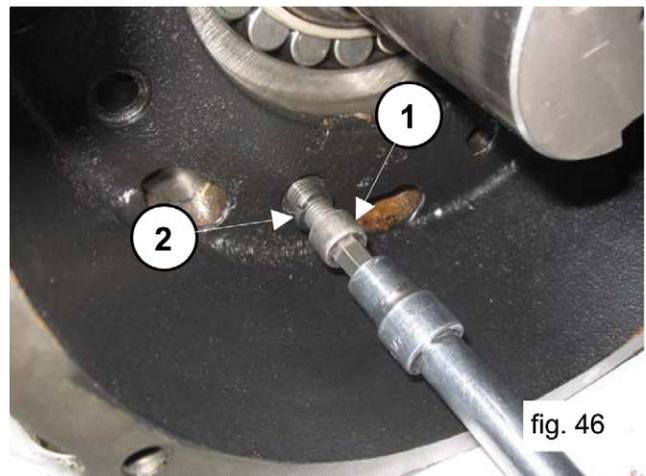
Assemble the reducer case (1, fig. 45) and the related gasket (2, fig 45) using the 6 M12 x 40 screws (1, fig. 46), the 2 M12 x 50 screws (1, fig. 47) and the Ø 12 Grower washers (2, fig. 46 and fig. 47). Calibrate the screws with a torque wrench (1, fig. 48) as indicated in paragraph 3. "SCREW CALIBRATION"

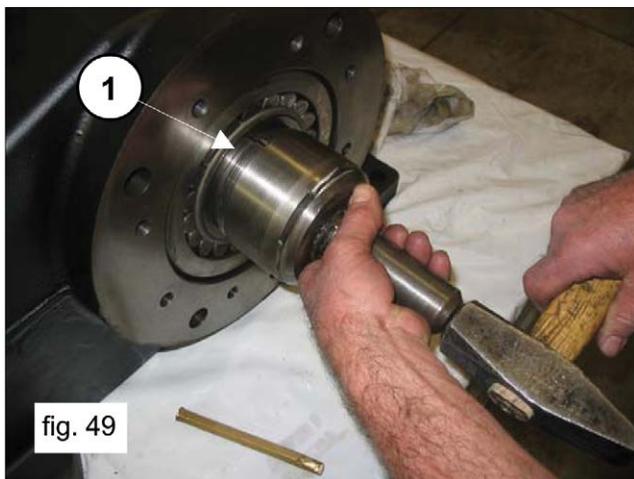
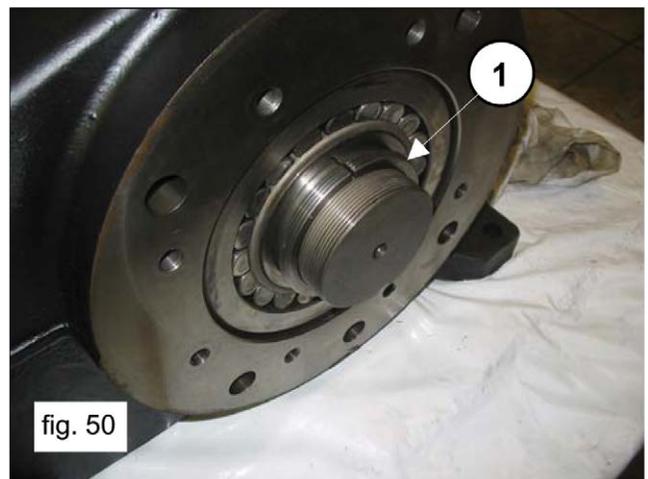
Completely insert the pressure sleeve on the shaft from the opposite side of the PTO (1, fig. 49 and fig. 50).

Pressure sleeve insertion must be done without oil or lubricants.

Insert the sleeve until the external surface (tapered) couples perfectly with the inside of the bearing. During insertion, be sure that the bearing remains in contact with the shaft shoulder.

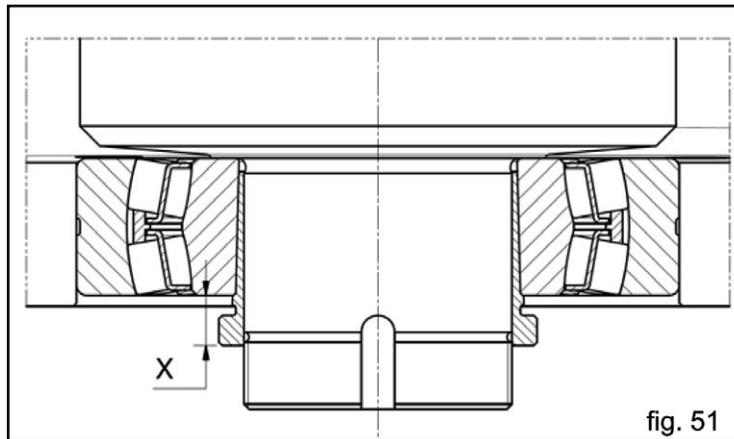
Measure the dimension "X" indicated in fig. 51.

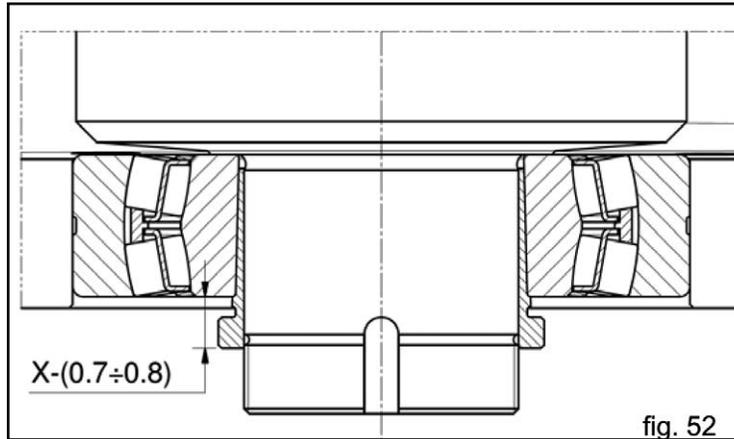
Screw the ring nut and fasten the sleeve until the dimension "X" is reduced by a value ranging between 0.7 and 0.8 mm (fig. 52).

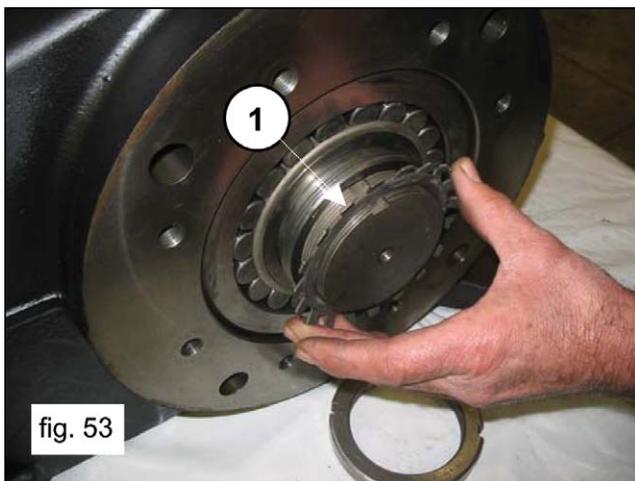
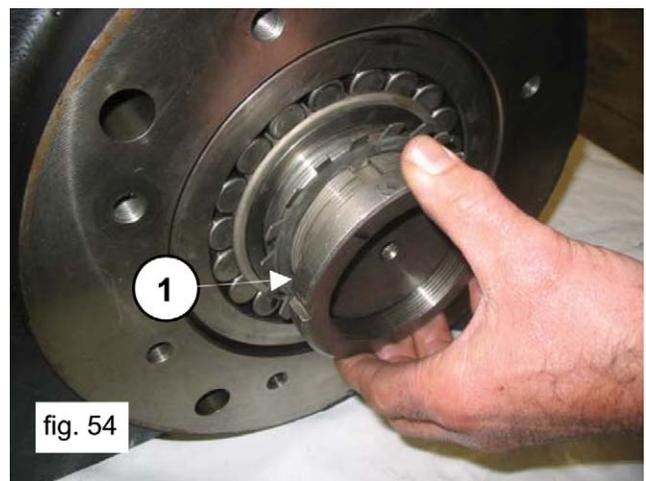
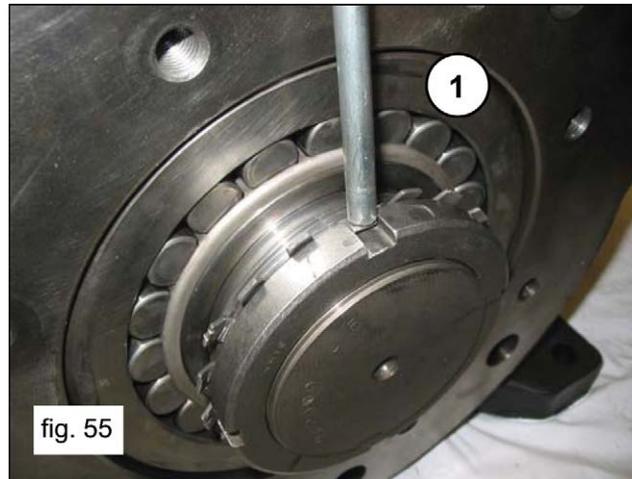
Unscrew the ring nut, insert the safety washer (1, fig. 53) and completely screw the ring nut (1, fig. 54); then fold the washer's locking key (1, fig. 55).

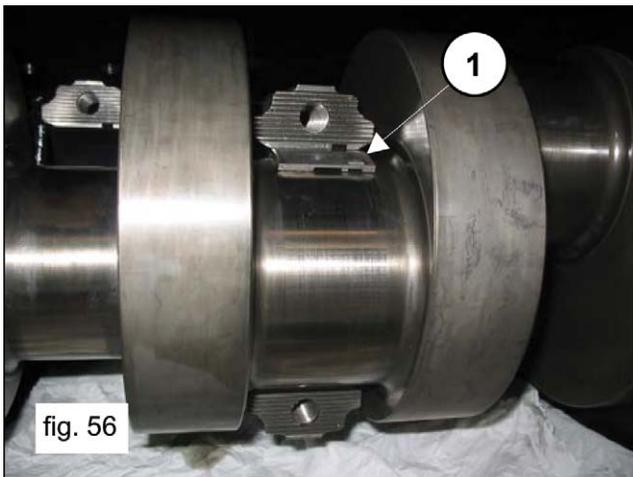
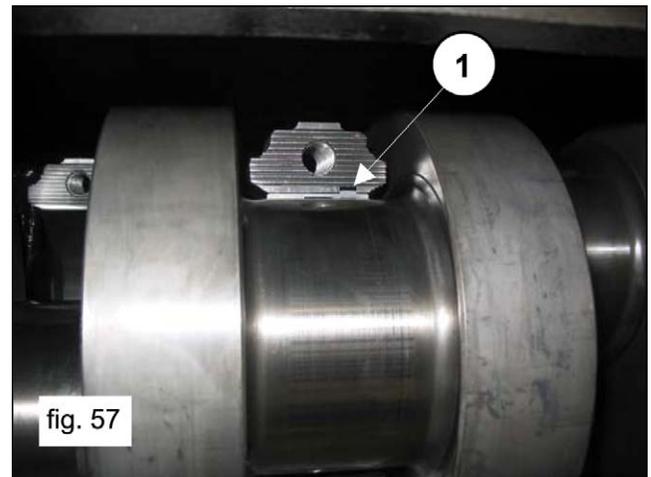
Insert the upper split bearings between the connecting rods and the shaft (1, fig. 56)

In order to correctly assemble the split bearings, be sure that the split bearings' reference key in the appropriate seat on the connecting rod (1, fig. 57).

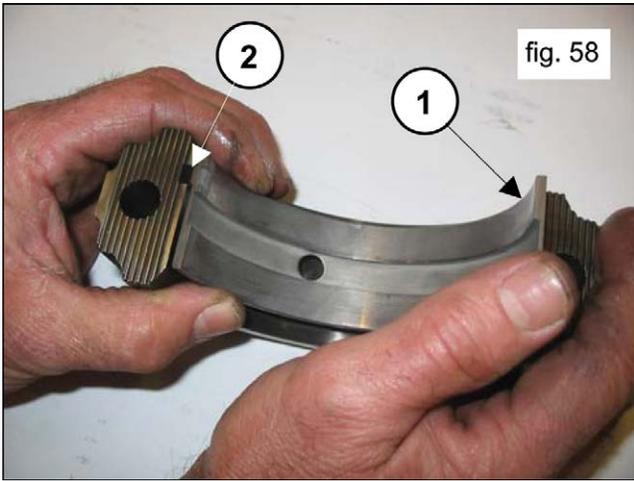
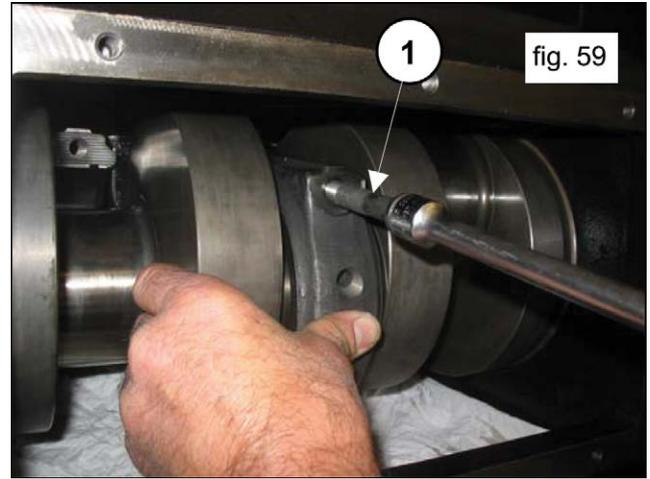
Apply the lower split bearings to the caps, (1, fig. 58) being sure that the split bearings' reference key is positioned in the appropriate seat on the cap (1, fig. 58).

Fasten the caps to the connecting rods using the M12 x 1.25 x 87 screws (1, fig. 59).

Pay attention to the correct assembly of the caps. the numbering must face upwards.

Tighten the screws with a torque wrench set as indicated in the SCREW CALIBRATION chart of paragraph 3. The conrod screws should be tightened at intermediate incremental values.

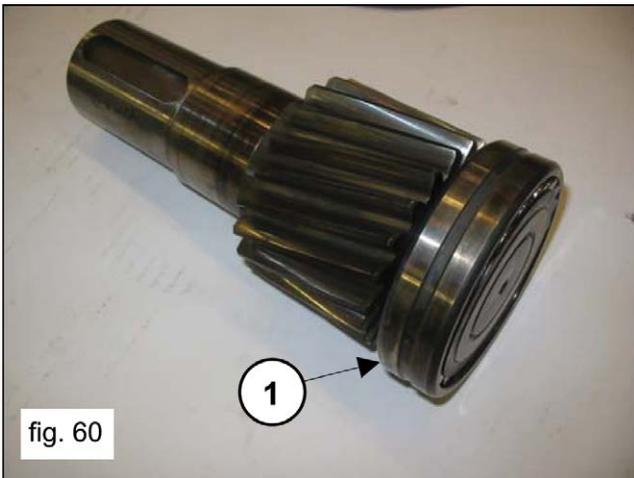
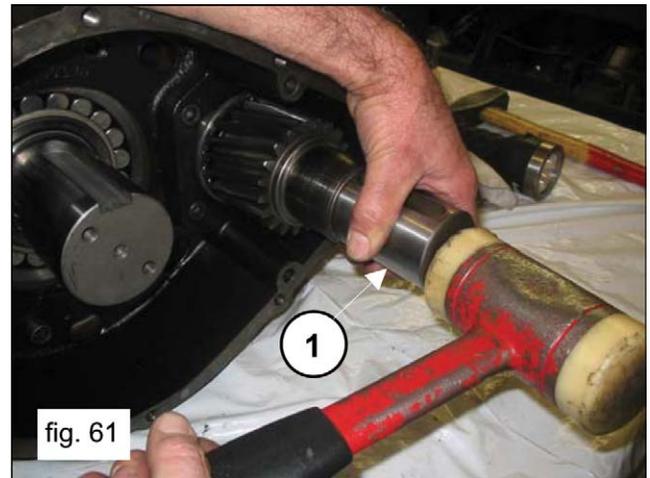
Reassemble the bearing on the pinion (1, fig. 60) and fully insert the pinion in the seat on the reduccase (1, fig. 61) by using a hammer.

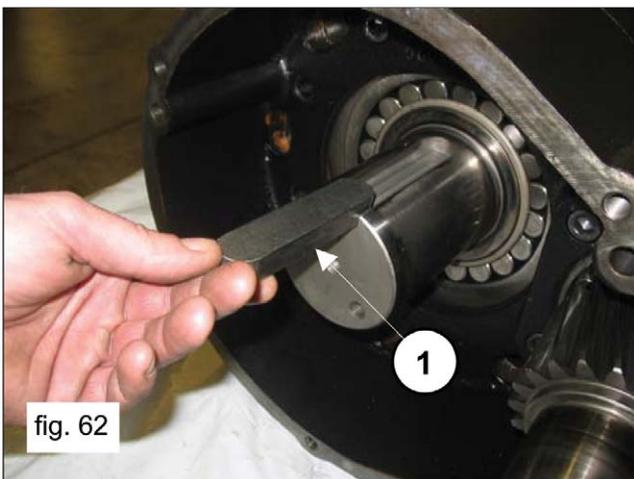
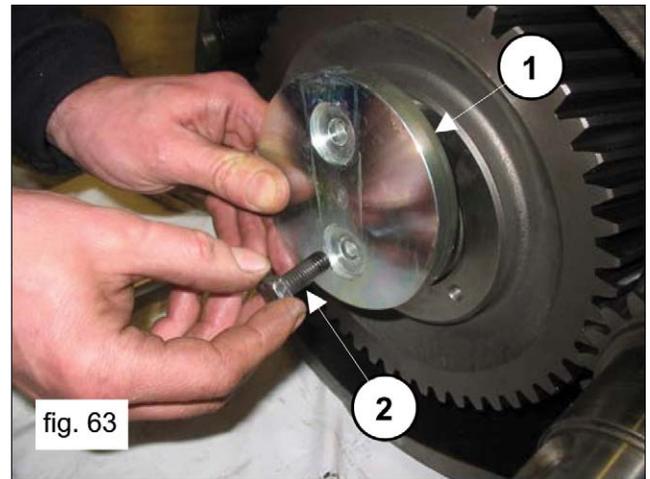
Apply the 22 x 14 x 100 key in the seat on the shaft (1, fig. 62) and insert the ring gear on the shaft. Fasten the ring gear stopper (1, fig. 63) using the 2 M10 x 25 screws (2, fig. 63). Calibrate the screws with the torque wrench as indicated in paragraph 3. "SCREW CALIBRATION"

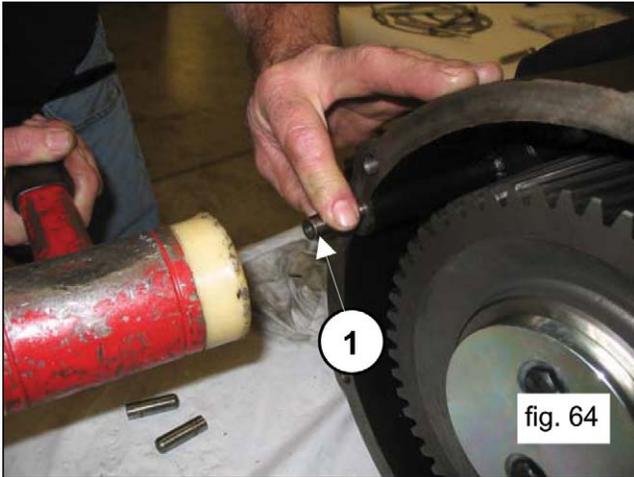
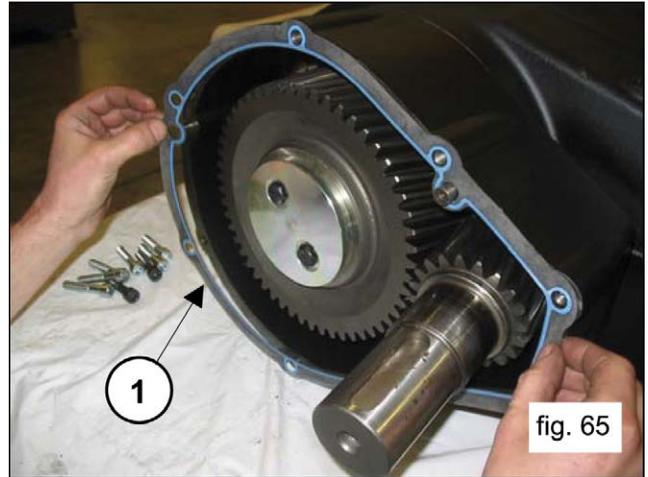
Apply the 3 Ø 12 x 40 pins to the reducer case (1, fig. 64) and insert the gasket (1, fig. 65).

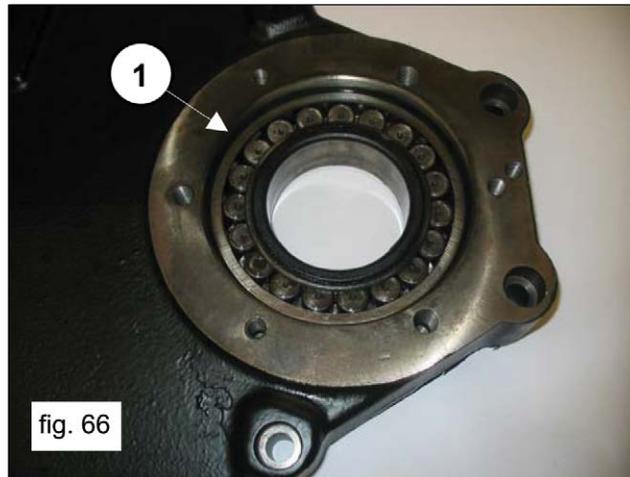
Assemble the bearing on the reducer cover (1, fig. 66).

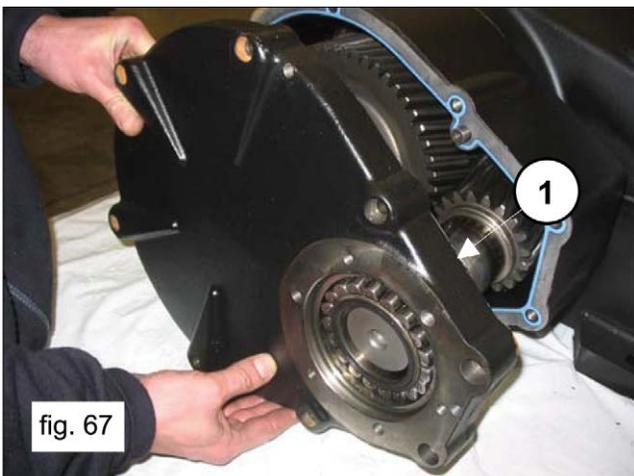
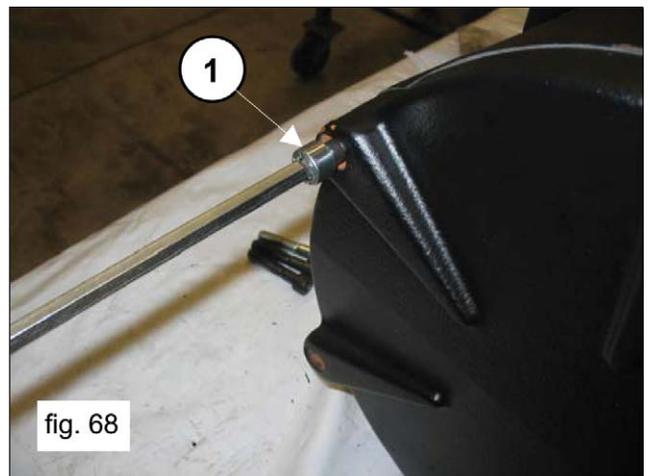
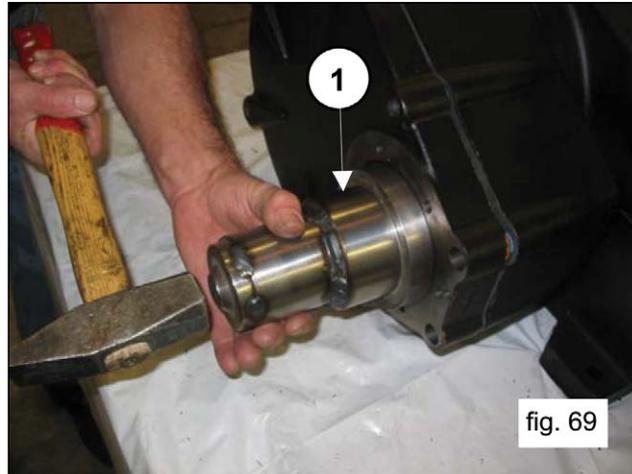
Assemble the reducer cover (1, fig. 67) and fasten it using 8 M10 x 50 screws (1, fig. 68). Use a stopper to avoid the bearing coming out of the seat (1, fig. 69). Calibrate the screws with the torque wrench as indicated in paragraph 3. "SCREW CALIBRATION"

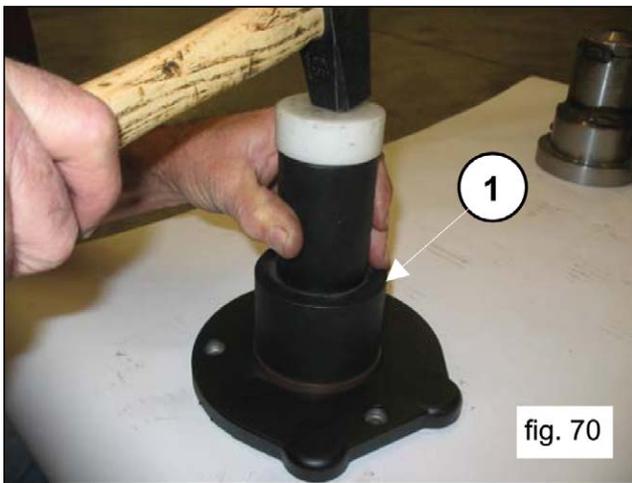
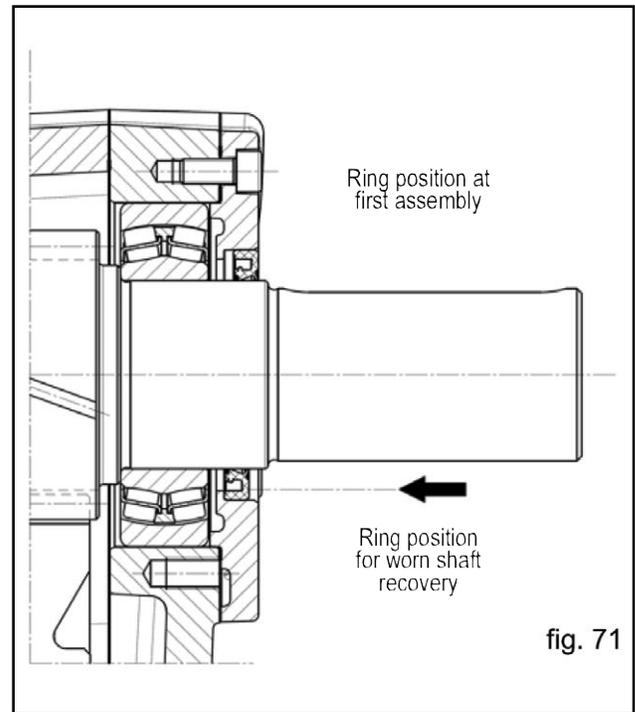
Insert the oil seal inside the reducer flange using the proper tools, p/n 27515900 and 27548200 (1, fig. 70). Before proceeding with oil seal assembly, verify the conditions of the sealing lip. If replacement is necessary, position the new ring as indicated in fig. 71.

If the shaft presents diameter wear corresponding to the sealing lip, to avoid the need for grinding it's possible to position the ring as indicated in fig. 71.
