Repair Manual

MK40A-MK45A-MK50A

MK55A-MK60A-MK65A

This manual describes the instructions for Repairing MK Series pumps, and must be carefully read and understood before performing any repair intervention on the pump. Correct use and adequate maintenance is fundamental for the pump's regular operation and long wear. General Pump declines any responsibility for damage caused by the misuse or the non-observance of the instructions described in this manual.

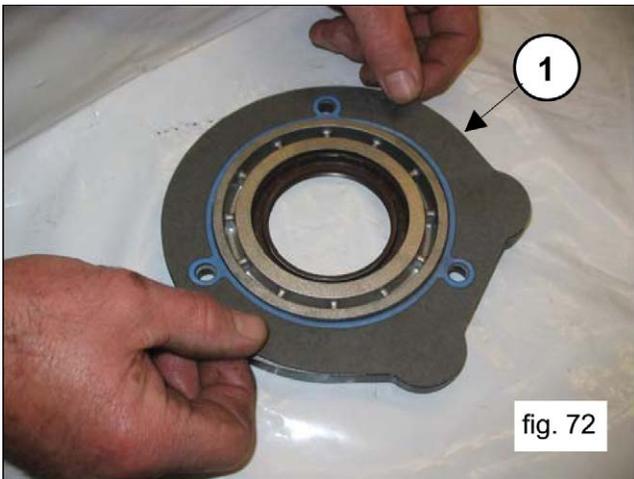
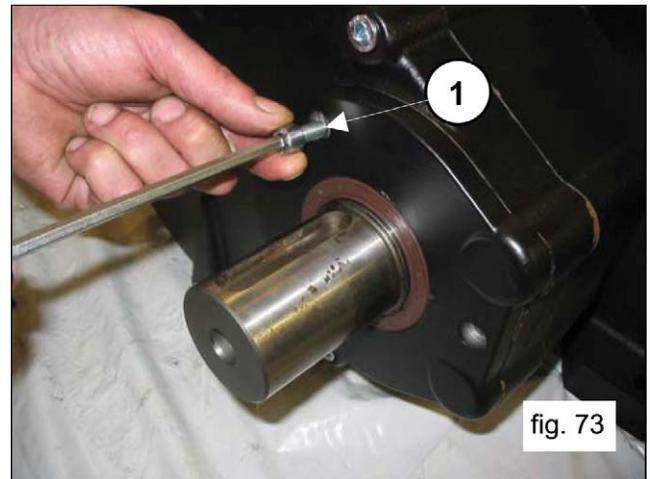
Apply the reducer flange with its gasket to the reducer case (1, fig. 72) and fasten it using 3 M8 x 18 screws (1, fig. 73).

To avoid damaging the oil seal, pay particular attention when inserting the flange on the pinion.

Calibrate the screws with the torque wrench as indicated in paragraph 3. "SCREW CALIBRATION"

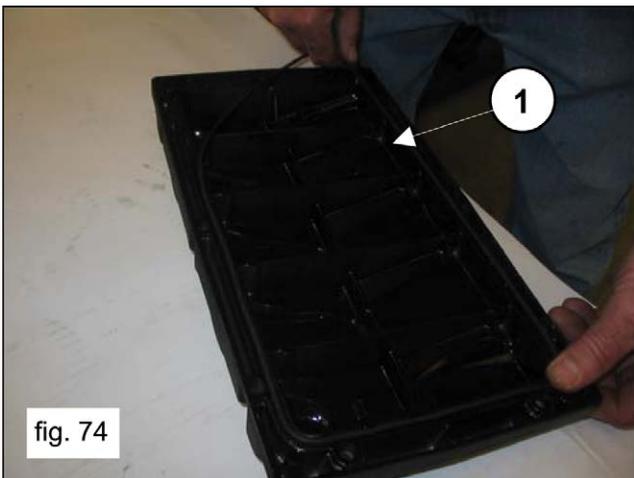
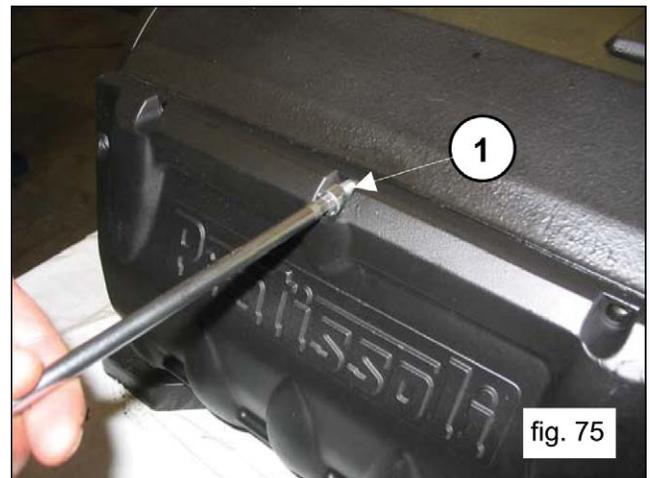
Insert the O-ring in the rear cover (1, fig. 74) and fasten it to the crankcase using 10 M8 x 18 screws (1, fig. 75).

Calibrate the screws with the torque wrench as indicated in paragraph 3. "SCREW CALIBRATION"

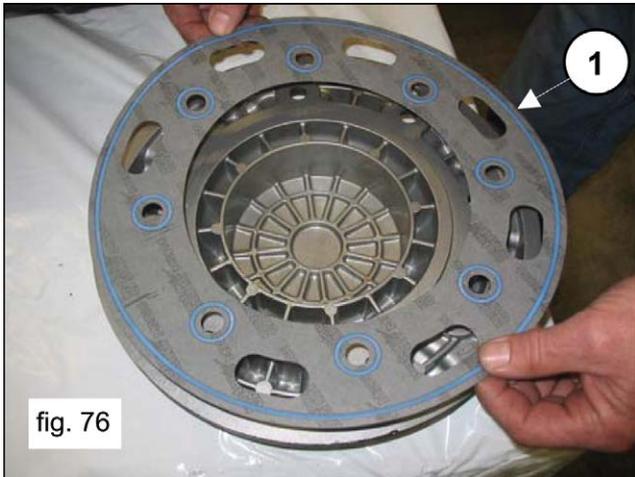
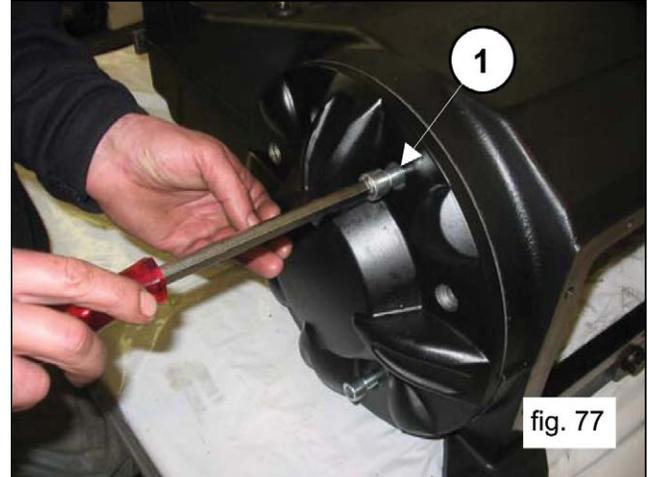
Assemble the bearing cover (and related gasket) (1, fig. 76) using 8 M12 x 30 screws (1, fig. 77).

Calibrate the screws with the torque wrench as indicated in paragraph 3. "SCREW CALIBRATION"

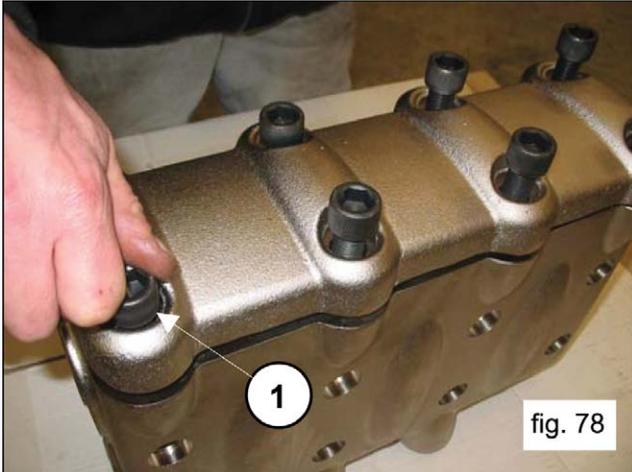
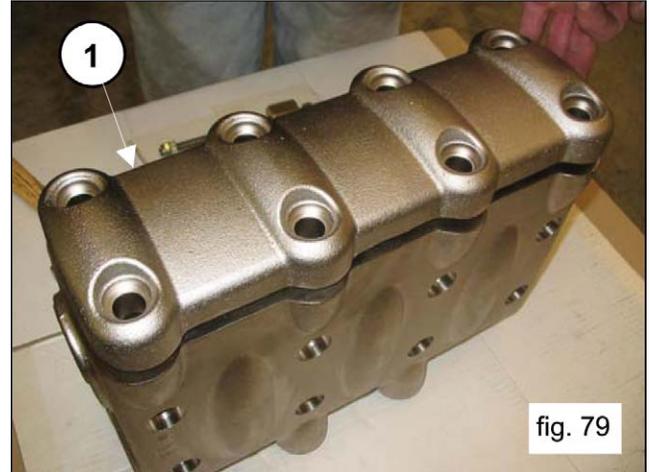
Unfasten the 8 M16 x 55 screws of the valve cover (1, fig. 78) and remove the cover (1, fig. 79).

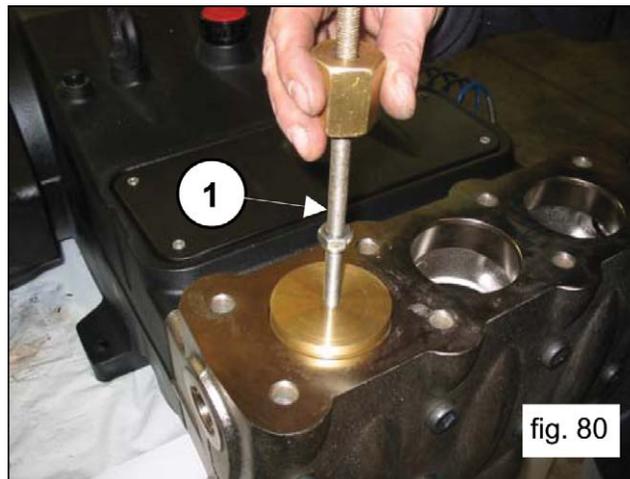
Extract the valve plug using a slide hammer applied to the M10 hole of the valve plug (1, fig. 80).

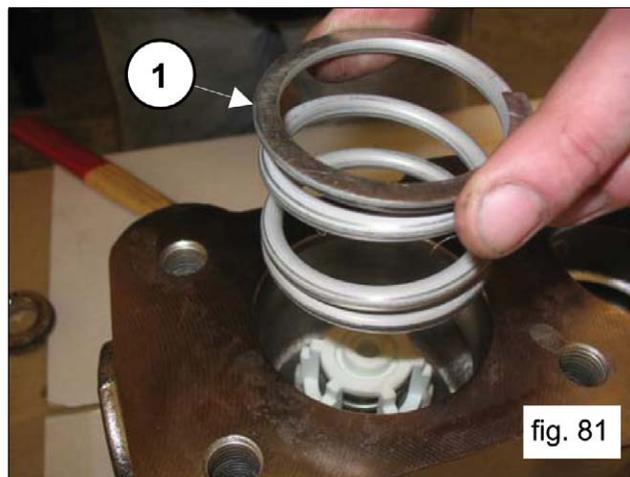
Remove the spring (1, fig. 81).

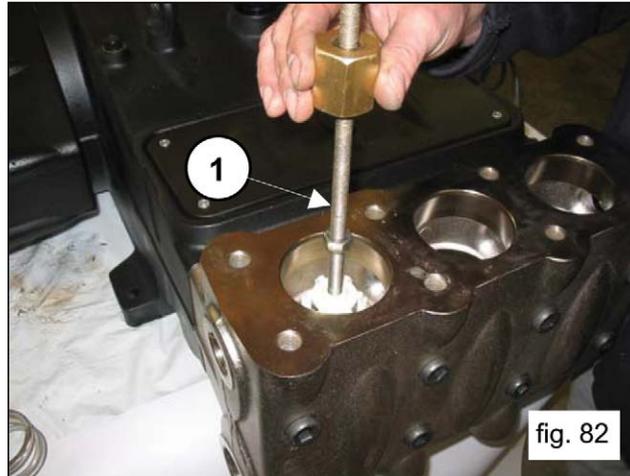
Extract the delivery valve unit using a slide hammer applied to the M10 hole of the valve guide (1, fig. 82)

If the extraction of the delivery valve unit is particularly difficult (for ex. due to incrustations caused by prolonged pump inactivity) use the extraction tool, p/n 27516400

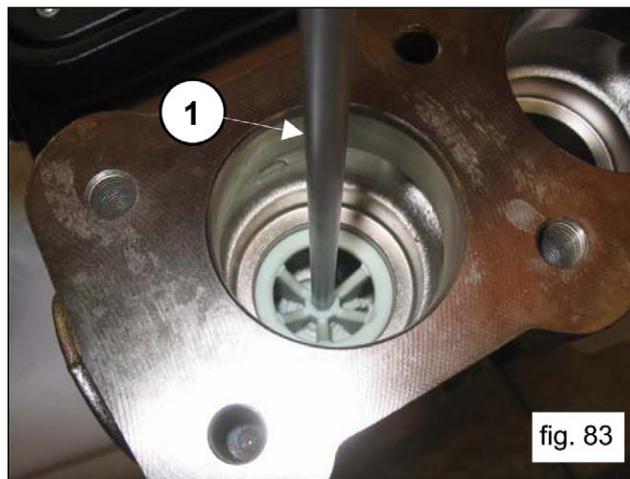
Unfasten the valve guide spacer using an 8 mm allen wrench (1, fig. 83).

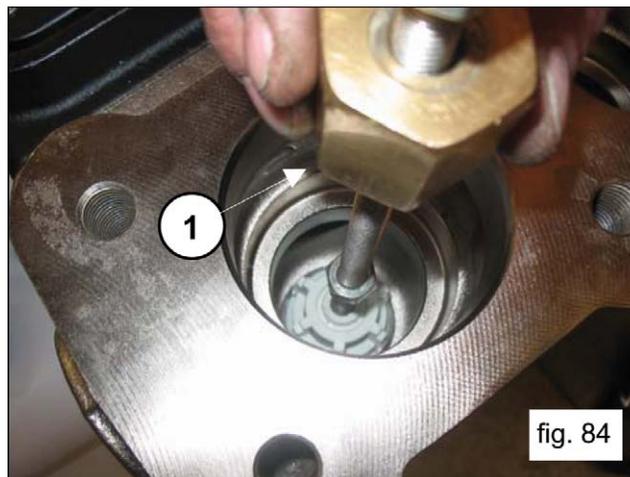
Remove the suction valve unit using a slide hammer applied to the M10 hole of the valve guide (1, fig. 84).

If the extraction of the of the suction valve unit is particularly difficult (for ex. due to incrustations caused by prolonged pump inactivity) use the extraction tool p/n 27516200 (for MK40A, MK45A, MK50A) or p/n 27516300 (for MK55A, MK60A and MK65A) (1, fig. 85) and act as indicated.

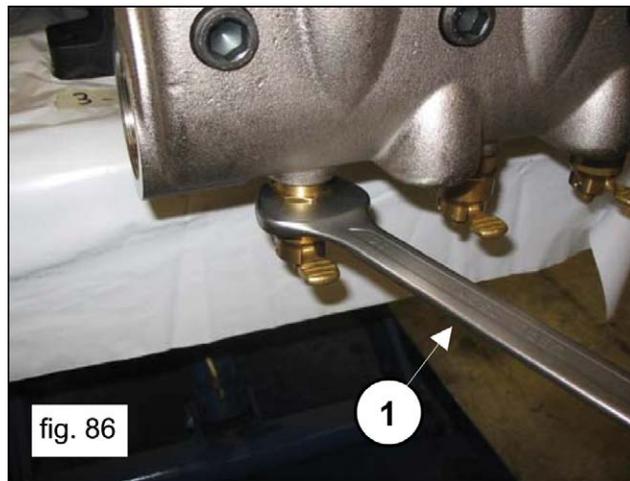
Unscrew the valve opening device using a 30 mm wrench (1, fig. 86).

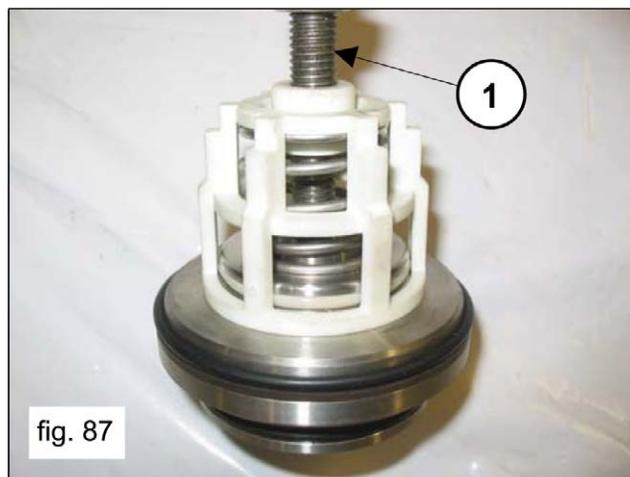
Disassemble the suction and delivery valve units by screwing on an M10 screw long enough to act on the valve and extract the valve guide from the valve seat (1, fig. 87).

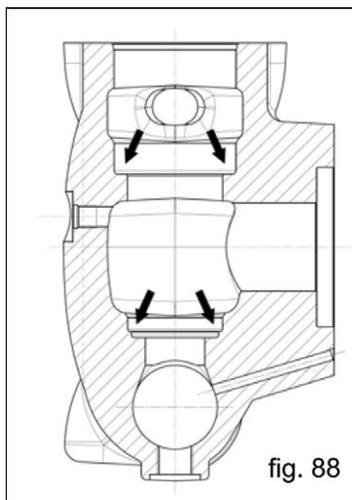
Before repositioning the valve units, clean and perfectly dry the relevant seats in the head indicated by the arrows (1, fig. 88).

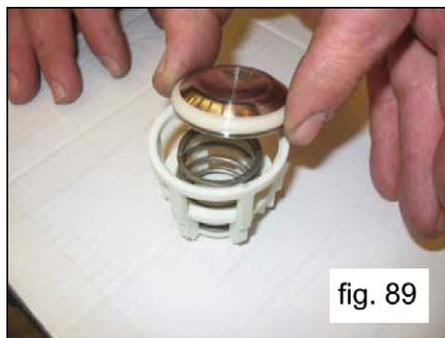
fig. 89

Assemble the suction and delivery valve units (fig. 89 and fig. 90) paying attention not to invert the previously disassembled springs.

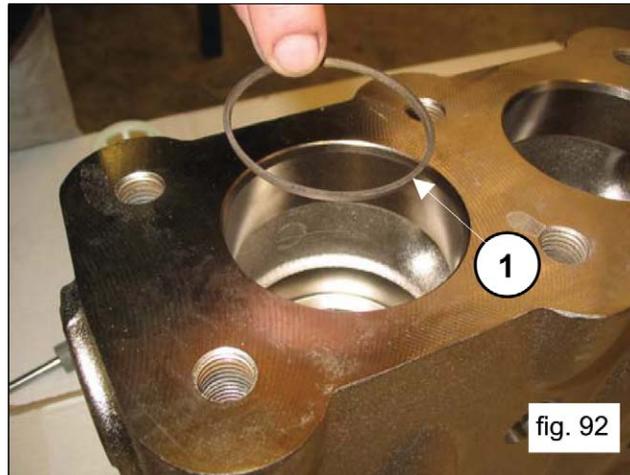
The correct assembly sequence of the valve units in the head is the following:
Insert the anti-extrusion ring, exploded view item 4 from Owner's Manual (1, fig. 92).

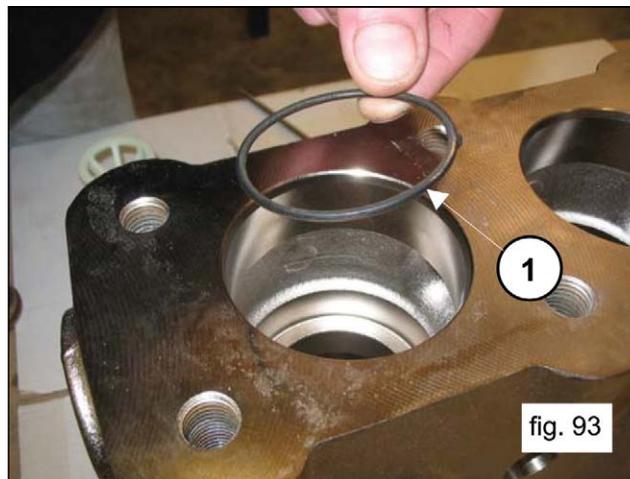
Insert the O-ring, exploded view item 5 from Owner's Manual (1, fig. 93).

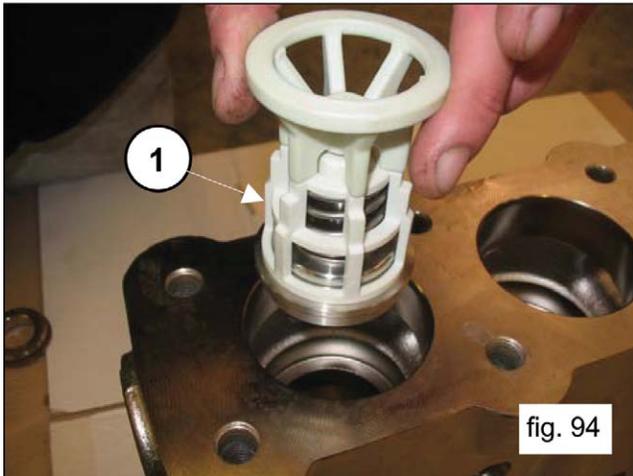
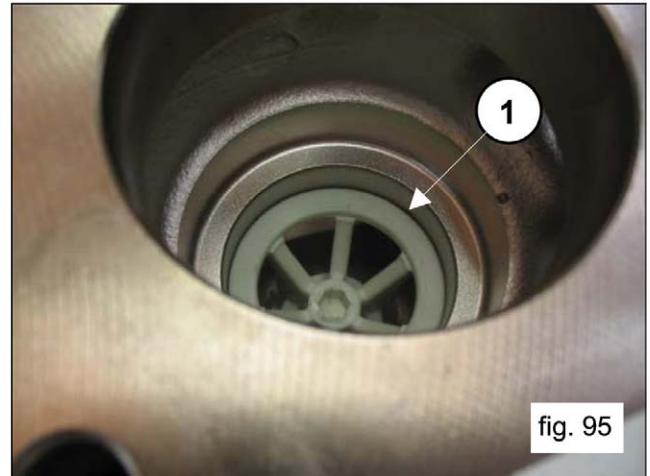
Be sure that the O-ring and the anti-extrusion ring are perfectly fit into their seats. Insert the suction valve unit together with the spacer (1, fig. 94). The valve unit must be fully inserted, as shown in 1, fig. 95.

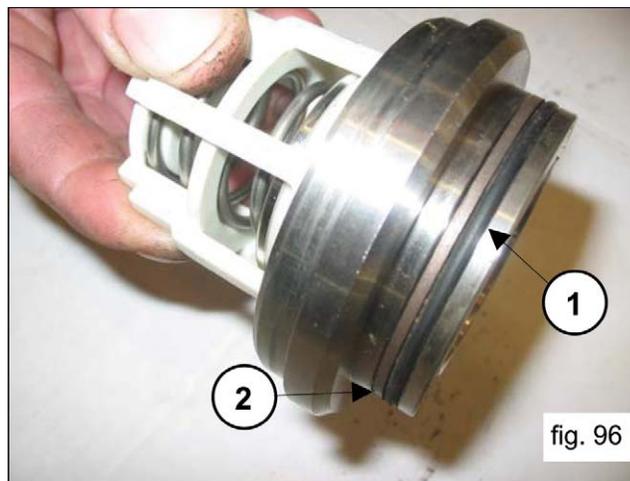
Mount the O-ring, exploded view item 5 from Owner's Manual (1, fig. 96) and the anti-extrusion ring, exploded view item 15 from Owner's Manual (2, fig. 96) on the delivery valve seat.

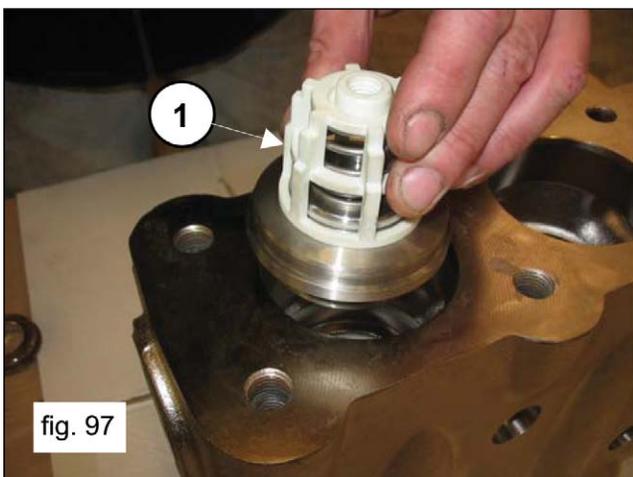
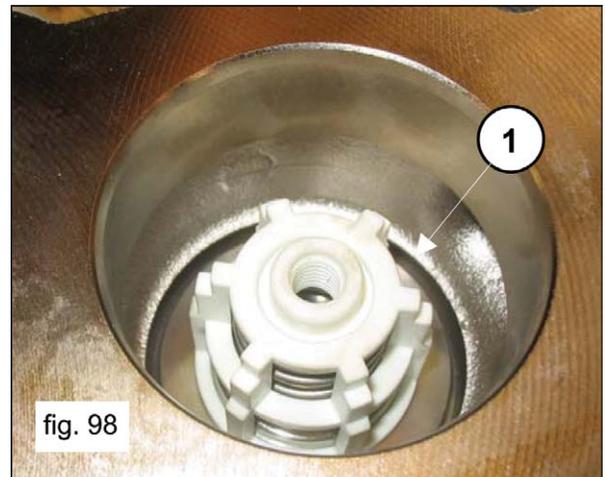
Insert the delivery valve unit (1, fig. 97). The valve unit must be fully inserted as shown in 1, fig. 98.

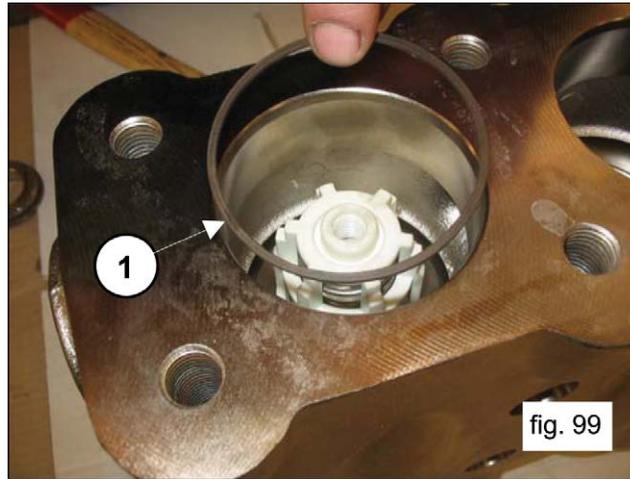
Insert the anti-extrusion ring, exploded view item 16 in Owner's Manual (1, fig. 99).

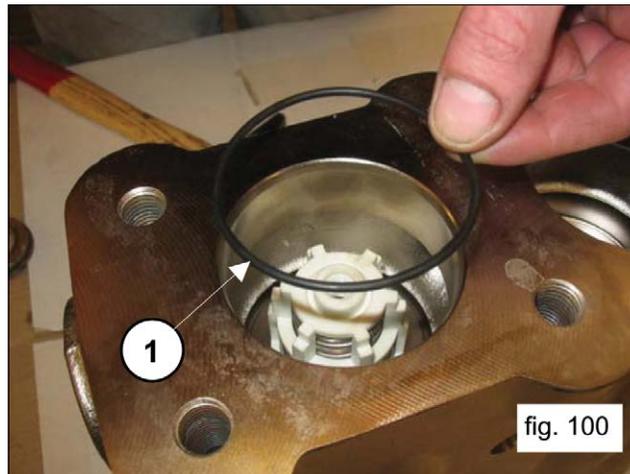
Insert the O-ring, exploded view item 17 in Owner's Manual, (1, fig. 100).

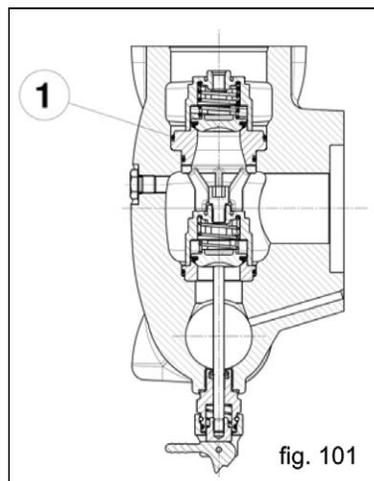
Pay particular attention when inserting the O-ring indicated in 1, fig. 101. We advise to use the correct tool p/n 27516000 (for MK40A, MK45A and MK50A) or p/n 27516100 (for MK55A, MK60A and MK65A) in order to avoid cutting the O-ring during insertion.

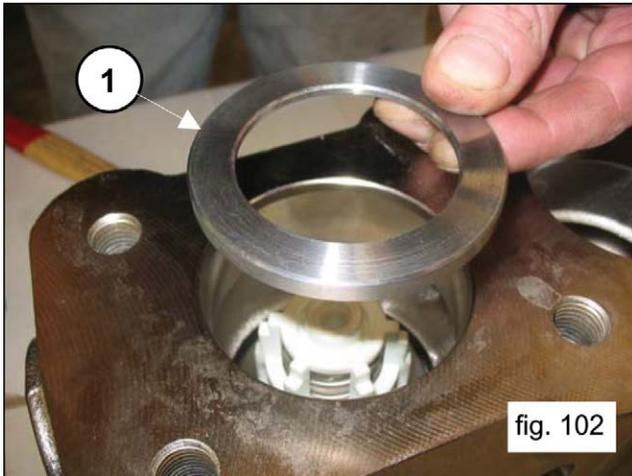
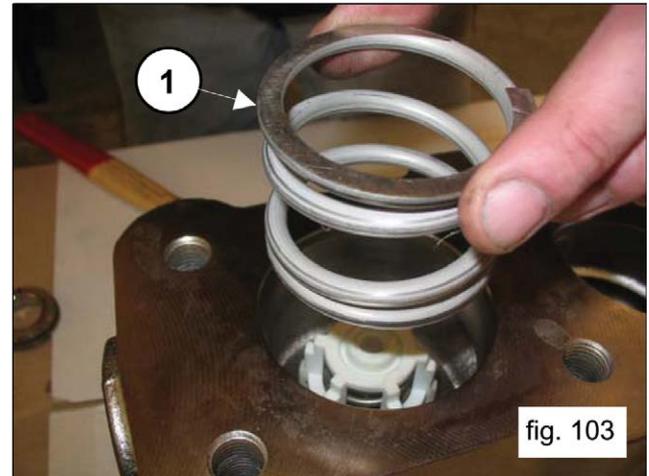
Insert the valve seat ring (1, fig 102) and the spring (1, fig. 103).

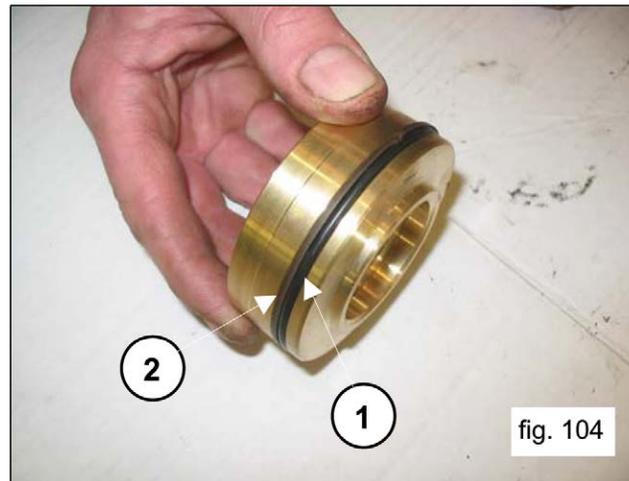
Assemble the O-ring, exploded view item 17 in Owner's Manual, (1, fig. 104) and the anti-extrusion ring, exploded view item 21 in Owner's Manual (2, fig. 104) on the delivery valve plug.

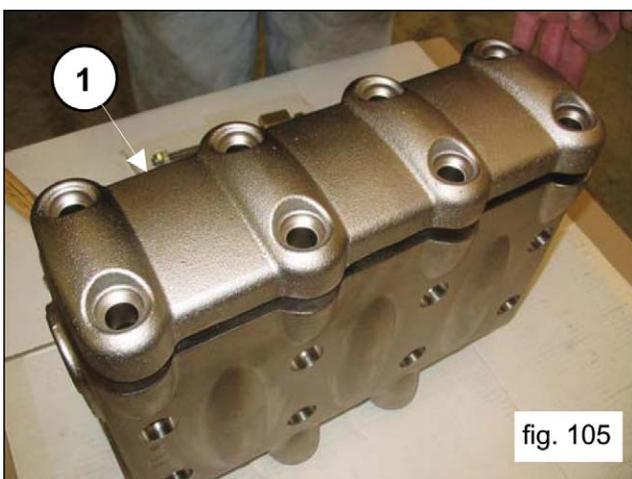
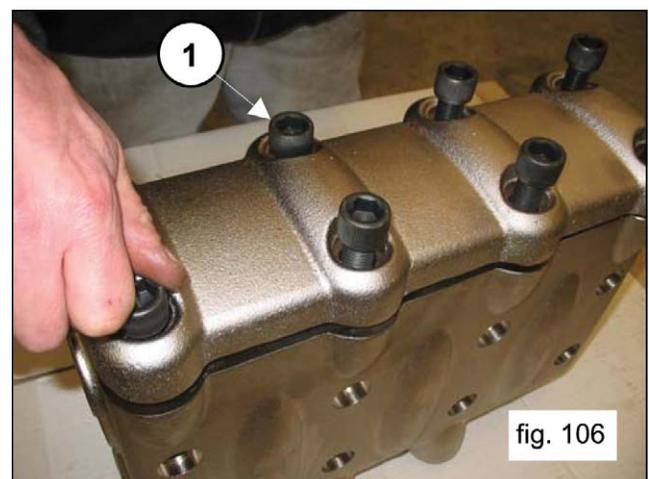
After assembling the valve unit and the valve plug, apply the valve cover (1, fig. 105) and screw on the 8 M16 x 55 screws (1, fig. 106).

Calibrate the M16 x 55 cover screws with the torque wrench as indicated in paragraph 3. "SCREW CALIBRATION"

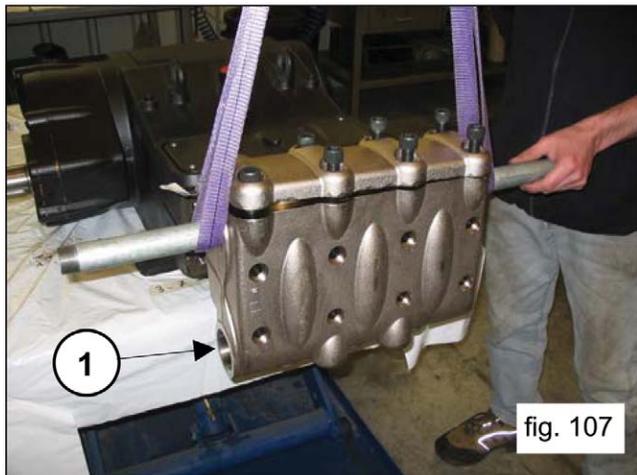
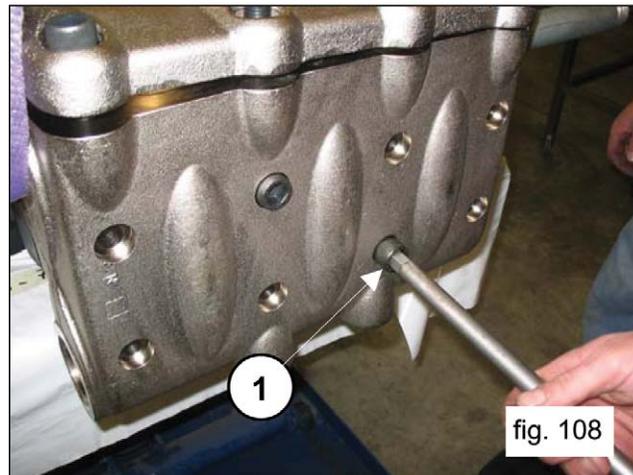
Assemble the head on the pump casing (1, fig. 107) being careful not to bump against the plungers, and fasten the 8 M16 x 180 screws (1, fig. 108).

Proceed with calibrating the M16 by 180 screws with the torque wrench as indicated in paragraph 3. "SCREW CALIBRATION"

Fasten the 8 M16 x 180 screws starting from the 4 internal screws cross-wise (see fig. 107), and then proceed with the 4 external screws, again fastening cross-wise.

** Tightening sequence always cross-wise starting from the 4 internal screws then the 4 external screws (see fig. 108)

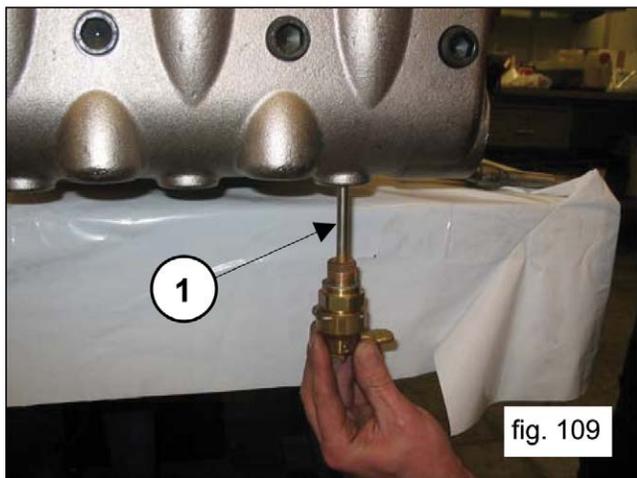
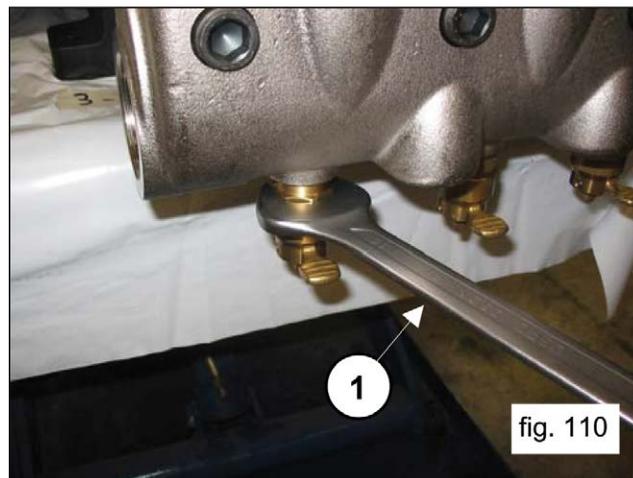
Apply the valve opening devices (1, fig. 109) and fasten them using a 30 mm wrench (1, fig. 110).

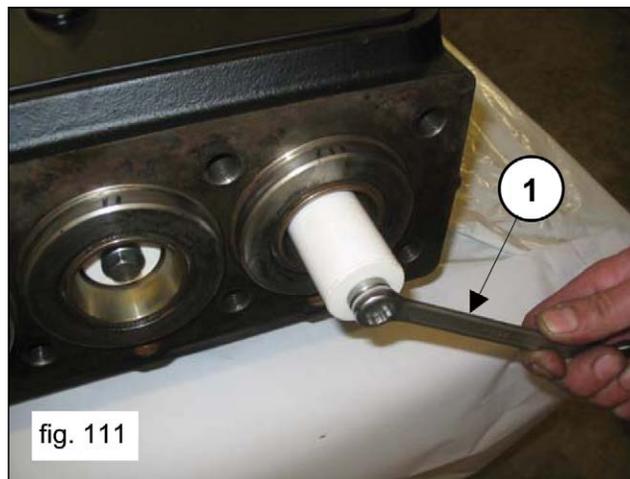
Disassemble the plungers by unfastening the screws (1, fig. 111).

Remove the plunger from the packing support and check that there are no scratches, or signs of wear or cavitation.

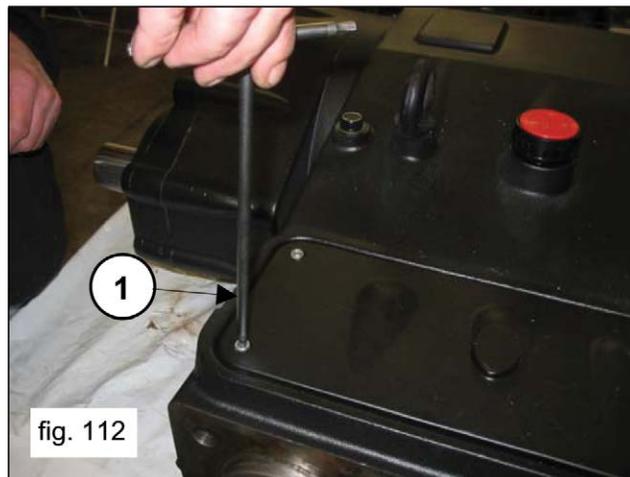
Remove the upper inspection cover by unscrewing the 4 fastening screws (1, fig. 112).

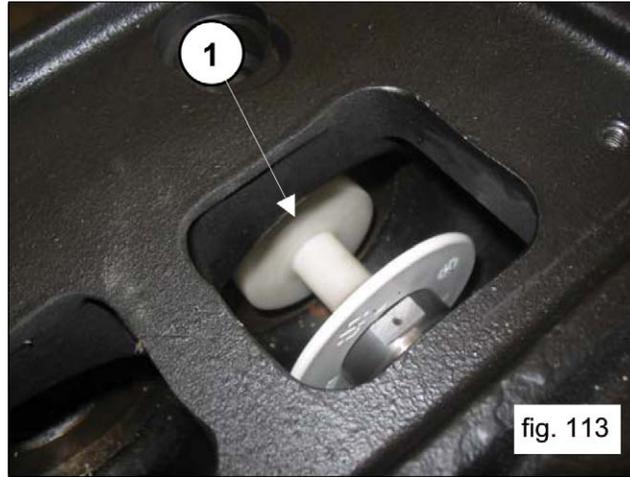
Manually rotate the shaft so that the 3 plungers are in the top dead center position.
Insert the stopper tool p/n 27516600 between the plunger guide and the plunger (1, fig 113).

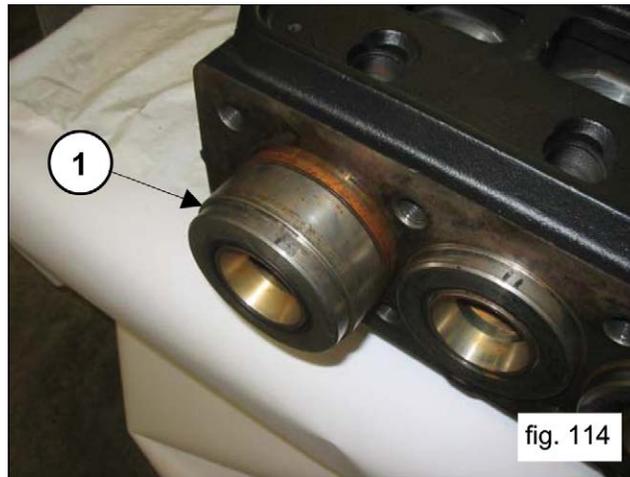
Turning the shaft, move the plunger forward so that the stopper, moving forward itself, can push out the packing support and the entire plunger unit (1, fig. 114).

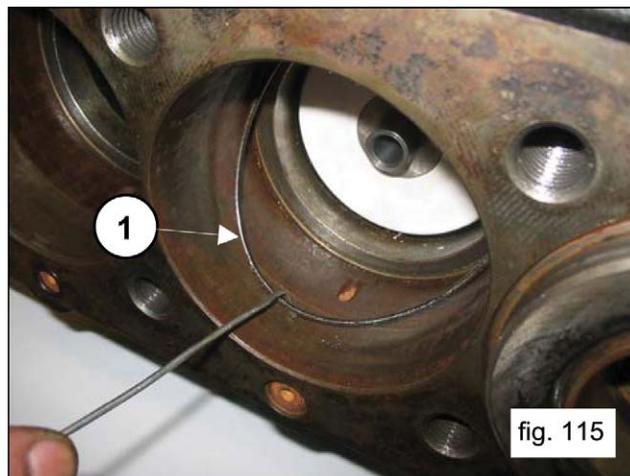
Remove the packing support O-ring if it remains inside the pump case (1, fig. 115)

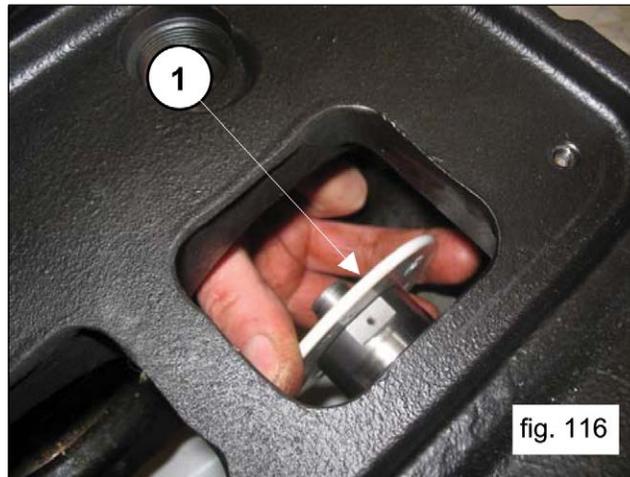
Remove the wiper rings from the plunger guides (1, fig. 116).

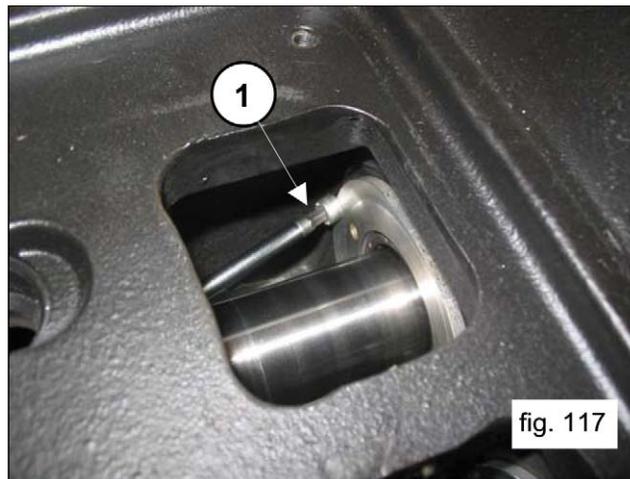
If replacement of the plunger guide oil seal is needed, disassemble the oil seal cover by operating as follows: Unfasten the two screws of the oil seal cover (1, fig. 117).

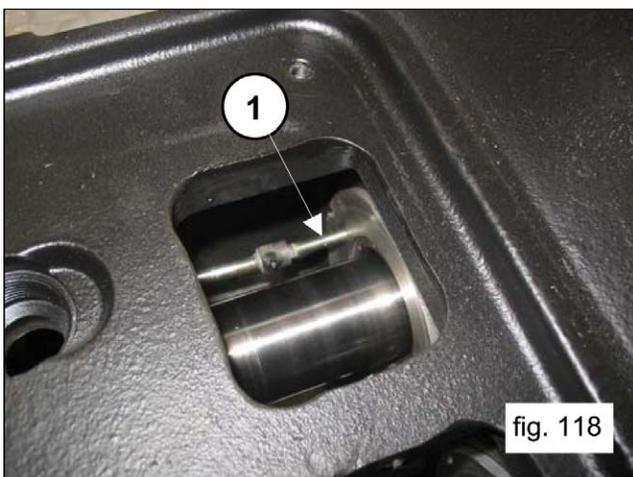
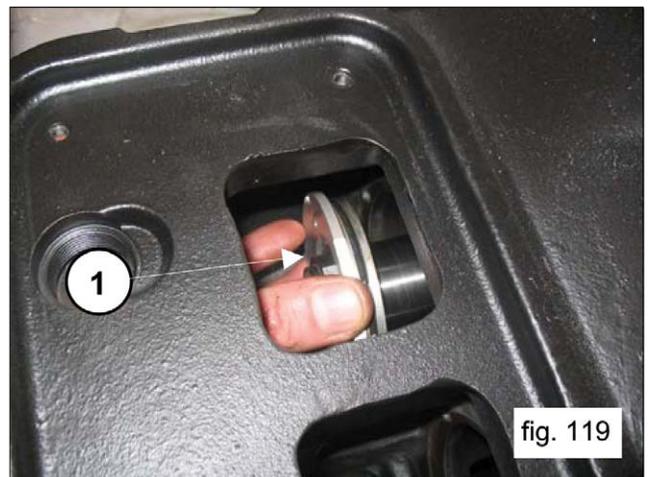
Extract the oil seal cover by screwing a threaded M5 bar or screw into the correct holes on the cover (1 fig. 118); extract the oil seal cover from the pump unit (1, fig. 119).

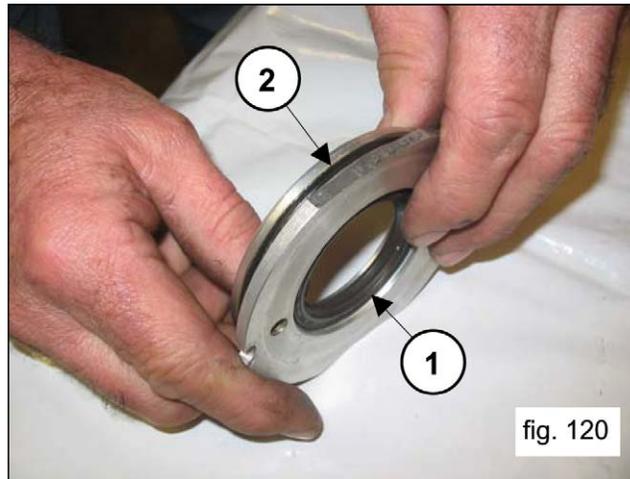
Replace the oil seal (1, fig. 120) and the external O-ring (2, fig. 120).

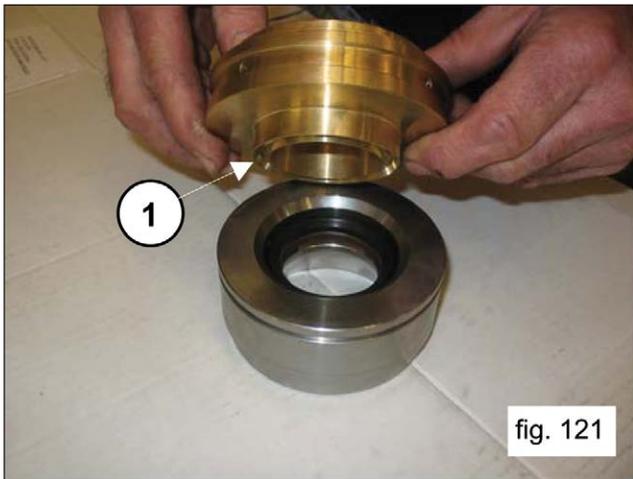
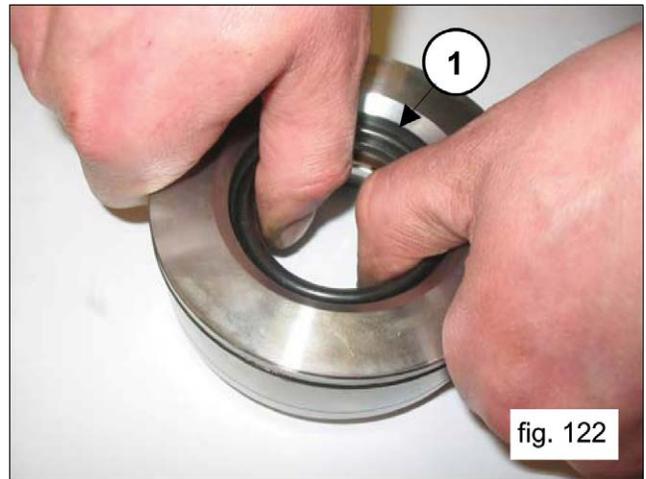
Separate the packing support from the liner (1, fig. 121) to access the pressure packings (1, fig. 122).

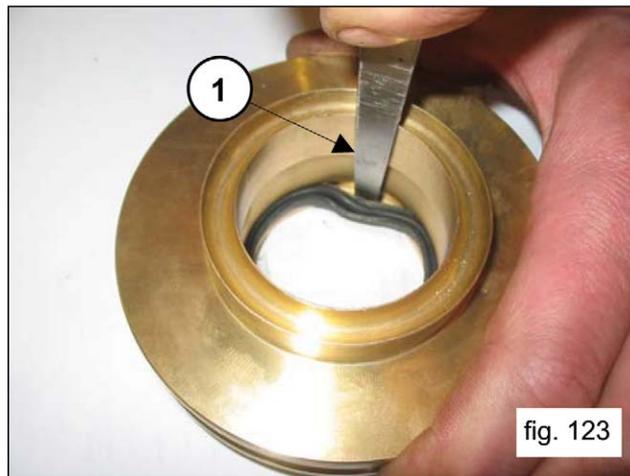
To remove the low pressure packing, use a shim or another tool that doesn't damage the seat of the packing support (1, fig. 123).

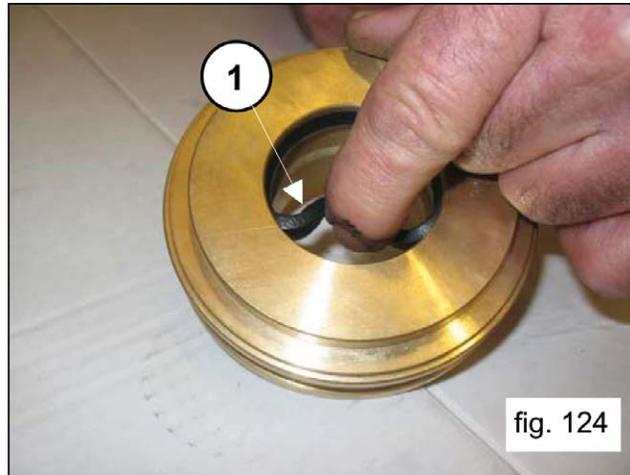
Insert the low pressure packings in the packing support (1, fig 124), being careful that the sealing lips are facing frontwards (toward the head).

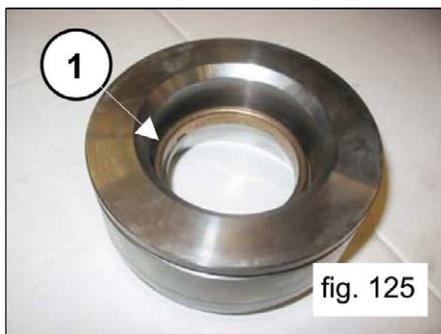
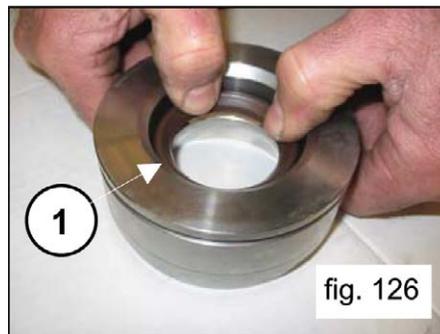
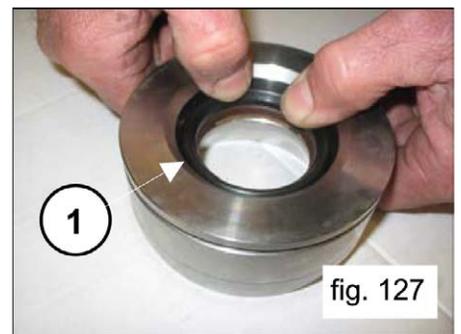
Assemble the head ring (1, fig. 125), the high pressure packing (1, fig. 126) and the restop ring (1, fig. 127).

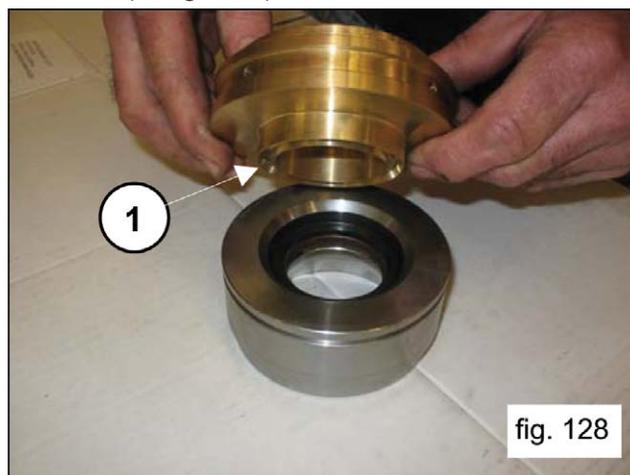
Couple the packing support to the liner (1, fig. 128).

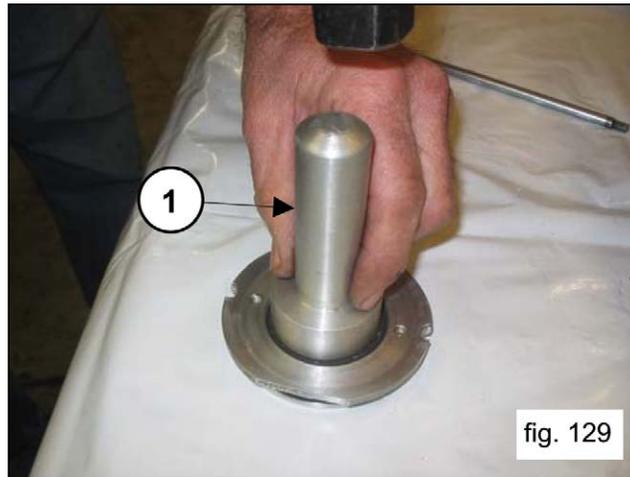
Insert the oil seal in its cover (1, fig. 129) using a stopper p/n 27515800.

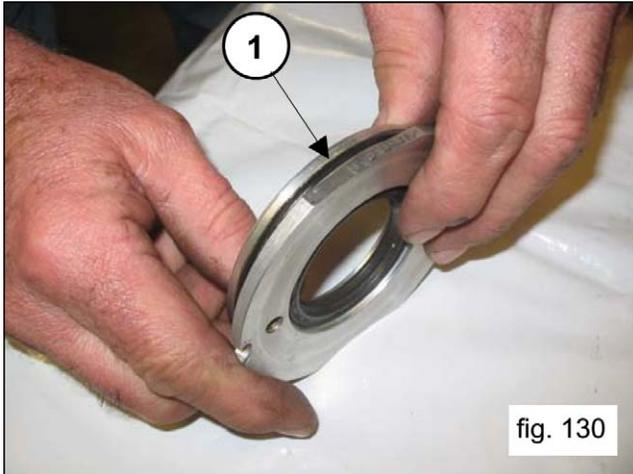
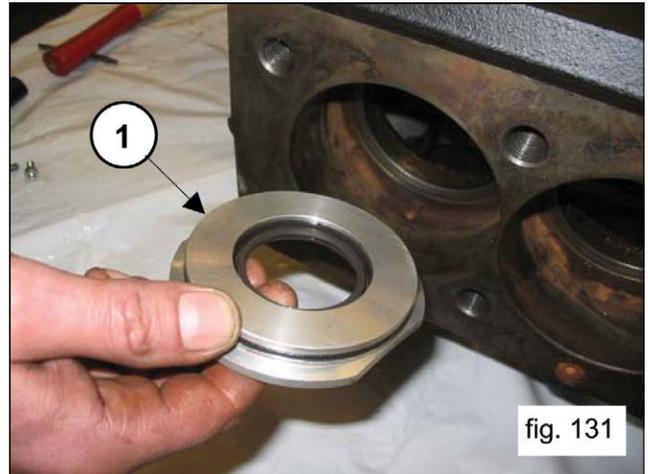
Position the O-ring (1, fig. 130) in its seat on the oil seal cover, and insert the assembled unit inside the crankcase in the correct space (1, fig. 131).

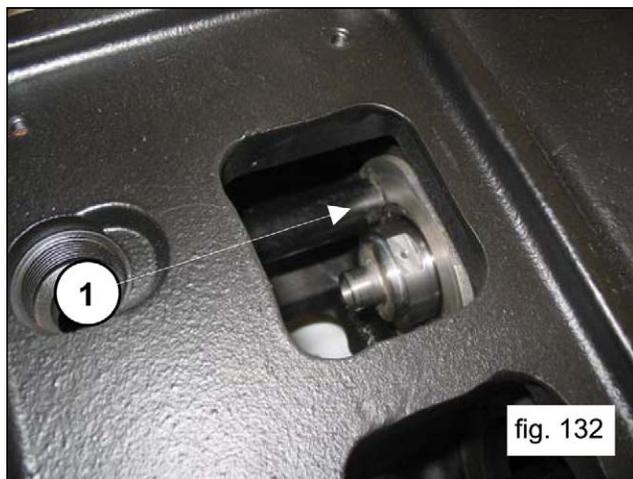
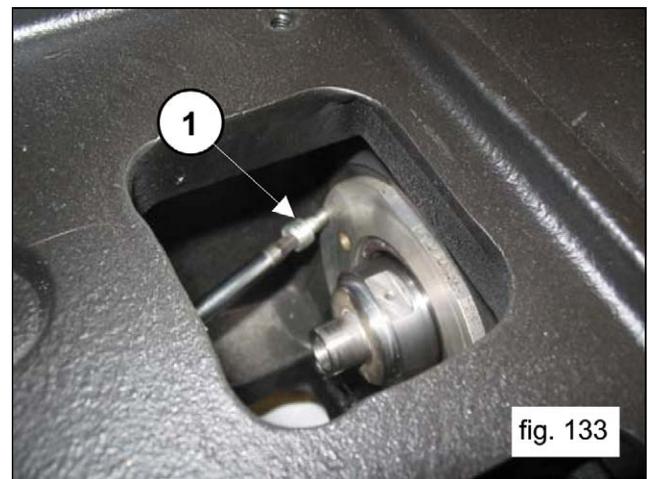
Perfectly insert the cover into its seat (1, fig. 132) being careful not to damage the oil seal lip. Fasten the oil seal cover with 2 M6 x 14 screws (1, fig. 133).

Calibrate the screws using a torque wrench as indicated in paragraph 3. "SCREW CALIBRATION"

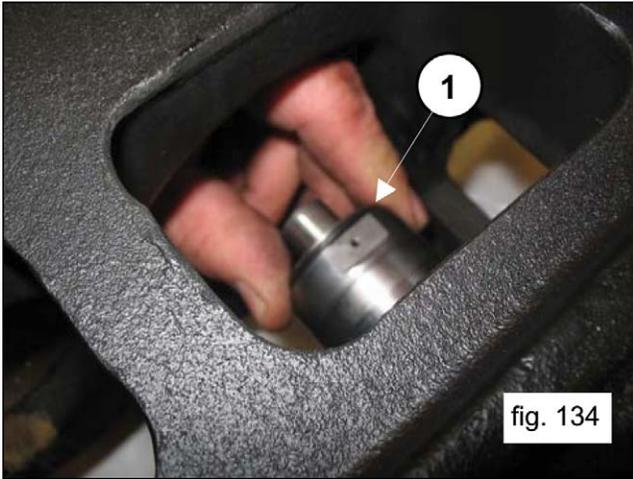
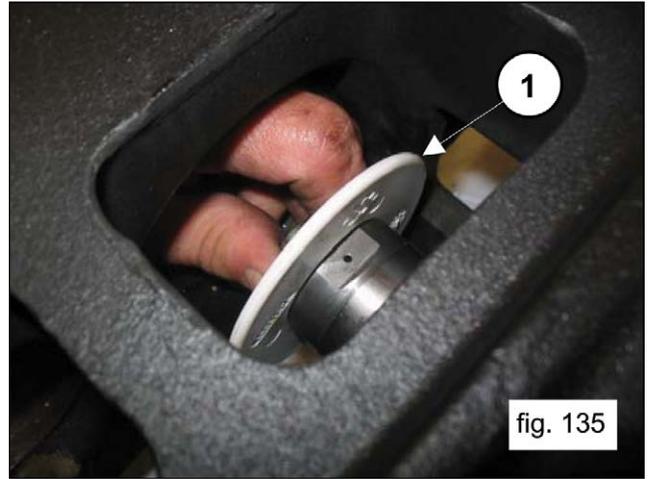
Position the wiper complete with its O-rings in its seat on the plunger guide (1, fig. 134 and fig. 135).

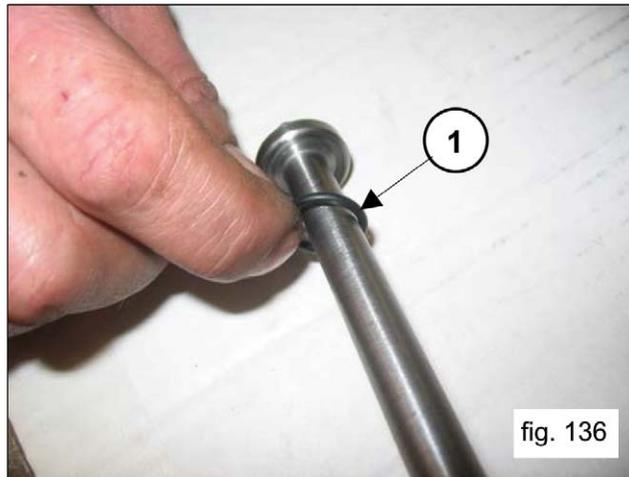
Insert the 14 x 2 O-ring in its correct seat on the plunger bolt (1, fig. 136).

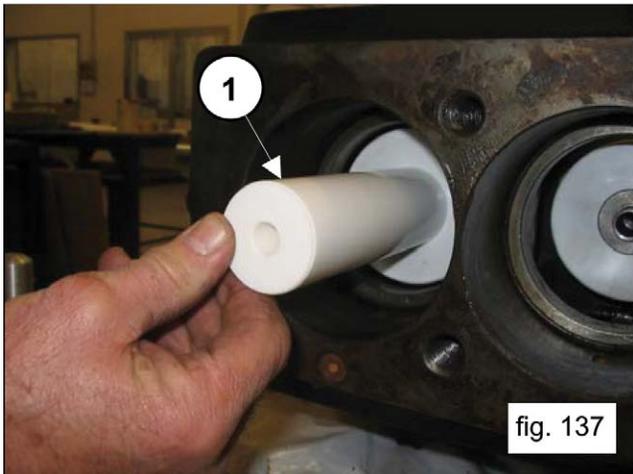
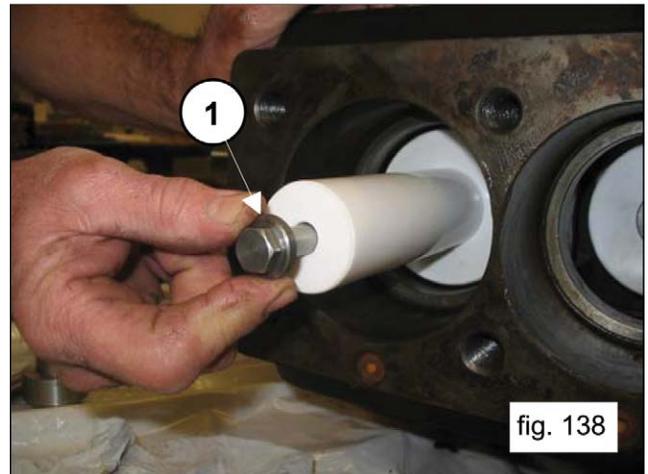
Assemble the plungers on their respective guides (1, fig. 137) and fasten them as in 1, fig. 138).

Calibrate the screws using the torque wrench as indicated in paragraph 3. "SCREW CALIBRATION"

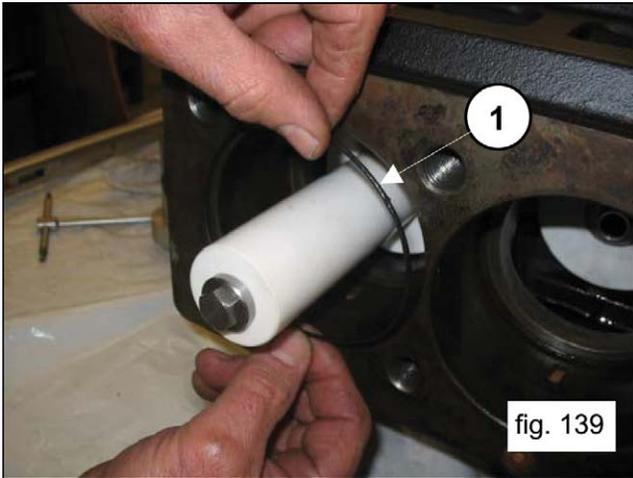
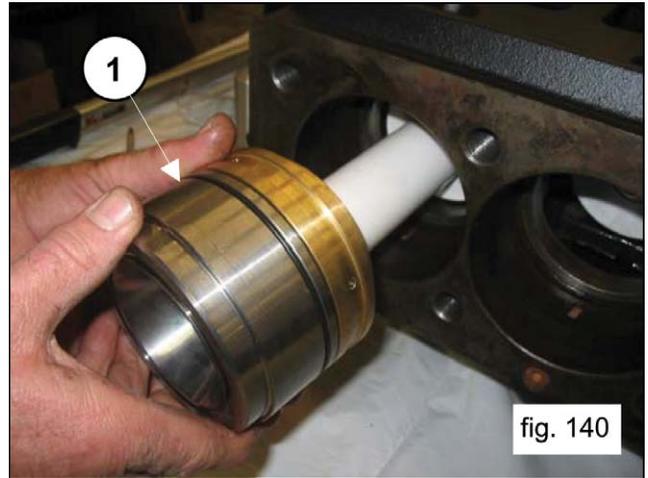
Insert the O-ring inside the pump case (1, fig. 139), followed by the previously assembled liner-packing support unit (complete with the O-ring), (1, fig. 140).

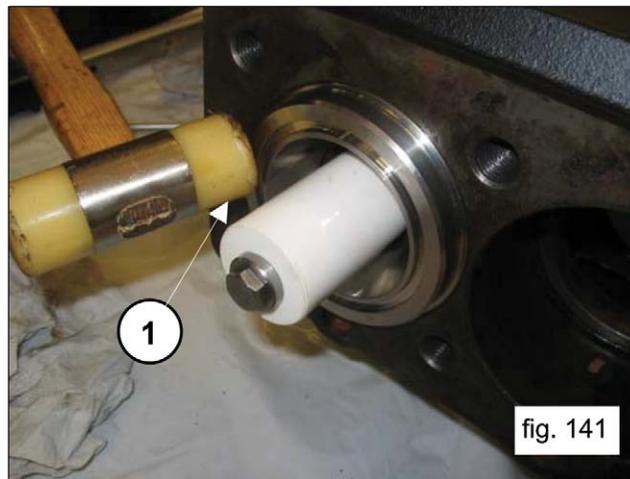
Be sure that the liner-support unit is correctly positioned in its seat (1, fig. 141).

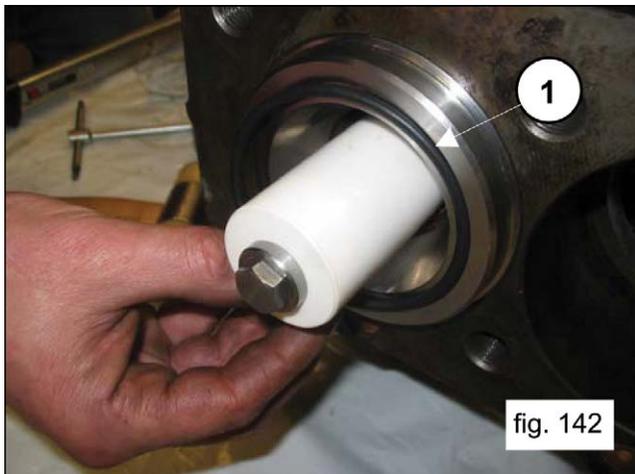
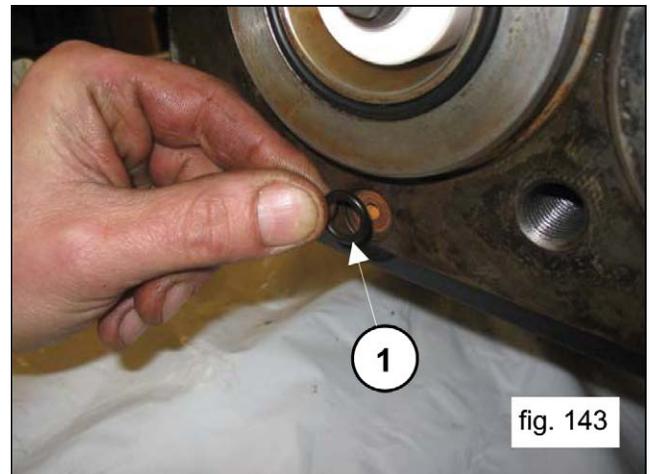
Assemble the liner's front O-ring (1, fig. 142) and the O-ring of the recirculation hole (1, fig. 143).

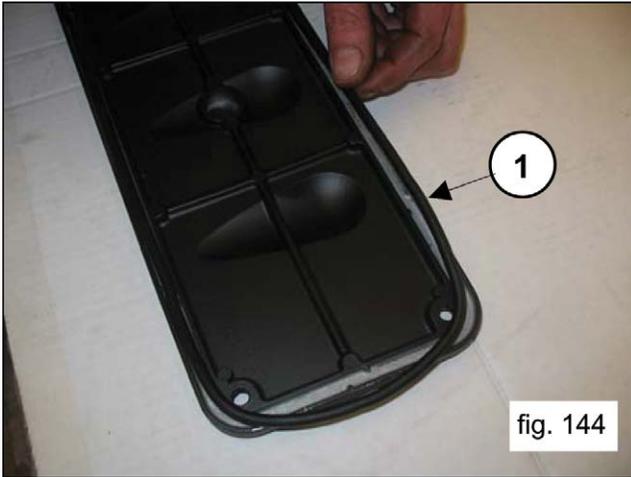
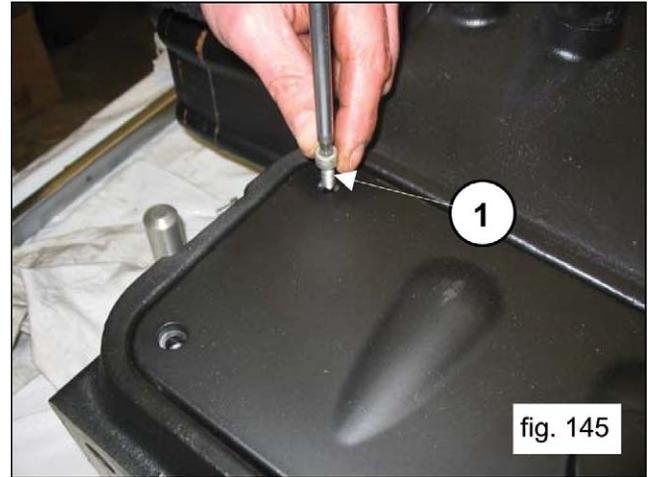
Insert the O-ring on the inspection covers (1, fig. 144) and mount the covers using 4 + 4 M6 x 14 screws (1, fig. 145).

Calibrate the screws with the torque wrench as indicated in paragraph 3. "SCREW CALIBRATION"
