Repair Manual

MK40A-MK45A-MK50A

MK55A-MK60A-MK65A

This manual describes the instructions for Repairing MK Series pumps, and must be carefully read and understood before performing any repair intervention on the pump. Correct use and adequate maintenance is fundamental for the pump's regular operation and long wear. General Pump declines any responsibility for damage caused by the misuse or the non-observance of the instructions described in this manual.

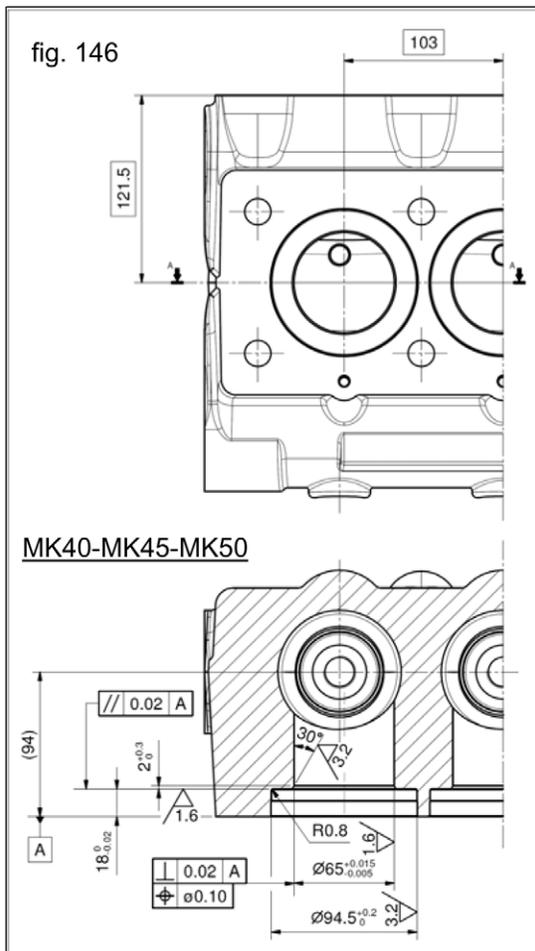
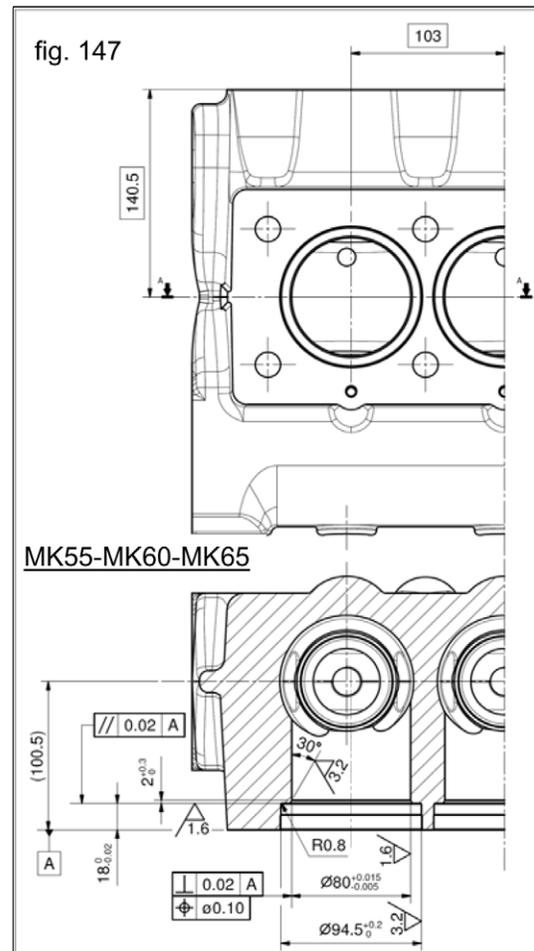
Manifold cavitation damages around the three cylinder bores can be fixed by re-tooling the damaged bores to a larger diameter (see fig. 146 for MK40A, 45A-50A and fig. 148 for MK55A-60A-65A).

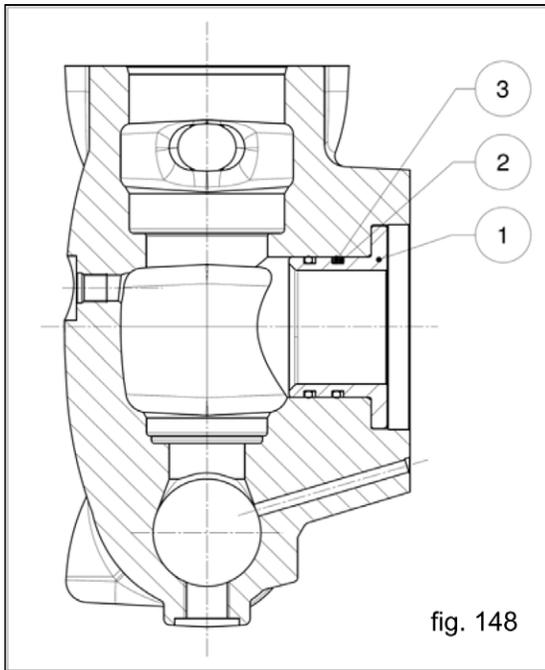
After re-tooling, three steel bushings designed to restore the original bores have to be driven in the manifold along with relevant O-rings and anti-extrusion rings as shown in fig. 148 and 149.

1. 3 pcs. x p/n F74215156 bushings MK40A-45A-50A
2. 6 pcs. x p/n F90526880 anti-extrusion rings
3. 6 pcs. x p/n F90410200 O-rings

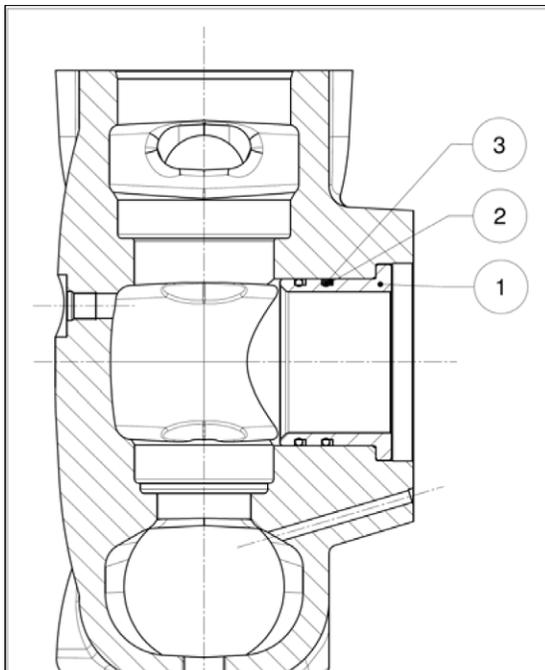
1. 3 pcs. x p/n F74215056 bushings MK55A-60A-65A
2. 6 pcs. x p/n F90528500 anti-extrusion rings
3. 6 pcs. x p/n F90412900 O-rings
