Repair Manual

GENERAL PUMP A member of the Interpump Group

PHTCK3623S

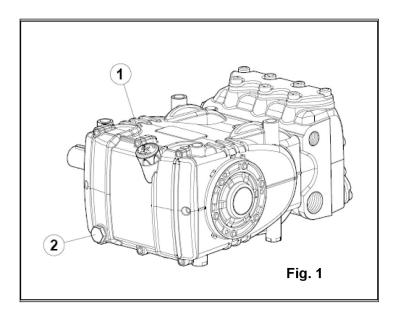
Mechanical parts repair must be performed after the oil has been removed from the casing. To drain the oil, remove the oil dipstick, (1, fig. 1) and then the draining plug (2, fig. 1).

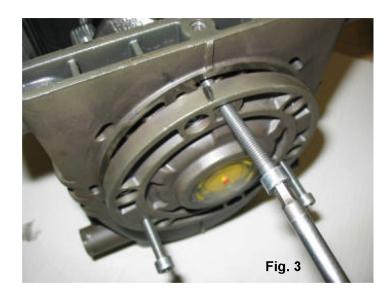
- the side covers using - for extraction - 3 fully threaded M6x50 screws, inserting them in the threaded holes as indicated in fig. 3.

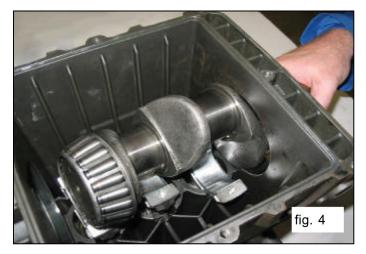
-push the plunger guides forward with their con-rods to facilitate side extraction of the pump shaft as shown in fig. 4

To facilitate pump shaft insertion (without the tab), it is essential to repeat the operation performed during disassembly, pushing the piston/con-rod guide units as far down as possible (paragraph 2.2.1).

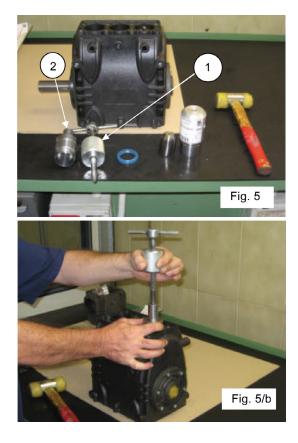
Use the extractor, p/n F26019400 (fig. 5, 1) and the gripper p/n 27503800 (fig. 5, 2). Insert the gripper as far as possible onto the seal ring with the aid of a hammer (fig. 5a), subsequently screwing the extractor to the gripper, and use the extractor hammer (fig. 5b) until the ring to be replaced is removed (fig. 5c).

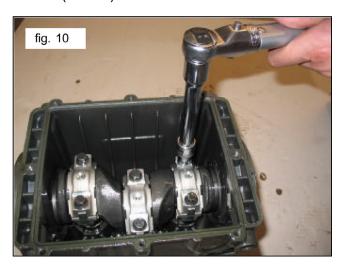
Fasten the caps to their respective con-rod shanks by means of M8x1x42 screws (fig. 10) lubricating both the underhead and the threaded shank. Proceeding in two different stages.

- 1. Manually turn the screws until they begin to tighten
- 2. Tighten torque: 22 ft.lbs. (30 Nm)

- 1. Pre-tightening torque: 7-11 ft.lbs. (10-15 Nm)
- 2. Tightening torque: 22 ft.lbs. (30 Nm)

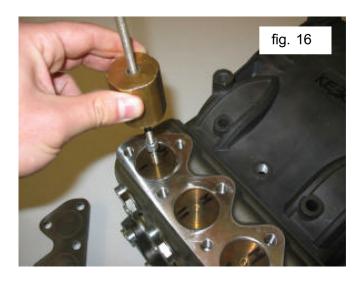
- -Unscrew the 7 M12x35 valve cover fixing screws and remove covers (fig. 16, 16a).
- -Extract valve plugs by means of an extractor hammer or an M6 threaded car (fig. 16)
- -Extract valve units using a gripper (fig. 16a).

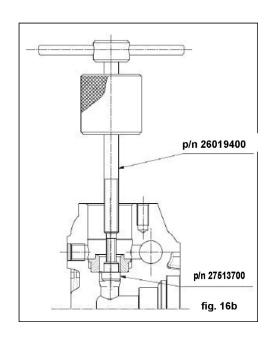
-using extractor tool p/n 26019400 combined with tool p/n 27513700 (fig. 16b).

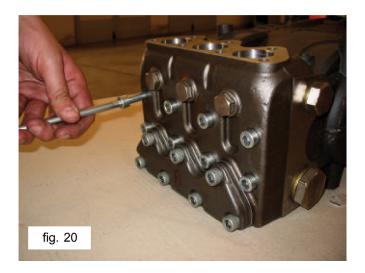
A) Unscrew the M10x110 head fixing screws as indicated in fig. 20.

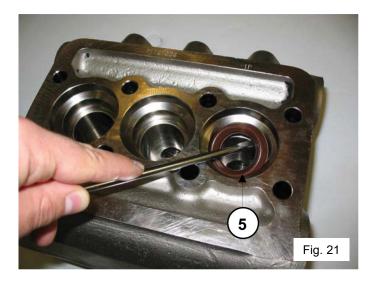
- B) Remove the head from the crankcase
- C) Extract the high pressure seals from the head, and the low pressure seals from their related support by using standard tools as shown fig. 21; be careful not to damage the seals.

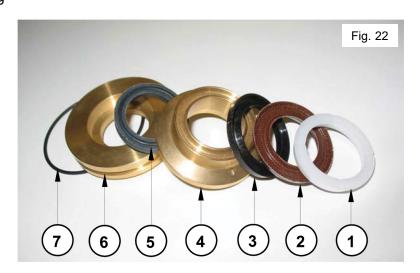
Pay attention to the order of seal pack disassembly as indicated in fig. 23 composed of:

- 1. Head Ring
- 2. High Pressure Seal
- 3. Restop Ring
- 4. Packing Support
- 5. Low Pressure Seal
- 6. Sealing Ring
- 7. Circlip
- 8. O-ring

- A) Seals pack: respect the same order used during disassembly operations.
- B) Lubricate components 1 and 3 with OCILIS 250 silicone grease p/n 12001600; only on the external diameter.
- C) For correct assembly of HP seals in their housing on the head without causing any damage to lip seals, use suitable tools according to the pump diameters as indicated in Chapter 5.
- D) Replace the piston, tightening the screws with a torque wrench, respecting the tightening torque as indicated in Chapter 3.
- E) Assembling the head: for the values of the torques and tightening sequences follow the instructions in Chapter 3.

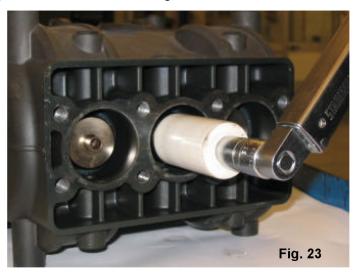
A) Unscrew the piston fixing screws as indicated in fig. 23.

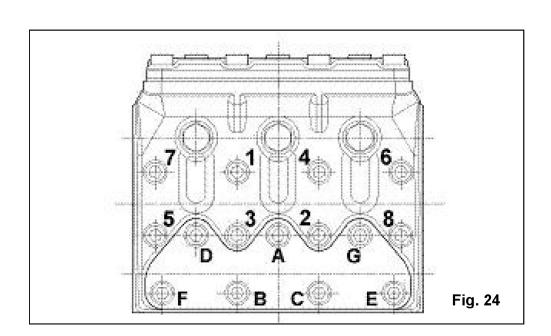
respecting the stages indicated on page 7
** The head fixing screws must be tightened with a

torque wrench, lubricating the underhead, respecting the order in fig. 24
*** The valve cover fixing screws must be tightened with a torque wrench, lubricating the underhead, respecting the order in fig. 24

Description	Exploded Drawing Position #	Tightening Torque		
Cover fixing screw	9	7.4 ft.lbs. (10 Nm)		
Piston fixing screw	28	14.8 ft.lbs (20 Nm)		
Connecting rod cap fixing screw	16	22.1 ft.lbs (30 Nm)*		
Head fixing screw	39	29.5 ft.lbs (40 Nm)**		
Valve cover fixing screws	40	59.0 ft.lbs (80 Nm)***		
Oil discharge plug	11	29.5 ft.lbs (40 Nm)		
G1" outlet plug	31	73.8 ft.lbs (100 Nm)		
G1-1/2" suction plug	29	88.5 ft.lbs (120 Nm)		
Type "A" flange fixing screw	66	16.2 ft.lbs (22 Nm)

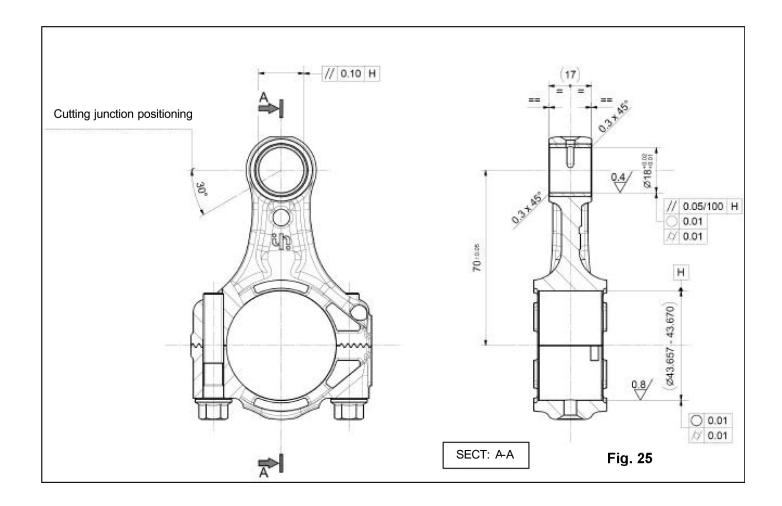
- the lubrication hole coincides with the corresponding hole on the connecting rod;
- the cutting junction is directed as shown in fig. 25

Then perform mechanical processing. The dimensions and tolerances shown in fig. 25 MUST be respected.
